NATIONAL TRANSPORTATION SAFETY BOARD

2024

SAFER SEAS Digest

Lessons Learned from
Marine Investigations

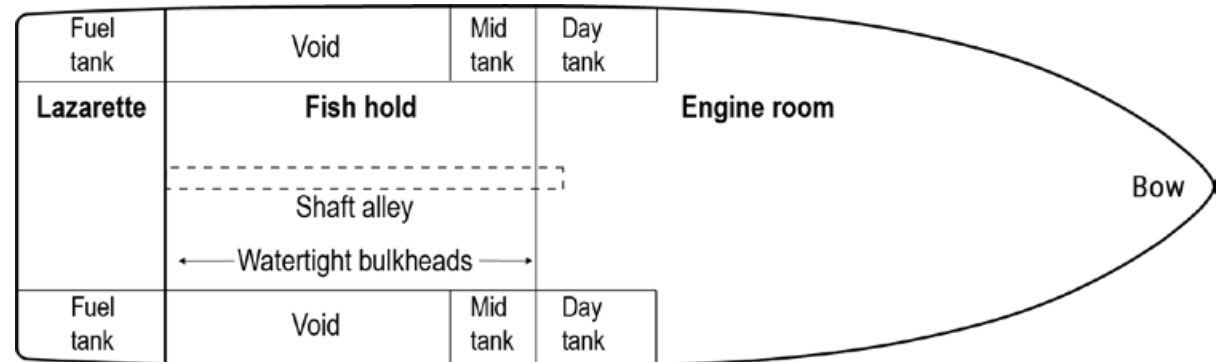
About 3 weeks before the casualty voyage, a hole in the hull had been repaired. There was no evidence that the vessel was damaged or that flooding originated from another source; it is possible that the flooding was caused by deterioration of the hull plating in another area, which went undetected.

THE PROBABLE CAUSE of the capsizing and sinking of fishing vessel *Hotspur* was flooding from an unknown source into the lazarette or the port void space, causing the vessel to lose stability, capsize, and sink.

Layout of *Hotspur* lower level, based on owner's drawing (not to scale).

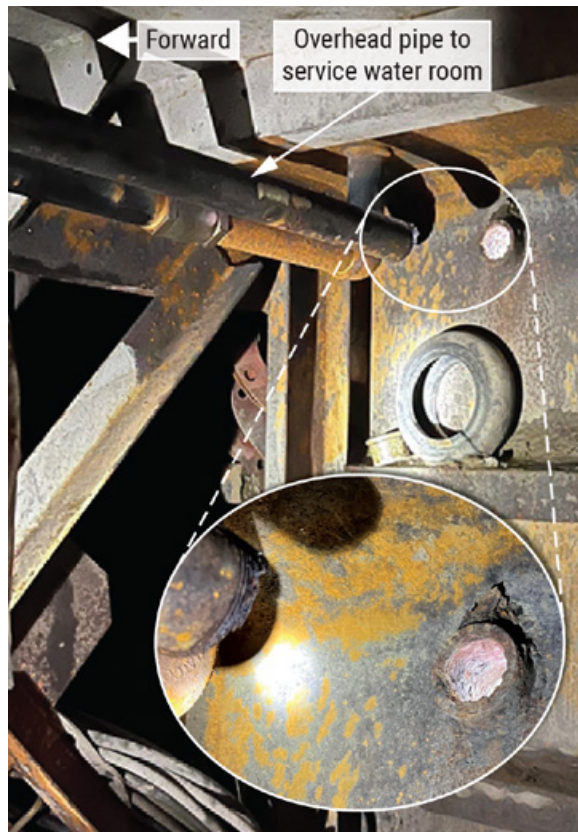
Postrecovery, a 2-inch through-hull pipe into the starboard storage space was found to be open, as its overboard check valve was missing and likely had been since before the casualty. The center of the through-hull pipe was about 5 inches above the dredge's normal waterline, so waves, a list to starboard, and/or an increase in stern trim could have submerged

the opening, allowing water to enter the storage space. Thus, it is likely that the initial starboard list was caused by flooding through the unsecurable through-hull pipe.

The starboard storage space showing the overhead pipe and the 2-inch through-hull pipe. Inset: The end of the overhead pipe and the unsecured through-hull pipe. SOURCE: COAST GUARD.

Vessel crews should regularly check tanks and voids that are adjacent to the vessel's hull to identify hull integrity issues (such as potential corrosion and steel wastage, and watertight integrity deficiencies) that can lead to flooding. The presence of water can indicate an issue with watertight integrity or wastage and should be addressed. Vessel operators should ensure crews have procedures for anticipating, preventing, and addressing the potential for water ingress and flooding, including establishing scheduled checks. Bilge alarms set to detect water at a low level in voids and other spaces are another means to ensure early detection.

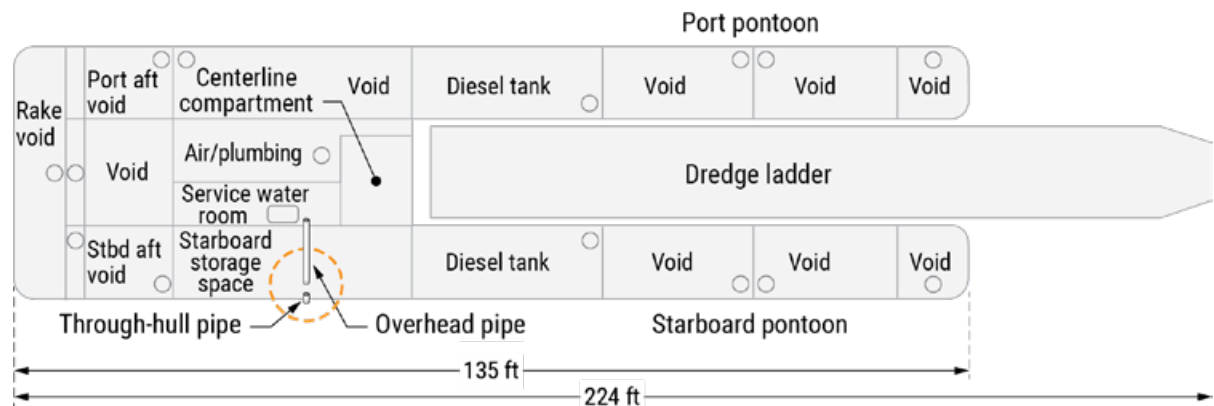
Investigators found wastage holes along the bottom 10 inches of the transverse forward bulkhead of the starboard aft void. If the adjacent starboard storage space flooded first, the water level in the starboard aft void would eventually increase from communication with the storage space. Additionally, investigators found that the 2-inch through-hull pipe with the missing valve ran transversely along the overhead from the storage space and through the bulkhead into the service water room—where it was uncapped. Therefore, once the storage space filled with water, it would have begun flooding the service water room. The only

THE PROBABLE CAUSE of the capsizing of the dredging vessel *WB Wood* was a lack of company requirements for crew to regularly check compartments below deck, which resulted in undetected flooding from a through-hull pipe that was missing its overboard check valve and subsequent progressive flooding from compromised watertight bulkheads.

Approximate plan view of the *WB Wood*'s hull below the main deck (not to scale). Hatches on the main deck are depicted as circles.

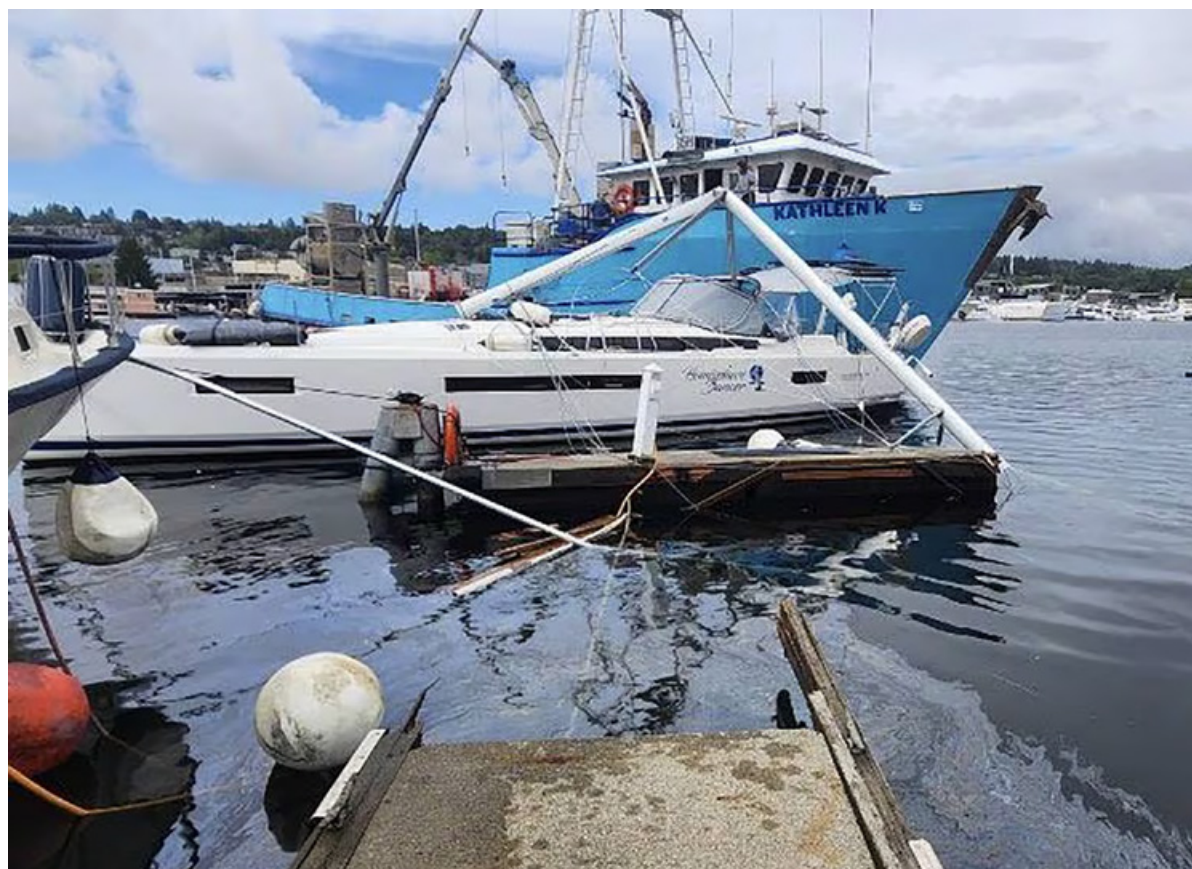
The *Kathleen K*, a damaged sailing vessel, and a damaged dock following the collision. SOURCE: COAST GUARD.

On May 22, 2024, about 1024 local time, the fishing vessel *Kathleen K* was transiting from its berth to a fuel dock in Salmon Bay, Seattle, Washington. While en route, the vessel lost engine control and subsequently collided with recreational vessels moored at a marina. A light oil sheen was observed in the water near the marina docks. There were no injuries. Damages to the moored vessels and the docks were estimated to exceed \$500,000.

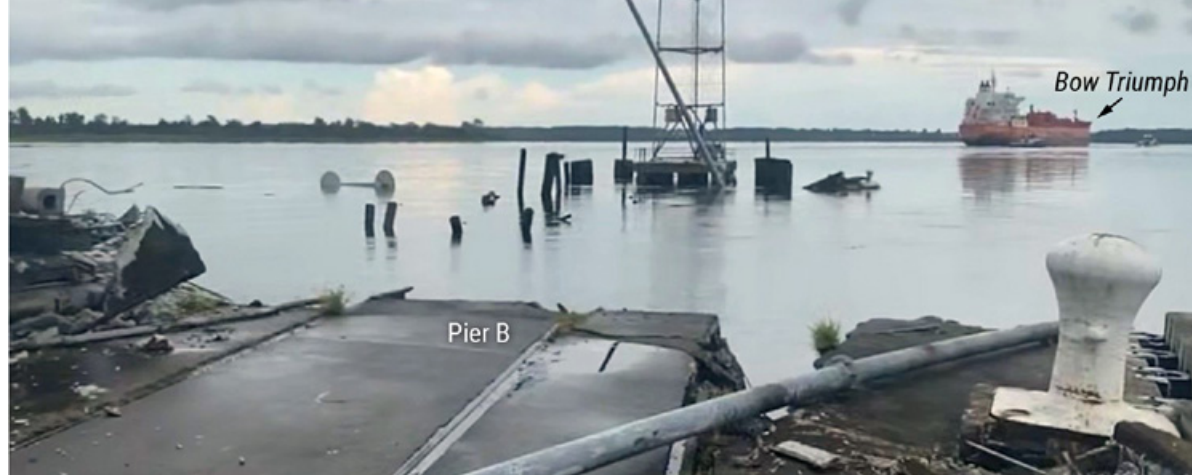
Witness photograph taken shortly after the contact showing damage to Pier B. BACKGROUND SOURCE: JACOB WALL.

THE PROBABLE CAUSE of the contact of the *Bow Triumph* with Naval Weapons Station Pier B was the pilot's decision to maneuver the vessel close to the left bank while approaching the turn immediately before the pier, exposing the tanker to bank effect, which the pilot's subsequent rudder and engine orders could not overcome.

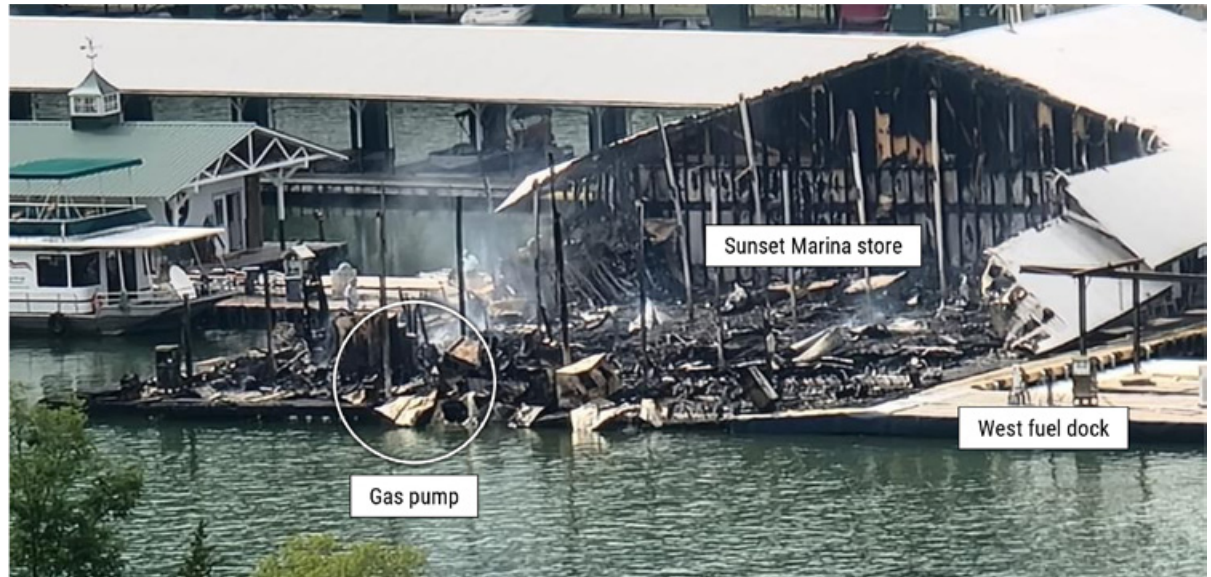
Sunset Marina store and fuel dock after the fire. BACKGROUND SOURCE: TENNESSEE WILDLIFE RESOURCES AGENCY.

THE PROBABLE CAUSE of the contact and subsequent fire at the Sunset Marina was a houseboat's "duckbill" bow striking a gasoline fuel dispenser (pump) when docking in windy conditions, which caused an undetermined electrical source on the dock to ignite vapors from the broken gasoline fuel line. Contributing to the contact was the proximity of the gas pump to the dock edge.

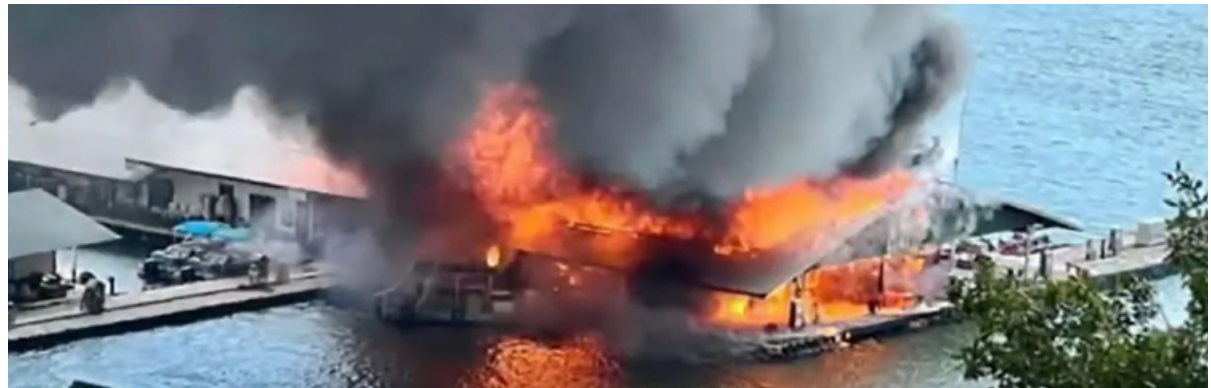
Sunset Marina fuel dock and store on fire after the contact. SOURCE: WIRED2FISH.COM.

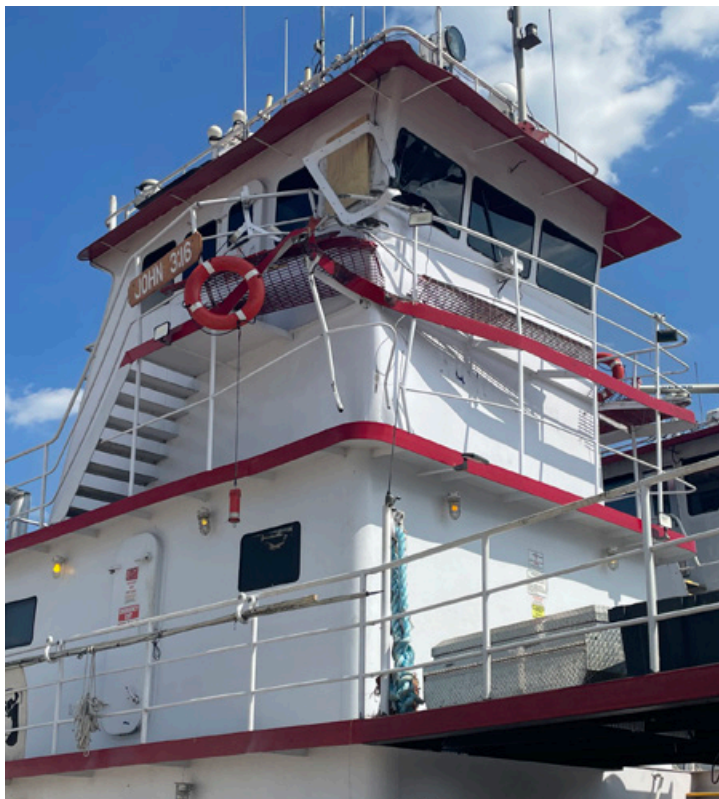
Damage to the *John 3:16* wheelhouse structure.

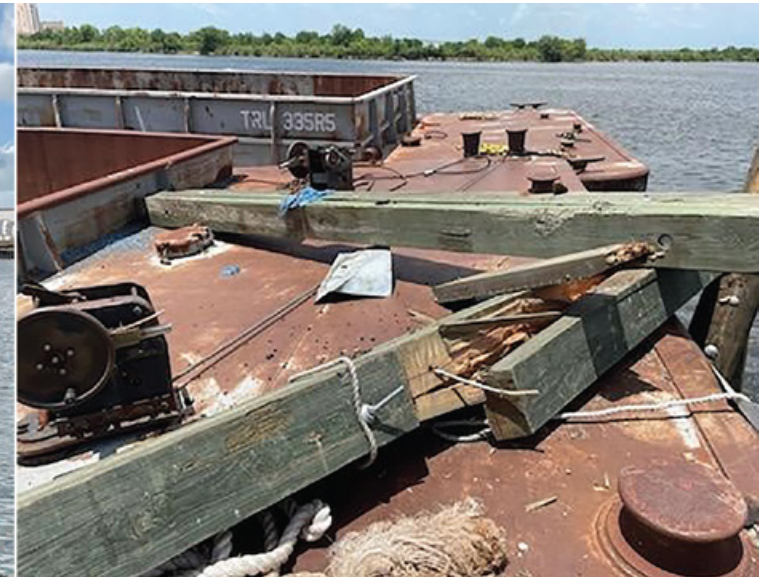
Left to right: Damage to the Port of Lake Charles pier. Timber from the pier found on the starboard lead barge of the *Danny Terral*. SOURCE: COAST GUARD.

THE PROBABLE CAUSE of the contact of the *Danny Terral* with the Port of Lake Charles pier was the mate misjudging the approach to an unlit, unfamiliar pier in the dark.

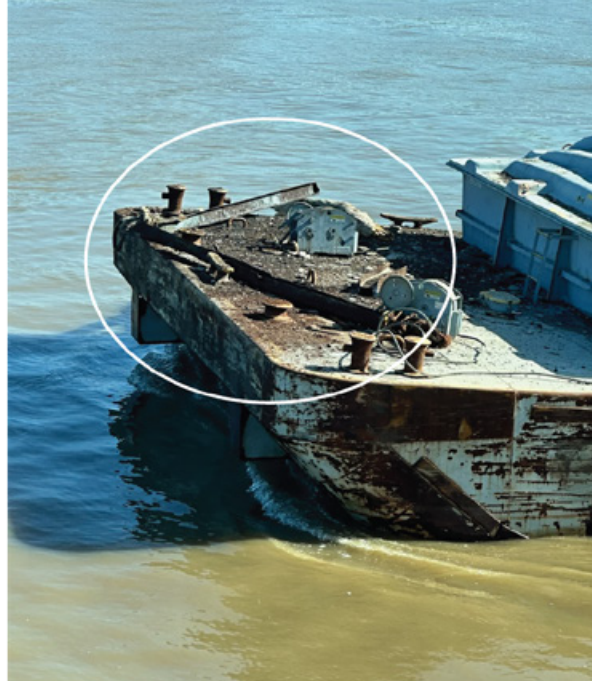
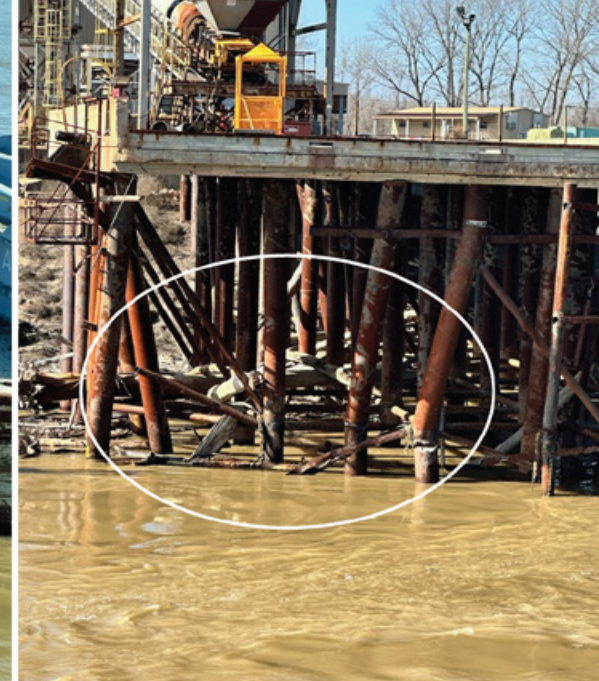
Left to right: The damage to barge ACBL2549 after the contact (circled), and the damage to the Port of West Memphis dock (circled). SOURCE: COAST GUARD.

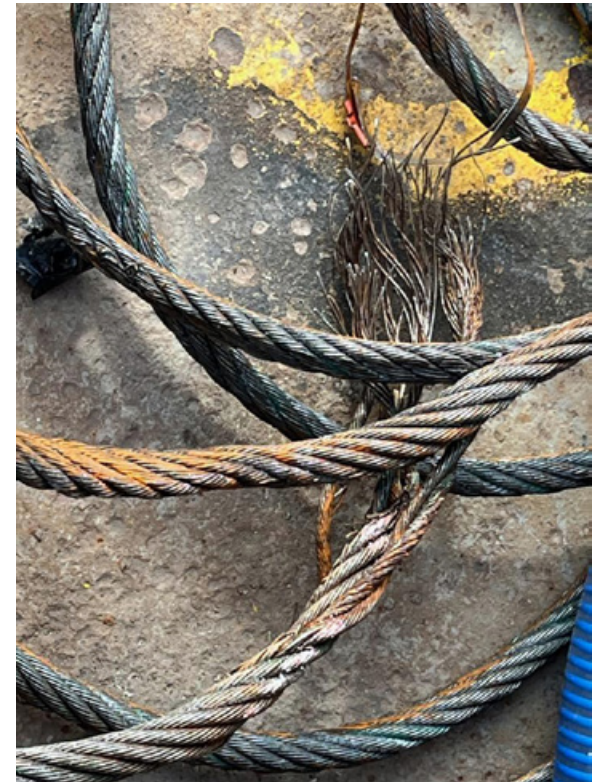
THE PROBABLE CAUSE of the breakaway of the barges **ACL23401** and **ACBL2549** and subsequent contact of the barge **ACBL2549** with the Port of West Memphis dock was the parting of the starboard facing wire connecting barge **ACL23401** to the towing vessel *Nell Womack*, likely due to undetected damage to its wire strands.

Parted wire after the breakaway.

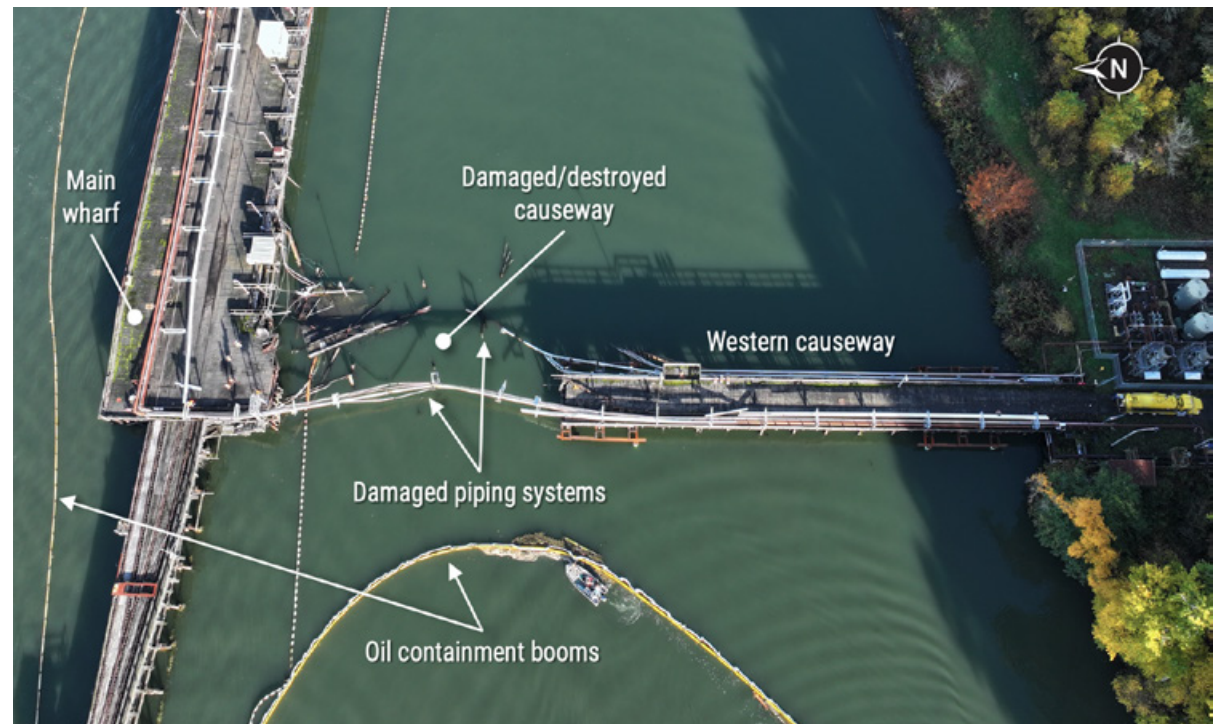
THE PROBABLE CAUSE of the contact of the *Cindy B* tow with the Port Westward Beaver Dock was the deckhand falling asleep at the helm due to fatigue that he did not perceive, which occurred during a night watch, at a low point in his circadian rhythm, and following a change in his awake/sleep cycle. Contributing to the casualty was the pilothouse alerter system not alarming to wake the incapacitated deckhand at the helm because a swinging VHF radio microphone in the motion sensors' field of view defeated the system.

Beaver Dock after contact by the *Cindy B* tow. BACKGROUND SOURCE: COAST GUARD.

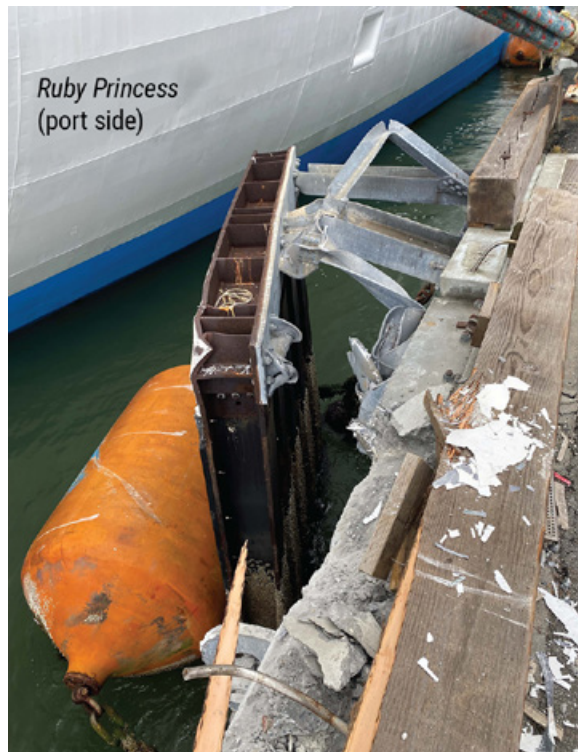
Ruby Princess damage. BACKGROUND SOURCE: COAST GUARD.

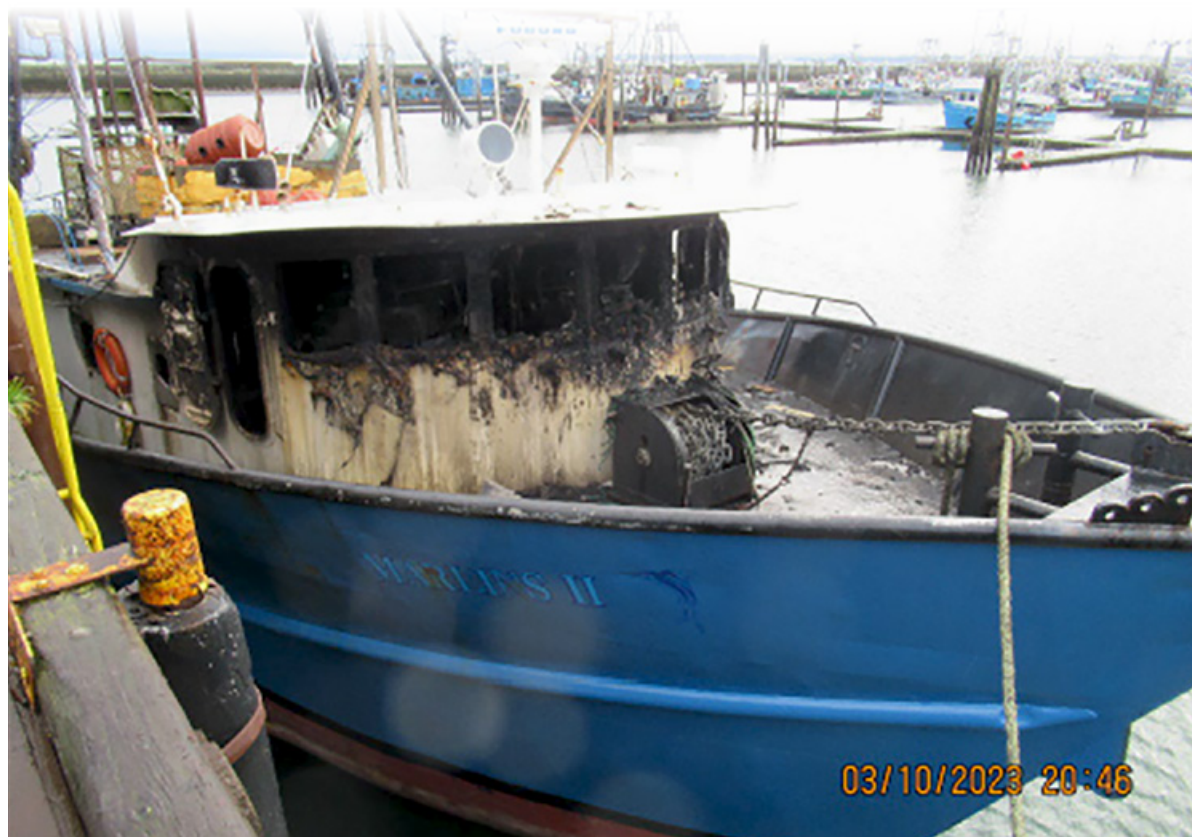
The burned-out *Marlins II* after the fire. SOURCE: BLOMQUIST MARINE SURVEYS.

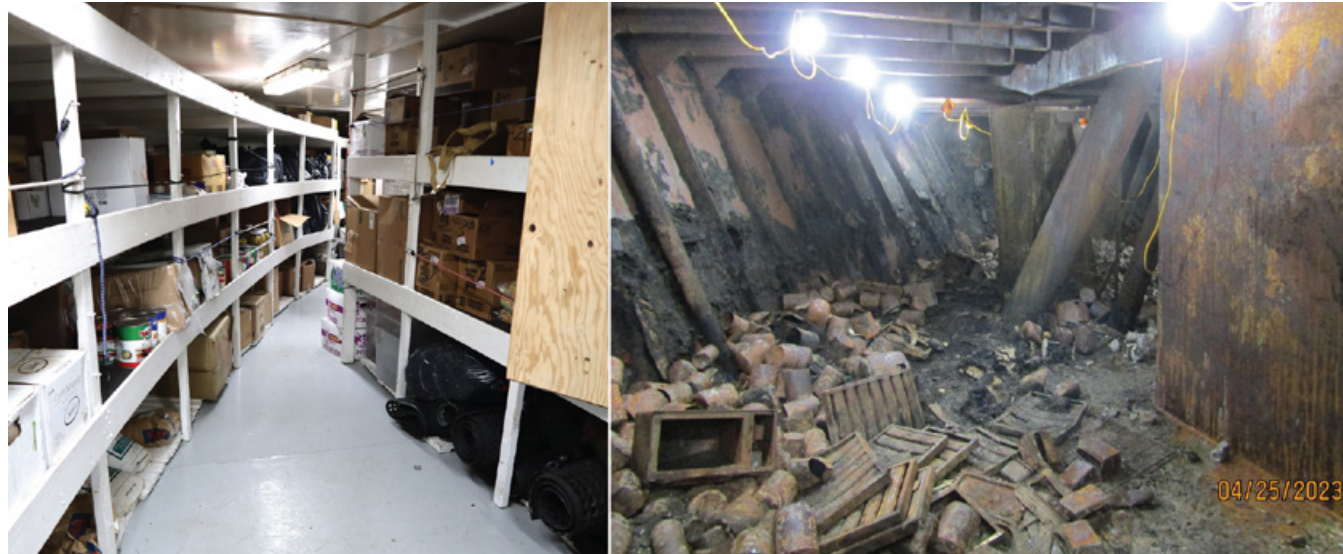
The dry stores room, looking forward, before and after the fire.

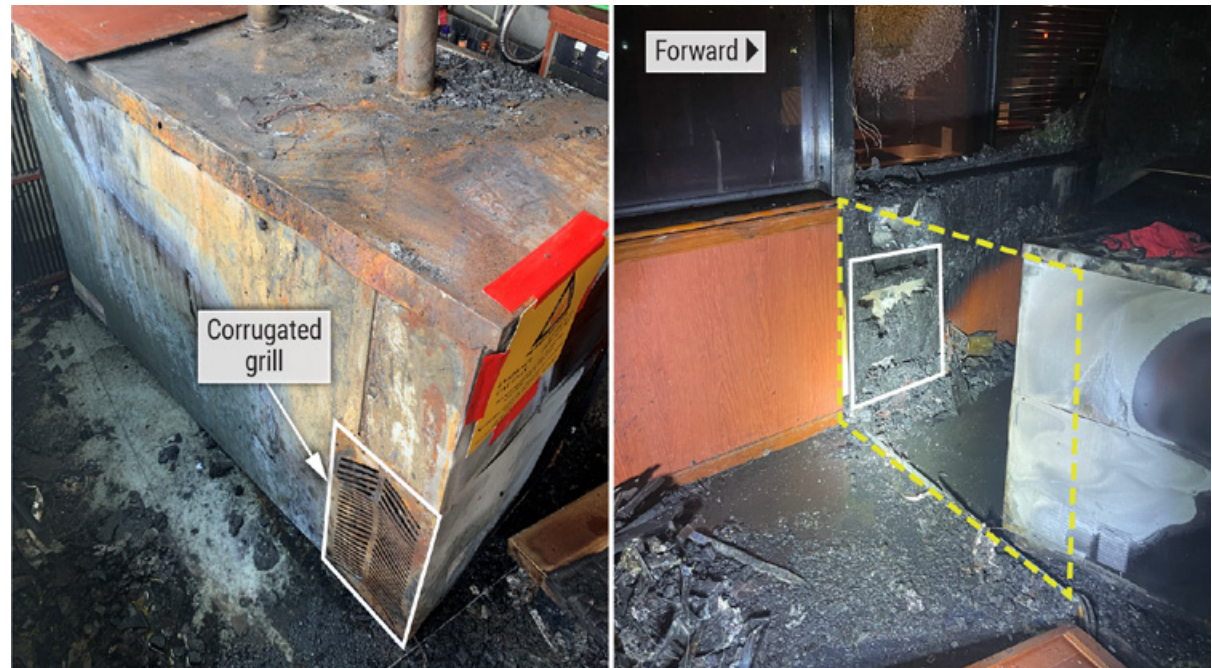
Left to right: Origin area of the fire on corrugated grill (outlined) on main deck bar refrigeration unit, with fire pattern mirrored (outlined) on portside bulkhead. The area of a cabinet end panel in place prior to the fire is indicated by a dashed line. SOURCE: FLORIDA BUREAU OF FIRE, ARSON, AND EXPLOSIVES.

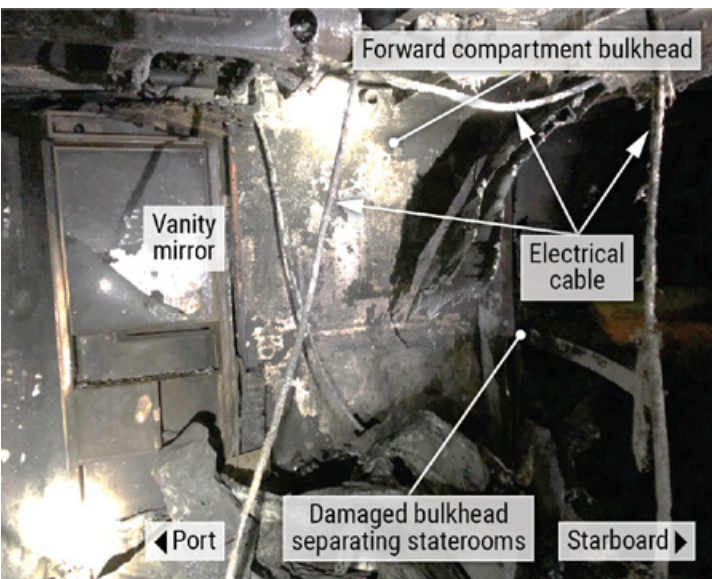
Qualifier 105 stateroom J interior postfire.

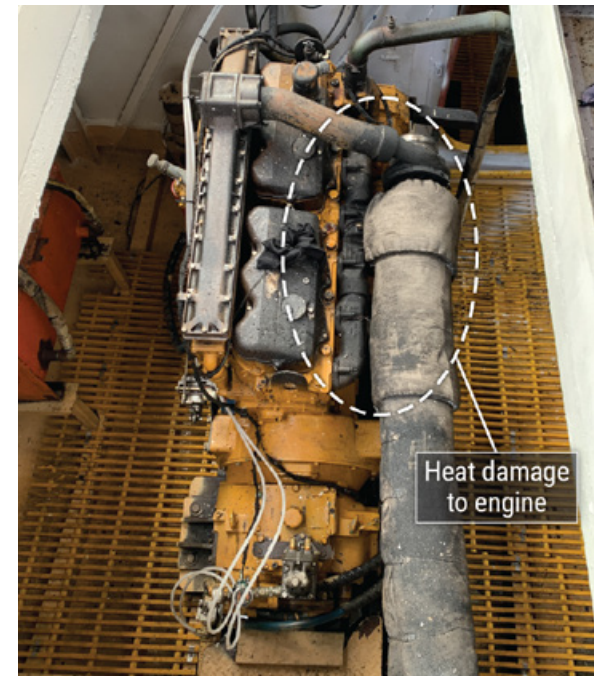
Port main propulsion engine damage on the *Desperado* after the fire.

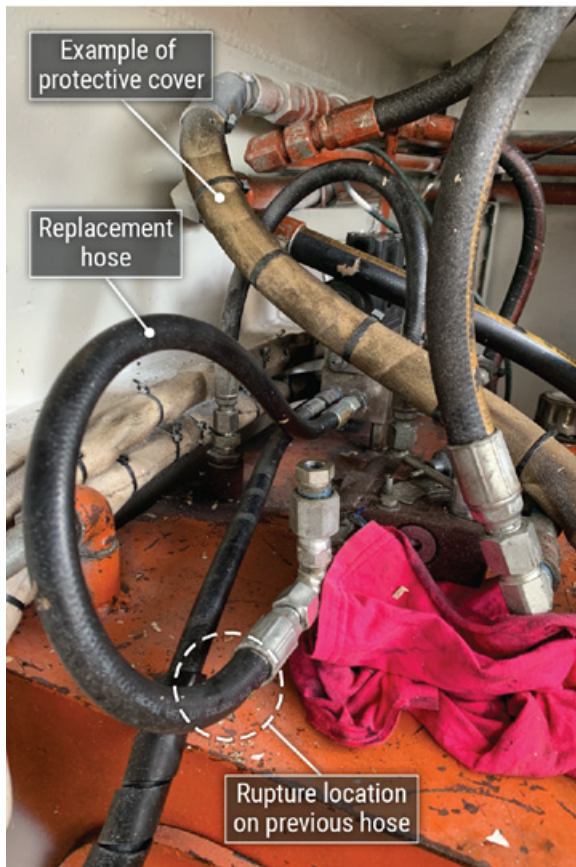
The replacement hydraulic hose, with the location of the rupture on the previous hose circled.

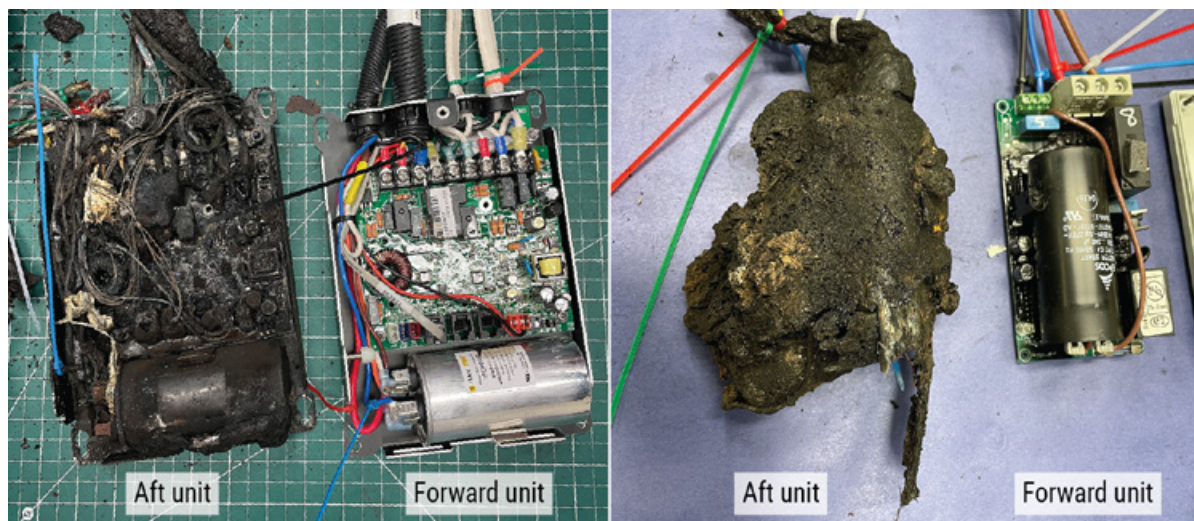
Left to right: Larger soft start control device from damaged air conditioning unit alongside identical forward unit (shown as an exemplar). Smaller soft start control device from damaged air conditioning unit alongside forward unit after fire.

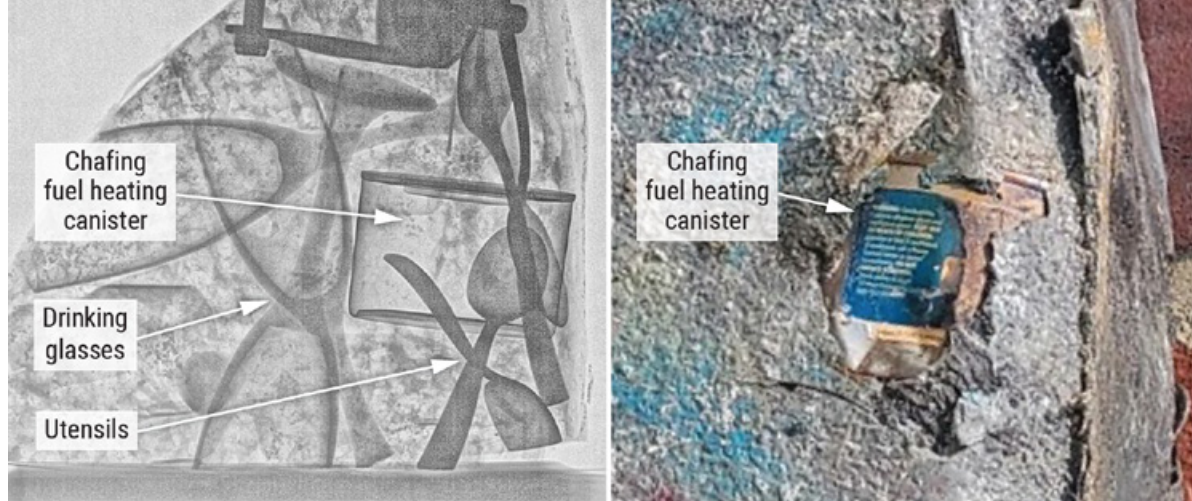
Other investigations, such as the 2023 fire aboard the dinner cruise vessel **Spirit of Boston**, further demonstrate that no action is too small to affect safety. In this case, the fire was caused by a chafing fuel heating canister that had been improperly extinguished. The canister ignited a plastic glassware rolling cart after it was unintentionally dropped by a hospitality staff member as they attempted to throw it away. Again, we are thankful that all 16 persons aboard the vessel safely evacuated.

Left to right: X-ray image of debris removed from the *Spirit of Boston* deck 1 wait station showing chafing fuel heating canister. Closeup of chafing fuel heating canister found in the same debris.

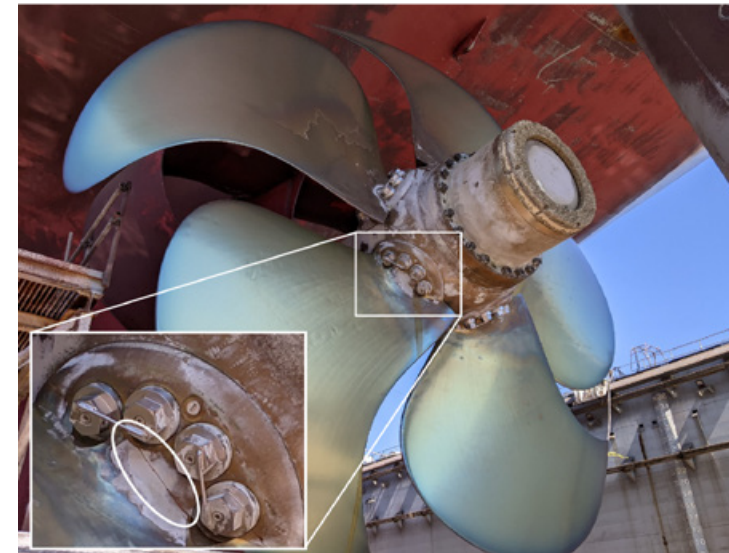
The CPP on the *Maunalei* after the casualty, showing a fracture (inset) at the base of the no. 4 blade.

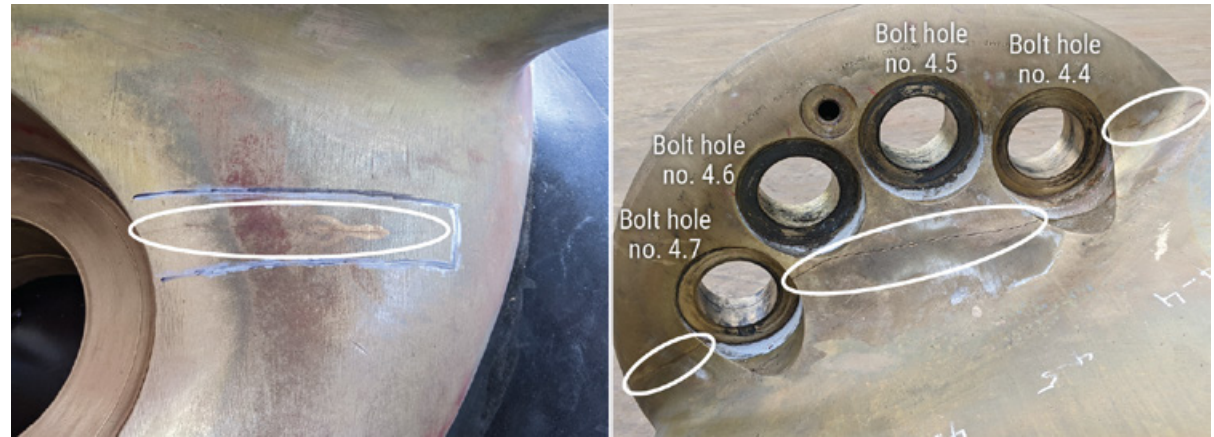
Left to right: Fractures (circled) on propeller blade no. 2, suction side and no. 4, pressure side.
