NATIONAL
TRANSPORTATION
SAFETY
BOARD

HIGHWAY ACCIDENT REPORT

COLLAPSE OF THE
NORTHBOUND U.S. ROUTE 51 BRIDGE SPANS
OVER THE HATCHIE RIVER
NEAR COVINGTON, TENNESSEE
APRIL 1, 1989

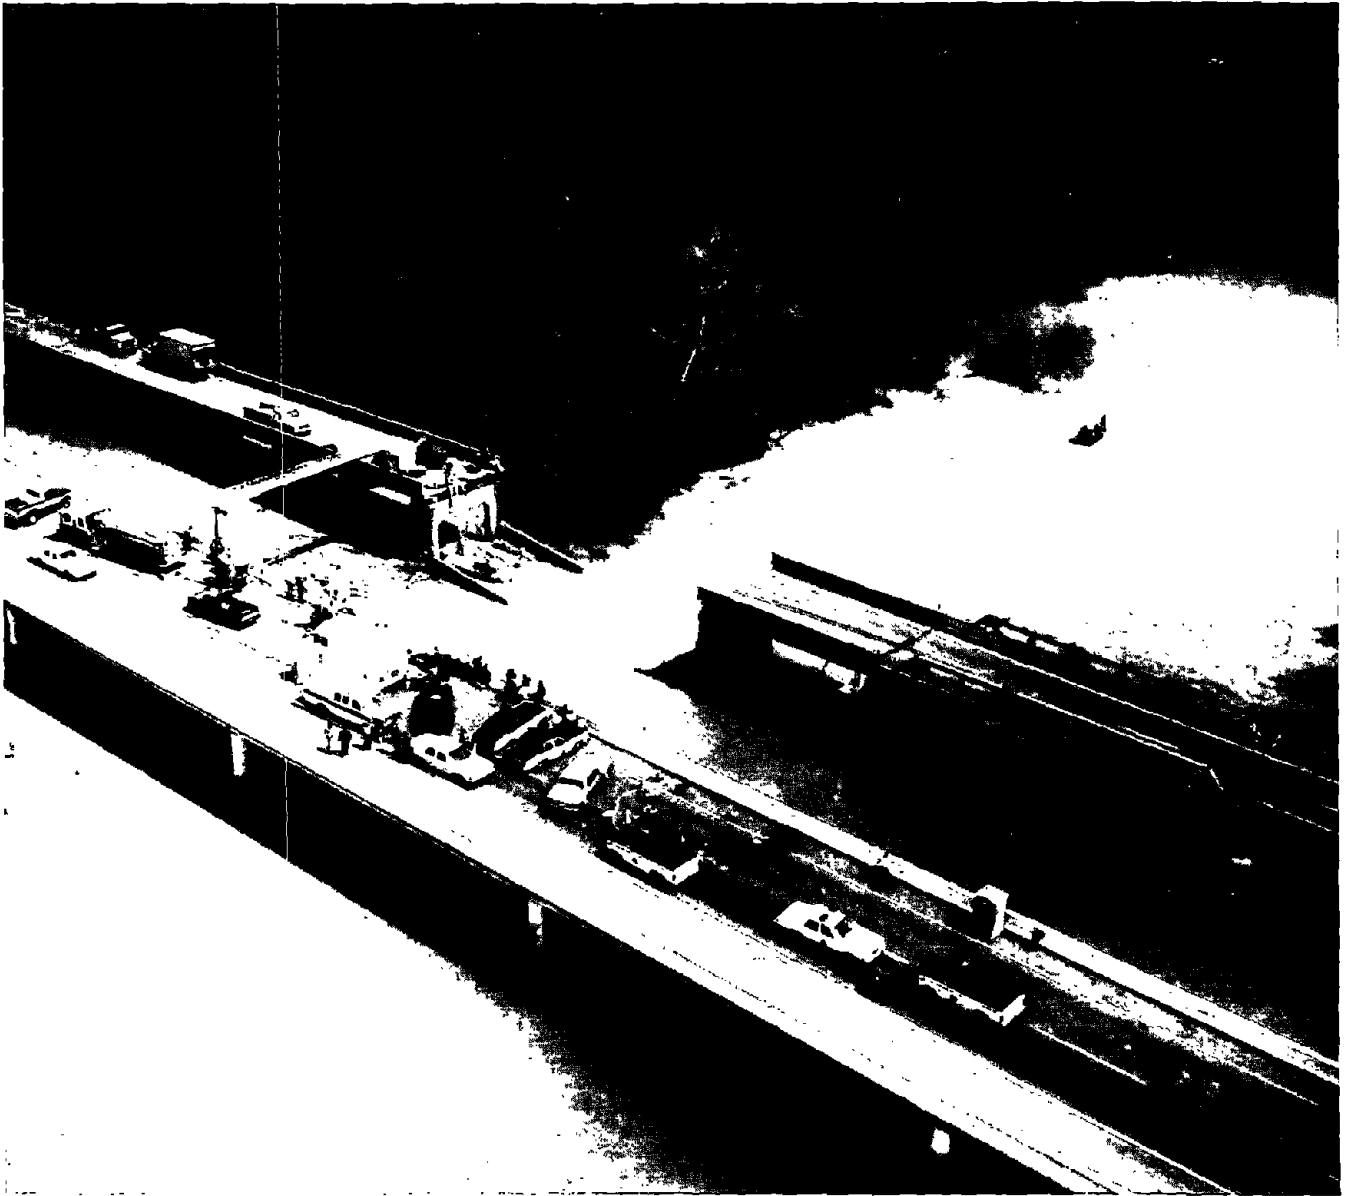
Figure 2.--View of the northbound U.S. 51 Bridge.
(looking northeast)

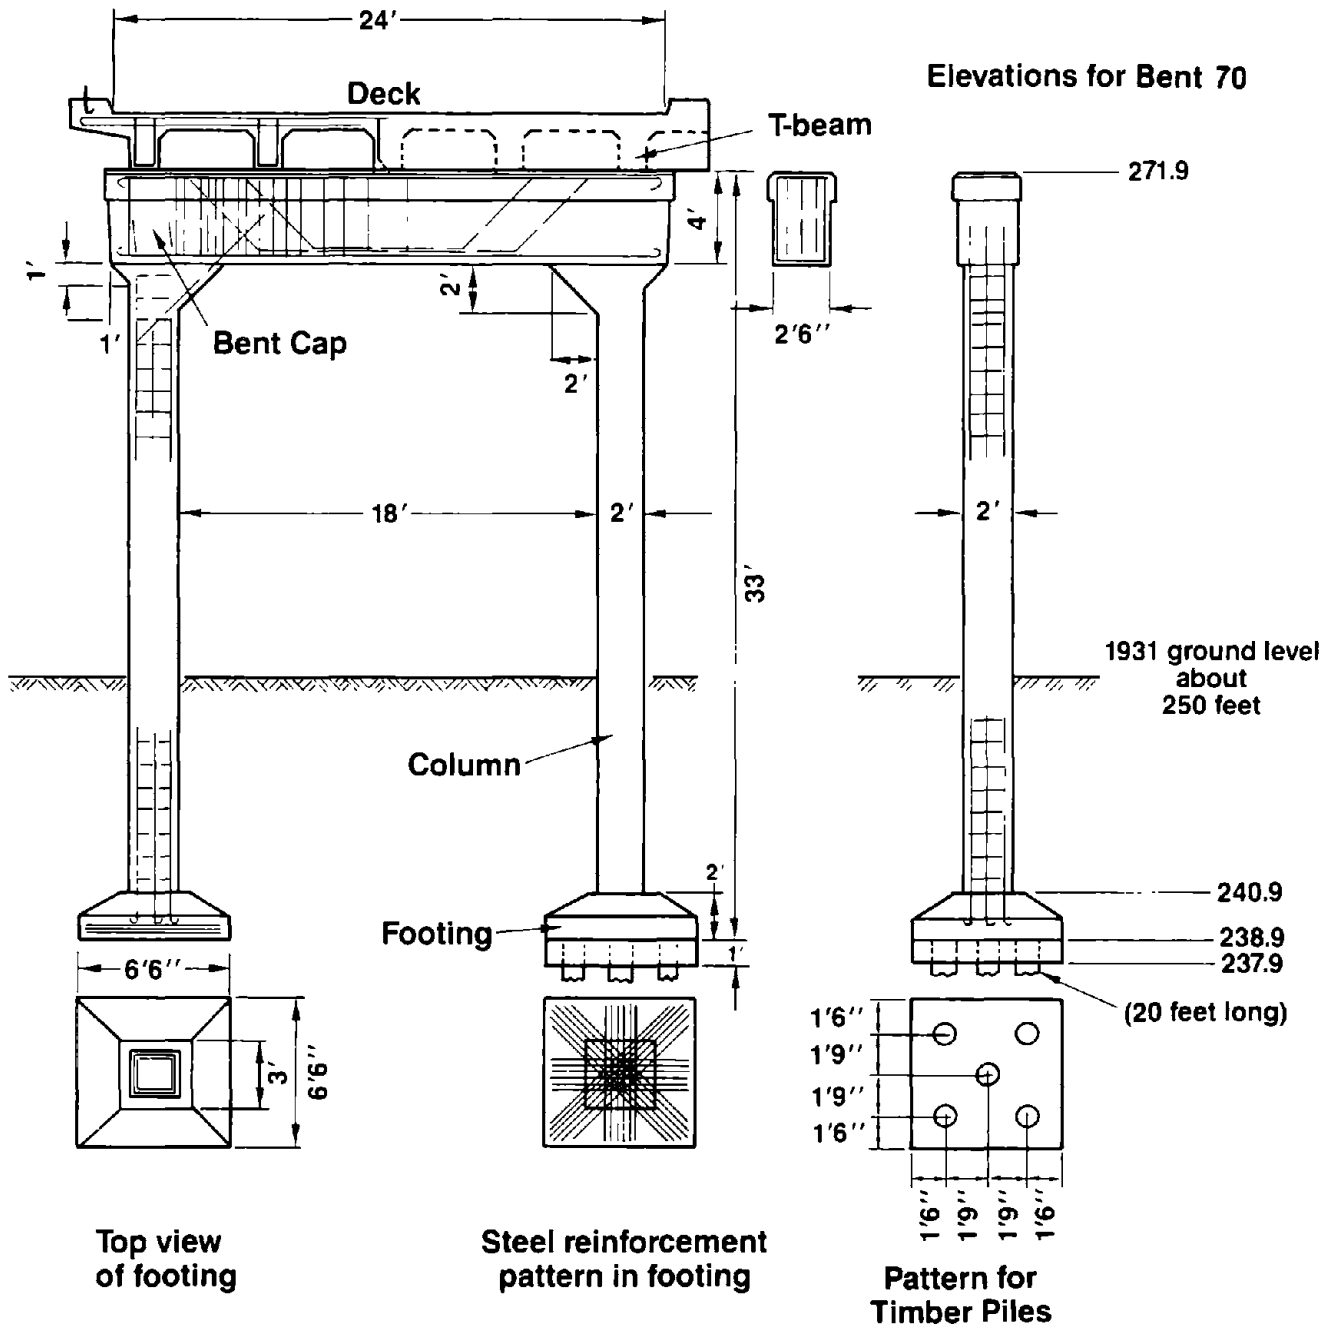
Figure 4.--Column bent 70 cross section.

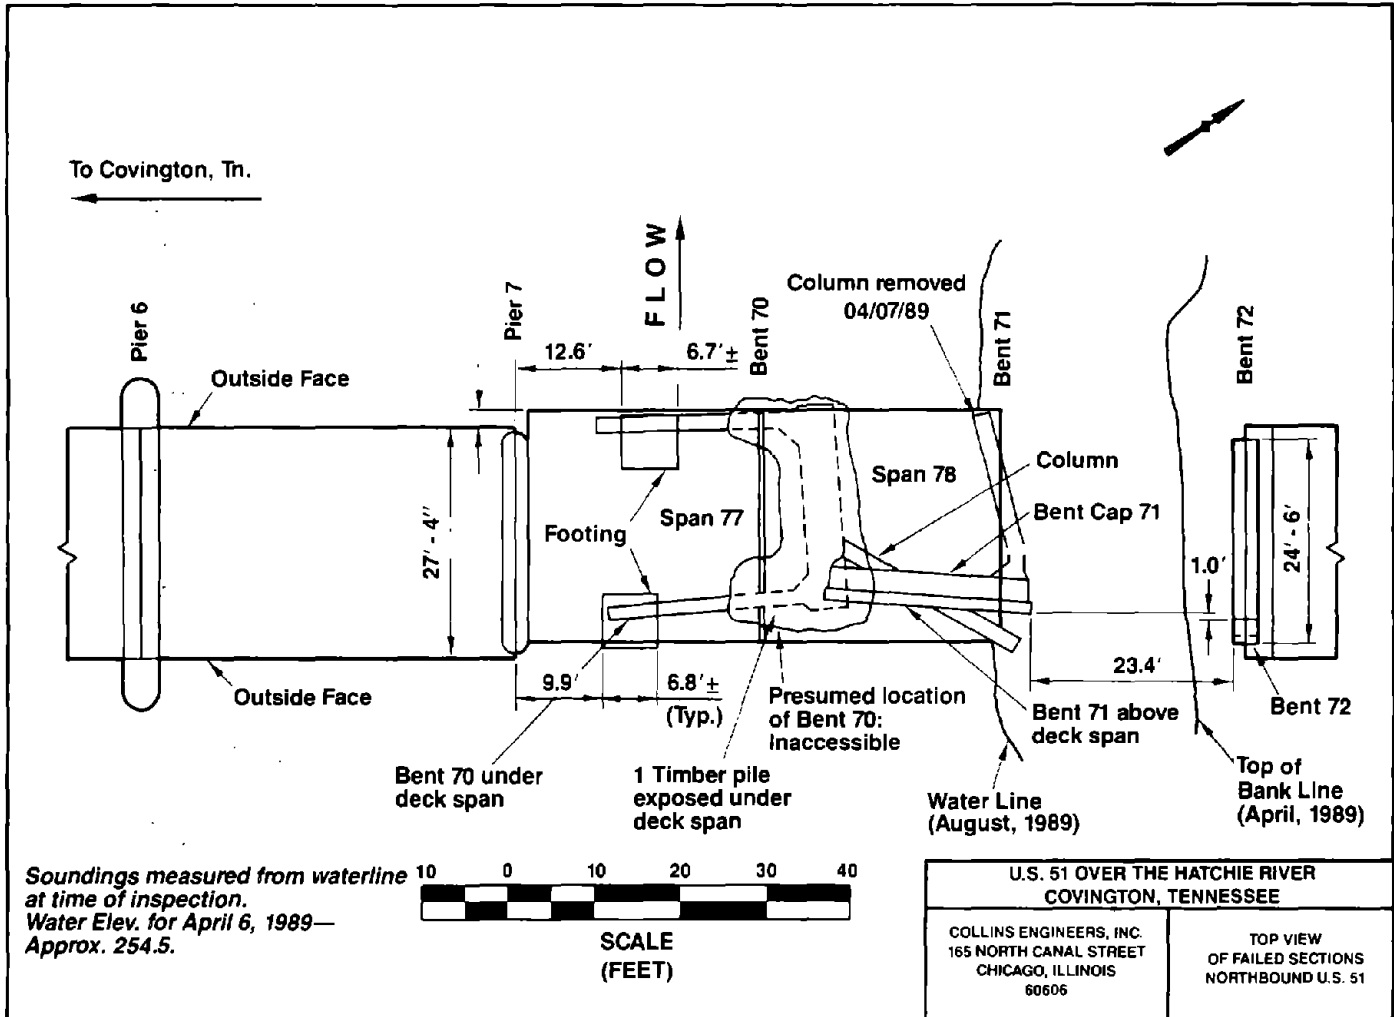
Superstructure Wreckage Documentation.--The underwater examinations of the bridge wreckage indicated that spans 77 and 78 fell almost in line and slightly west of their original positions. (See figure 5.) The exterior girders of both spans appeared to be intact. CEI reported that they found only minor broken concrete on the girder ends that would have rested on column bent 70, and no significant distress in the girders. The concrete bridge railing of both spans was irregularly broken near column bent 70, and divers discovered trees lodged underneath the upstream bridge rail near the center of span 77. The southern end of span 77 was leaning against pier 7 about 12 feet above the streambed. Span 78 and the northern end of span 77 were resting on both the streambed and portions of the substructure wreckage. The deck of both spans appeared to be intact with partial delamination of the asphalt overlay.

Figure 5.--Wreckage Distribution-Top View

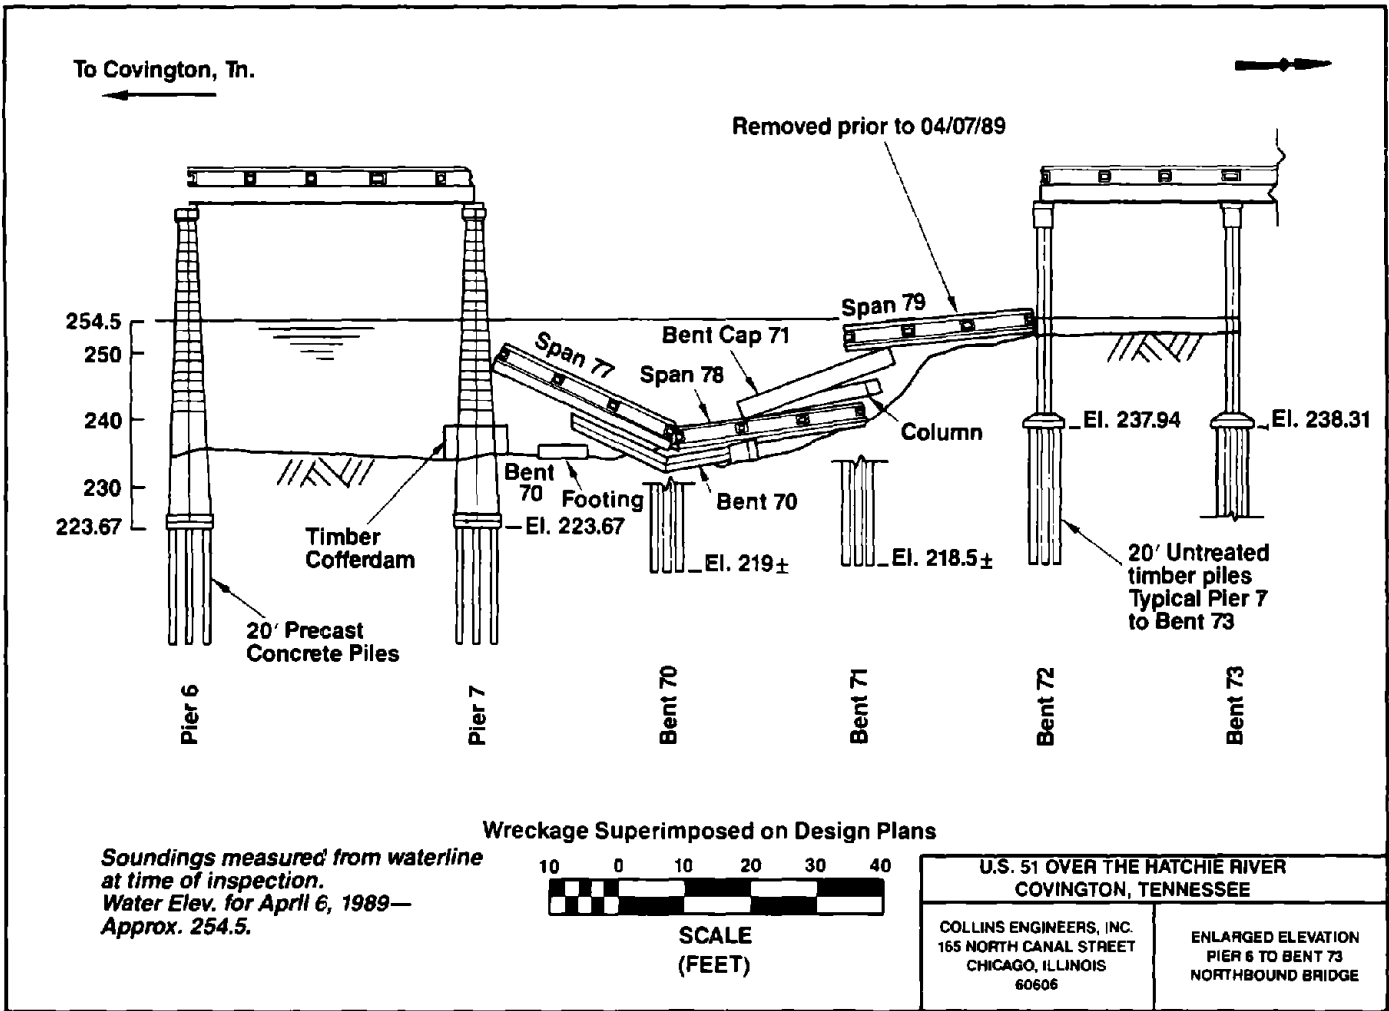
Figure 6.--Wreckage Side View

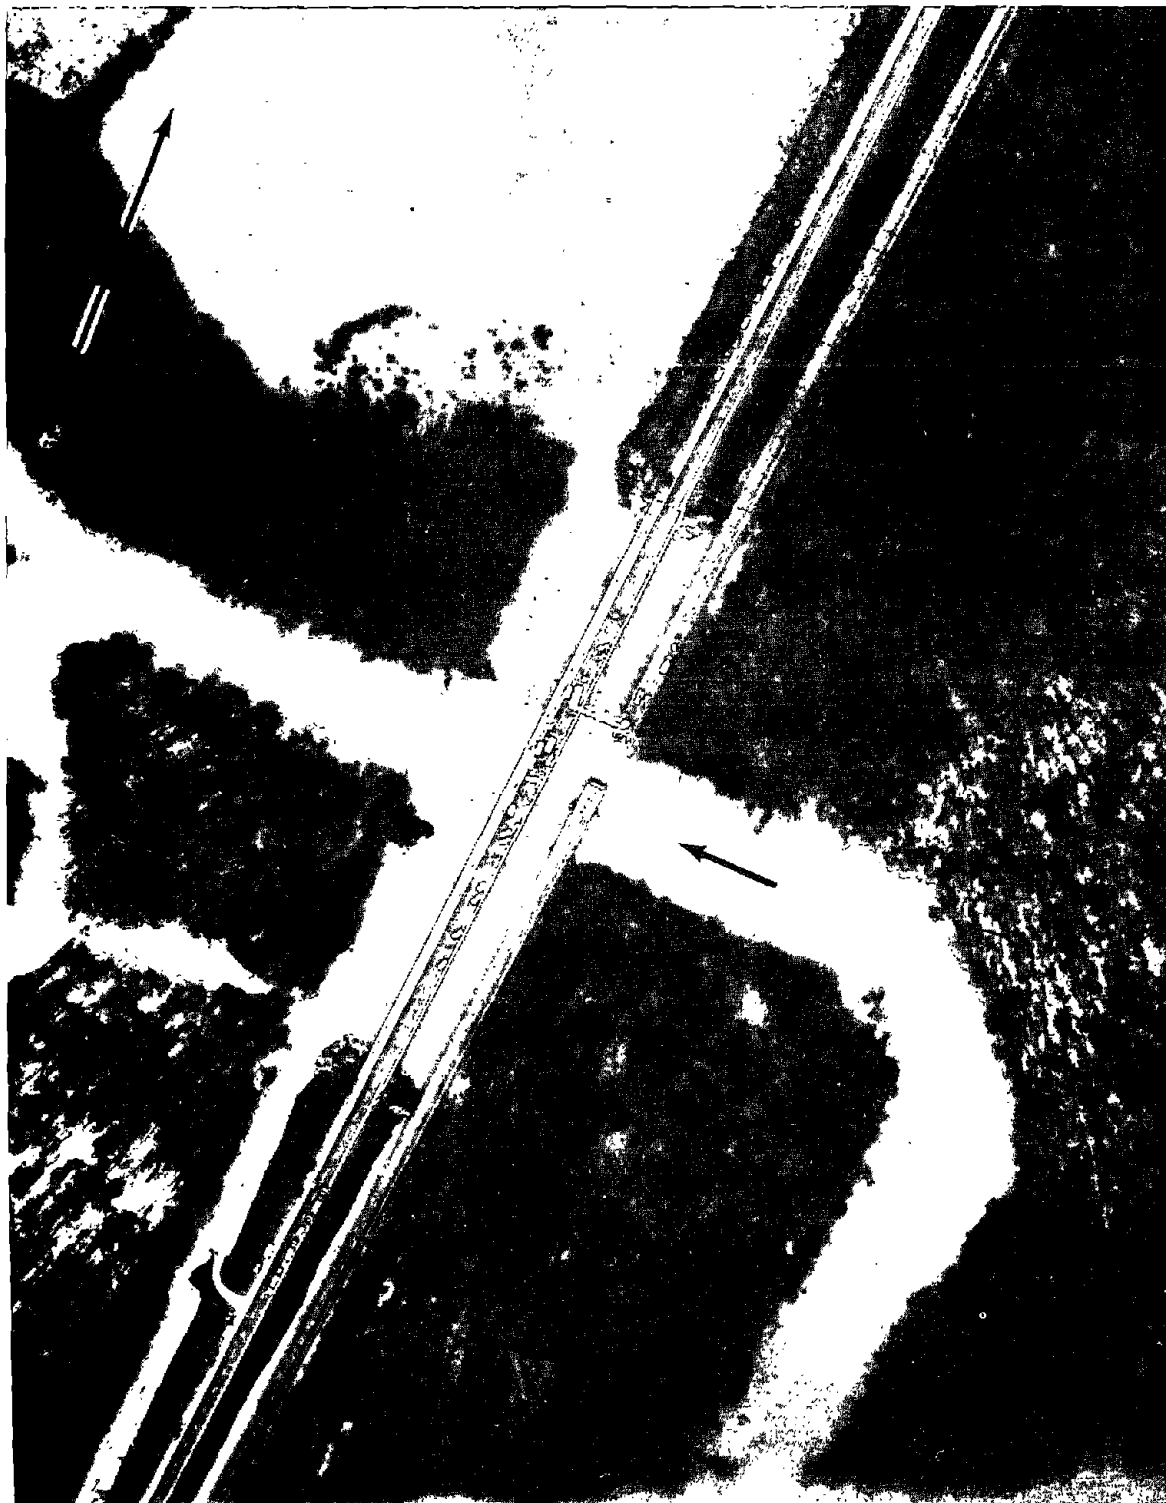
By January 1973, the old natural channel had filled in and the top of the south bank was located just south of pier 5. In 1973, the south flood plain elevation had increased to about 248 feet. The majority of the main channel was near elevation 236 feet. The top of the north bank was near 249 feet elevation, and the bank had moved 20 feet farther north since 1944

Figure 9.--Overhead View of the U.S. Route 51 Bridge Site.

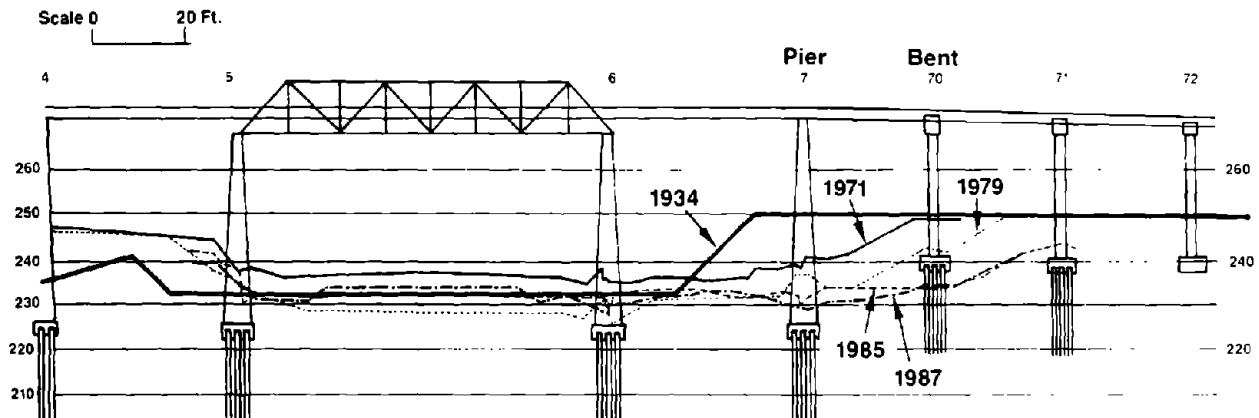
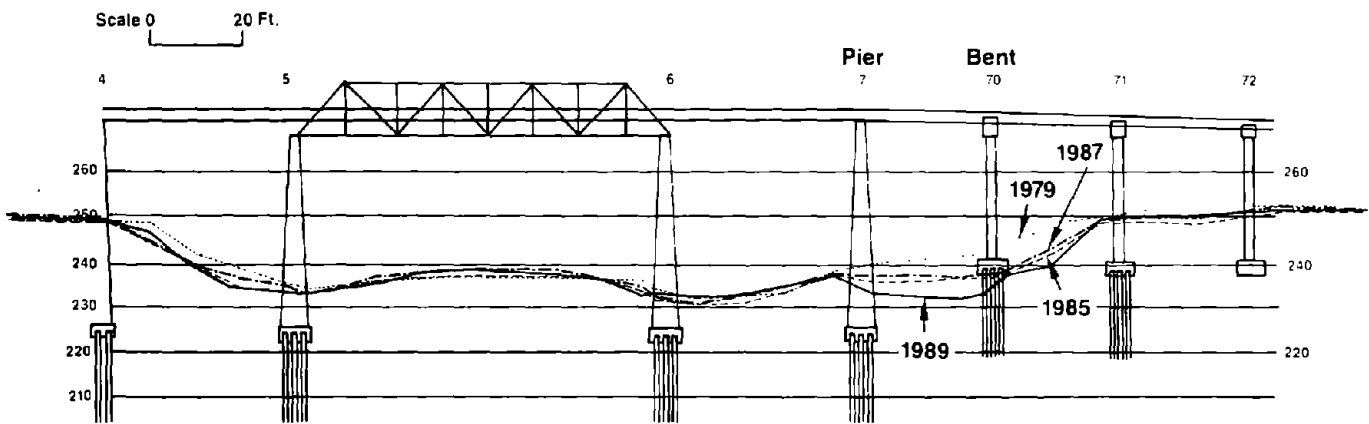
The USGS indicated that prior to 1975, the Hatchie River was following a natural, generally uninduced cycle of channel meandering, moving northward at an average rate of about 0.8 feet per year. The channel-bed lowering that occurred in March 1975 may have been solely due to high flow, "However, there was no serious bed lowering or widening in conjunction with a March 1973 high flow of 52,000 cfs" (about a 25 year flood event). The USGS stated that it was unlikely that the March 1975 moderate peak flood would cause the pronounced bed-level lowering, "if the hydraulic characteristics had not been significantly altered by the reduction in effective flow-width caused by the new embankments." A 1973 USGS study of "Man Induced Channel

Figure 10.--Channel cross sections from the Hatchie River at the U.S. 51 crossing.

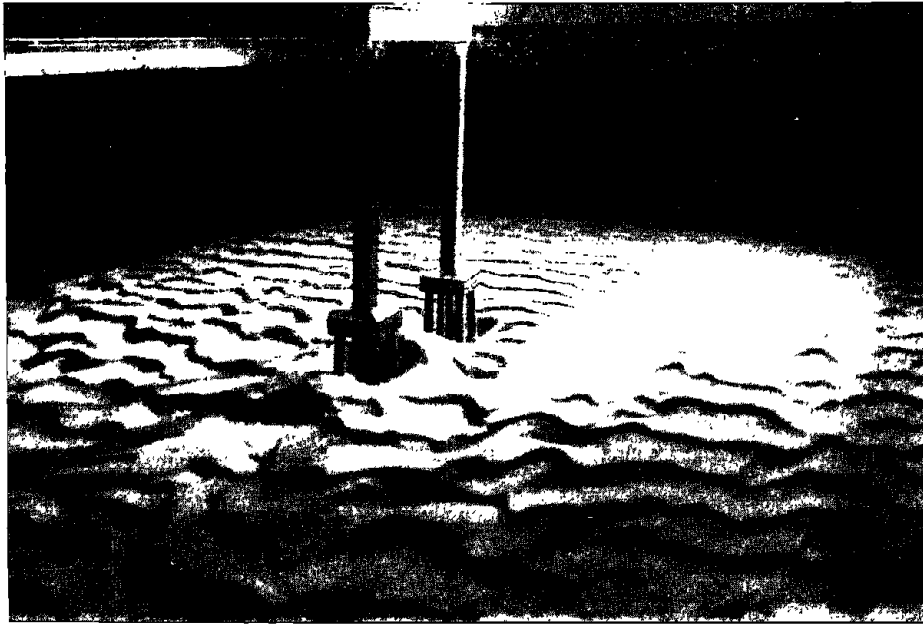
The FHWA concluded that the most likely failure mode was "a loss of vertical pile capacity caused by the removal of supporting soil material." Further, the FHWA determined that a pile buckling failure would only have

Figure 12.-- FHWA Flume Model Study (1).
