Highway Investigation Report HIR-25-02

# Collision of Motorcoach with Combination Vehicles Parked Along Exit Ramp to I-70 Rest Area

Highland, Illinois  
July 12, 2023

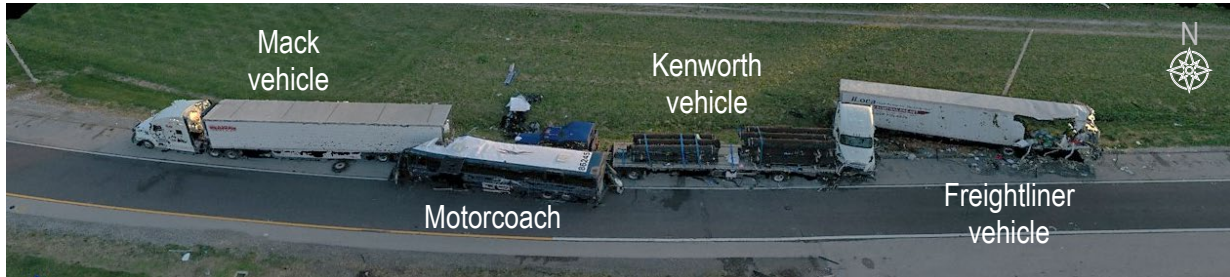
After sideswiping the Kenworth vehicle, the motorcoach continued forward and struck the left rear of the Mack vehicle. The semitrailer intruded into the right front of the motorcoach, which likely exacerbated the already crash-compromised motorcoach body structure. After striking the Mack vehicle, the motorcoach came to final rest after having traveled about 197 feet from the initial collision with the Freightliner vehicle. Figures 2 and 3 show the positions of the four vehicles at final rest.

**Figure 2.** Overhead photo of the four crash-involved vehicles at final rest. (Source: Illinois State Police aerial drone photographs; edited by the NTSB photogrammetry software and annotations)

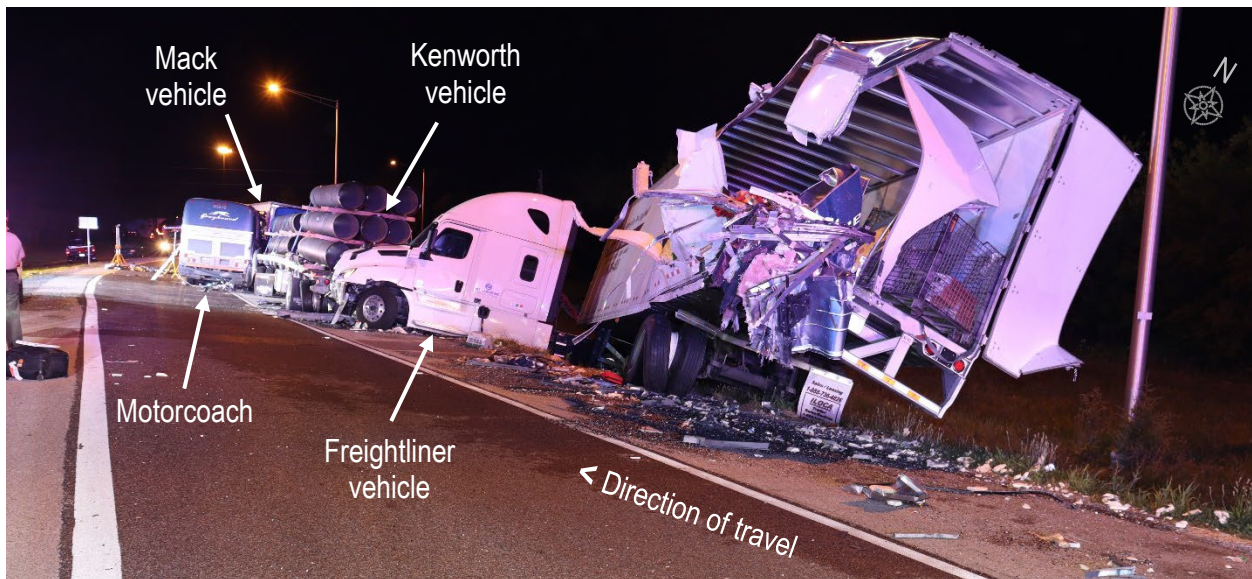
**Figure 3.** Crash scene photo of the motorcoach at final rest with the three combination vehicles. (Source: Illinois State Police; annotations by NTSB)

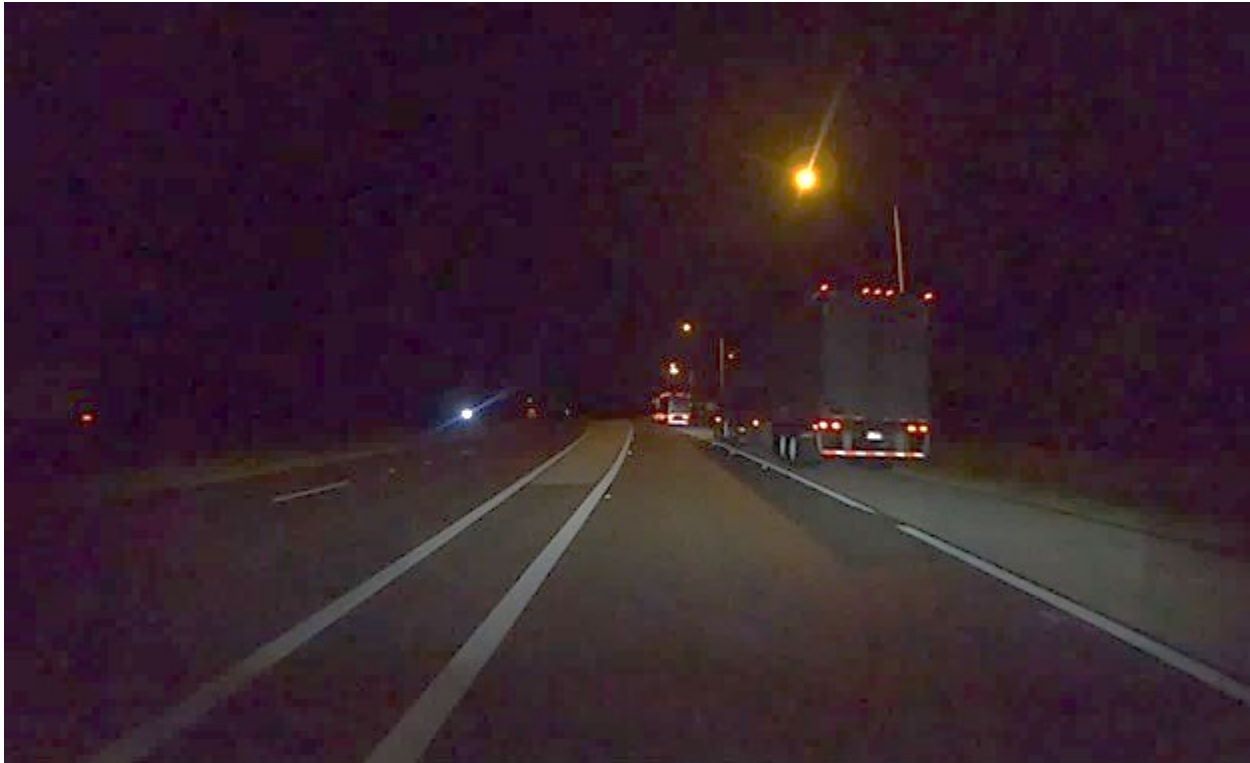
The NTSB observed vehicles parked on the shoulder several times while on scene during the investigation. Three days after the crash, the NTSB observed five combination vehicles parked on the shoulder to the westbound Silver Lake Rest Area. Figure 7 shows two of the vehicles.

**Figure 7.** Photo of two of the five combination vehicles parked on the shoulder of the exit ramp, Saturday, July 15, 2023, about 9:30 p.m.

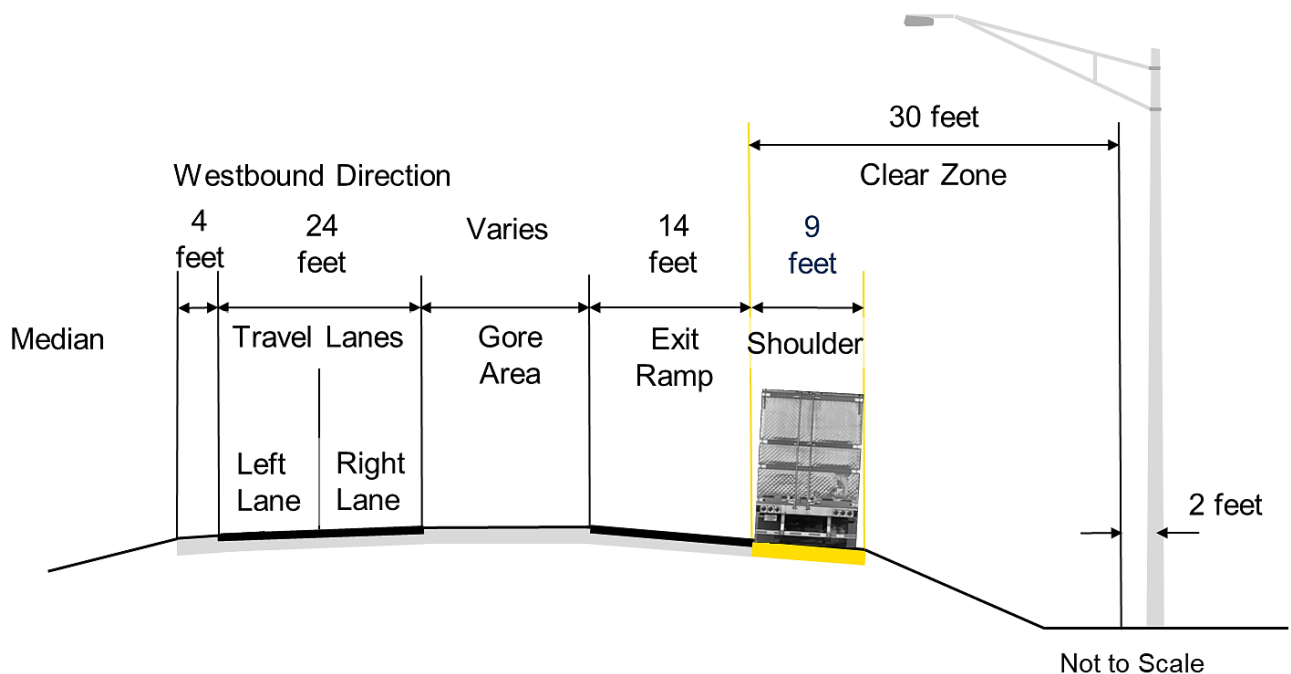
As shown in figure 8, the clear zone begins at the rightmost edge of the exit ramp travel way. The left edge of the parked trucks was approximately 1 foot from the edge of the ramp travel way. The three crash-involved combination vehicles parked on the exit ramp shoulder were then inside the 30-foot clear zone and would be considered obstacles.

**Figure 8.** Diagram of the I-70 westbound travel lanes and exit ramp, including the 30-foot clear zone, near the crash site. The combination vehicles were parked on the shoulder as marked in yellow.

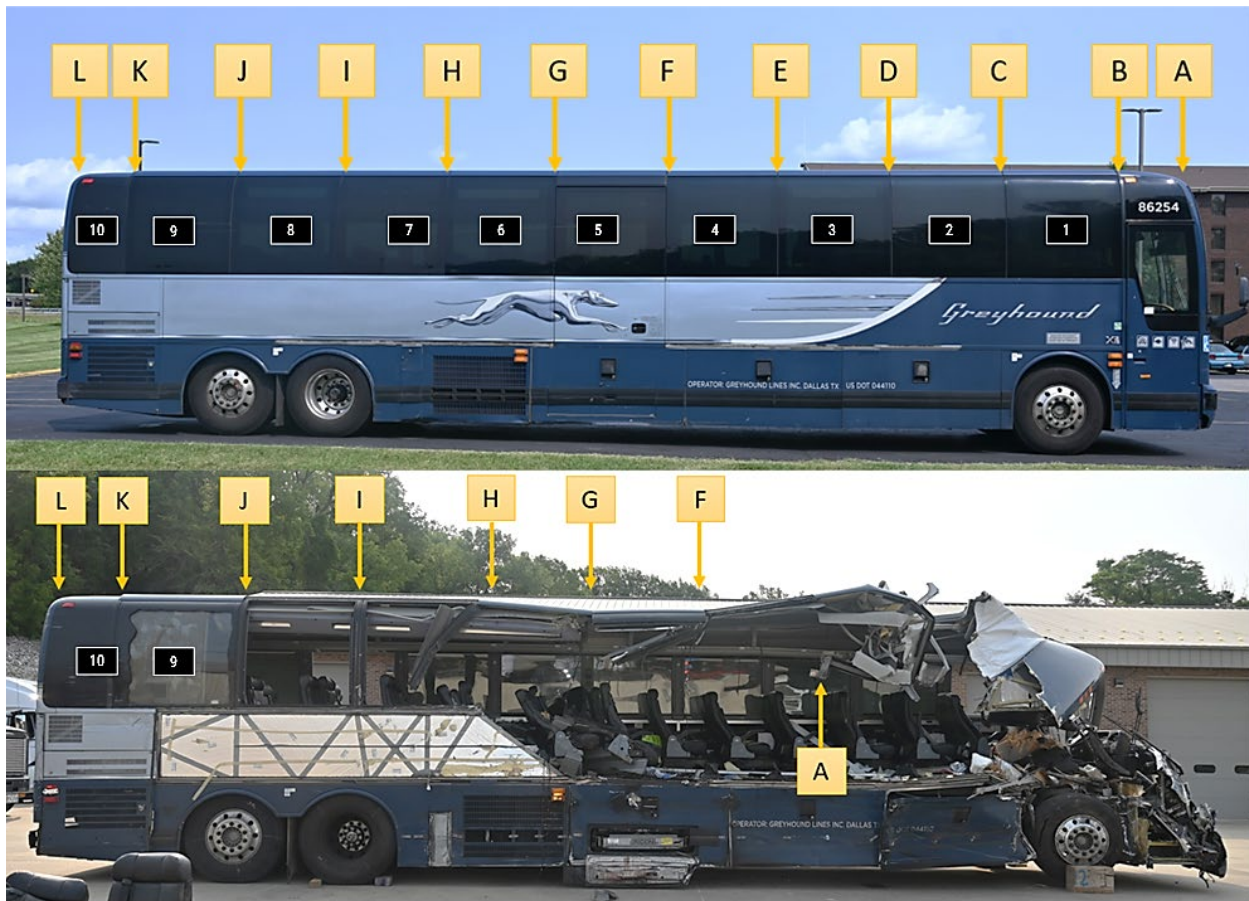
Figure 10 shows an exemplar motorcoach (top) and the crash-damaged motorcoach (bottom) with support pillars annotated by letters A through L and the windows of the exemplar motorcoach numbered 1 through 10. The motorcoach's collision with the three combination vehicles resulted in catastrophic damage to the motorcoach's front end, with deformation extending about 24.3 feet along the right side. The top of the motorcoach's front bumper was rotated forward, and the right side was pushed rearward. The right headlight assembly was damaged. The entrance door was sheared off and missing. The front of the motorcoach's right skirt rail was damaged and pushed rearward. The right-side-rail was damaged and pushed rearward from the front of the motorcoach to the C-pillar (seating row 2). The right-side waist rail was missing from the front of the motorcoach to the H-pillar (seating row 9).<sup>20</sup> The right A-pillar was detached from the base and was pushed rearward to the F-pillar (seating row 5). The left A-pillar showed crash-induced damage and was bent rightward while still attached to the roof support. Right-side pillars B, C, D, E, and G were missing; pillars F and H were severed and pushed rearward; and pillars I, J, K, and L remained intact, as observed in figure 10.

**Figure 10.** The crash-damaged motorcoach (bottom) and exemplar motorcoach (top). Letters denote corresponding body pillars between the exemplar motorcoach and the crash-damaged one. Windows are numbered in the exemplar motorcoach and corresponding intact or partially intact windows are numbered in the crash-damaged one. In the photo of the crash-damaged motorcoach, the fatally injured passengers were seated in the area extending back to pillar G (row 7).

The right side of the motorcoach body was compromised, the right front tire was torn and flat, and the interior was exposed from the front of the motorcoach to the H-pillar (approximately seating row 9). The storage door covers between the curb rail and the side rail were pushed inward and showed dark-colored paint transfer. The right-side paneling between the waist rail and the side rail were missing from the front of the motorcoach to the H-pillar and the exterior skin was missing between the H-pillar and the engine compartment. The wheelchair accessory door was damaged, stuck open, and hanging from the motorcoach. The windshield was missing. The first eight right-side windows were missing and the remaining two windows on that side were broken. Left-side windows 1 and 2 were missing; left-side window 9 was broken. The right side of the roof's leading edge was rotated downward and rightward. The roof was torn in the approximate area of pillar B (approximately seating row 2). From pillar B to pillar F (approximately seating row 5), the roof sustained crash-induced

damage and was rotated clockwise and upward. The fatally injured passengers were seated in rows 1-7, from approximately pillar B to pillar G.

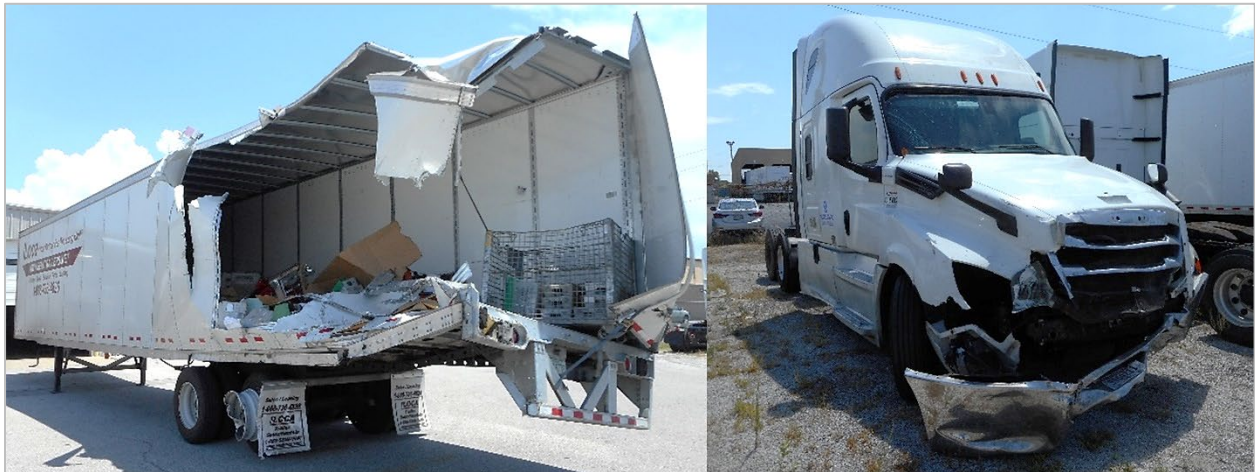
Images of the damaged semitrailer and truck-tractor are shown in figure 11. The rear portions of the semitrailer's structural support rails were damaged and displaced. Several roof bows and floor rails were damaged. The left rear of the semitrailer was displaced upward and rightward. Axle 5's left outside tire was damaged and had an approximately 4-inch cut, several small cuts, and abrasion marks located on the exterior of the sidewall. Axle 5's left outside wheel was deformed. The semitrailer also had an approximate 15-foot opening on the left side where several side skin panels were missing, extending to the rear of the trailer.

**Figure 11.** The Freightliner vehicle's semitrailer (left) and truck-tractor (right).

The Freightliner truck-tractor sustained damage to the front and front right of the vehicle. The front bumper was pushed downward and was peeled away from the right bumper support. The left headlight assembly was cracked and the right headlight assembly was damaged and separated from the vehicle. The front grille was pushed rearward. The left-side fiberglass hood was cracked.

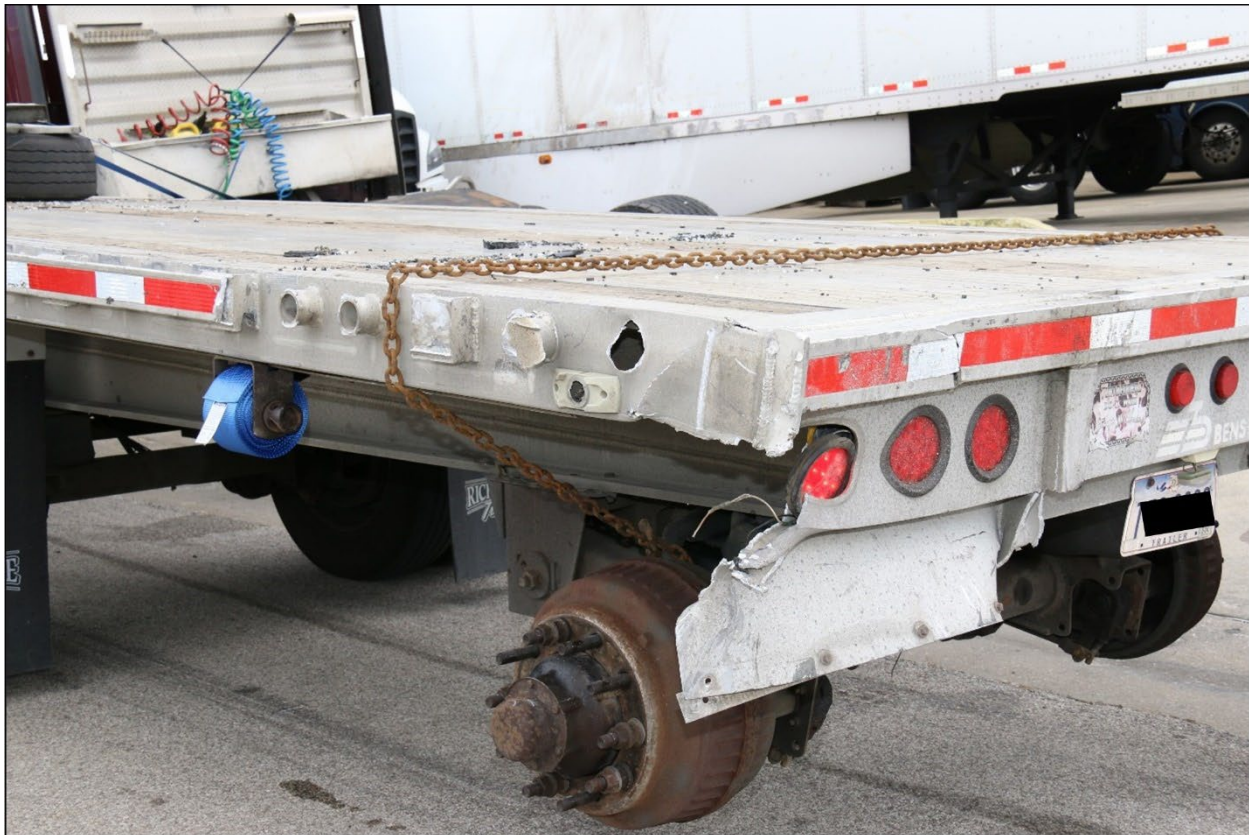
The Kenworth vehicle consisted of a 2000 Kenworth truck-tractor in combination with a 2007 Benson semitrailer; the semitrailer was a flatbed trailer loaded with pipe cargo. This vehicle was the second vehicle parked along the exit ramp and was struck from behind by the Freightliner truck-tractor and pushed forward; the Kenworth vehicle was also struck by the motorcoach as the motorcoach continued forward on the exit ramp. The damage to the left rear of the Kenworth vehicle is shown in figure 12. The semitrailer sustained contact damage to the left taillight assembly, the left mudflap and tire (missing from trailer), and the left-side tie-down assemblies, 4 feet of which were damaged and separated from the trailer. The truck-tractor sustained semi-horizontal scrape marks to the left fender, damage to the driver's entry and exit steps, and inward denting and horizontal scraping to the left side of the fuel tank. In addition, the fuel tank was punctured in the crash and fuel dripped onto the ground. The left-side exhaust stack was torn away from the truck cab.

**Figure 12.** Damage to the left rear of the Kenworth vehicle's semitrailer.

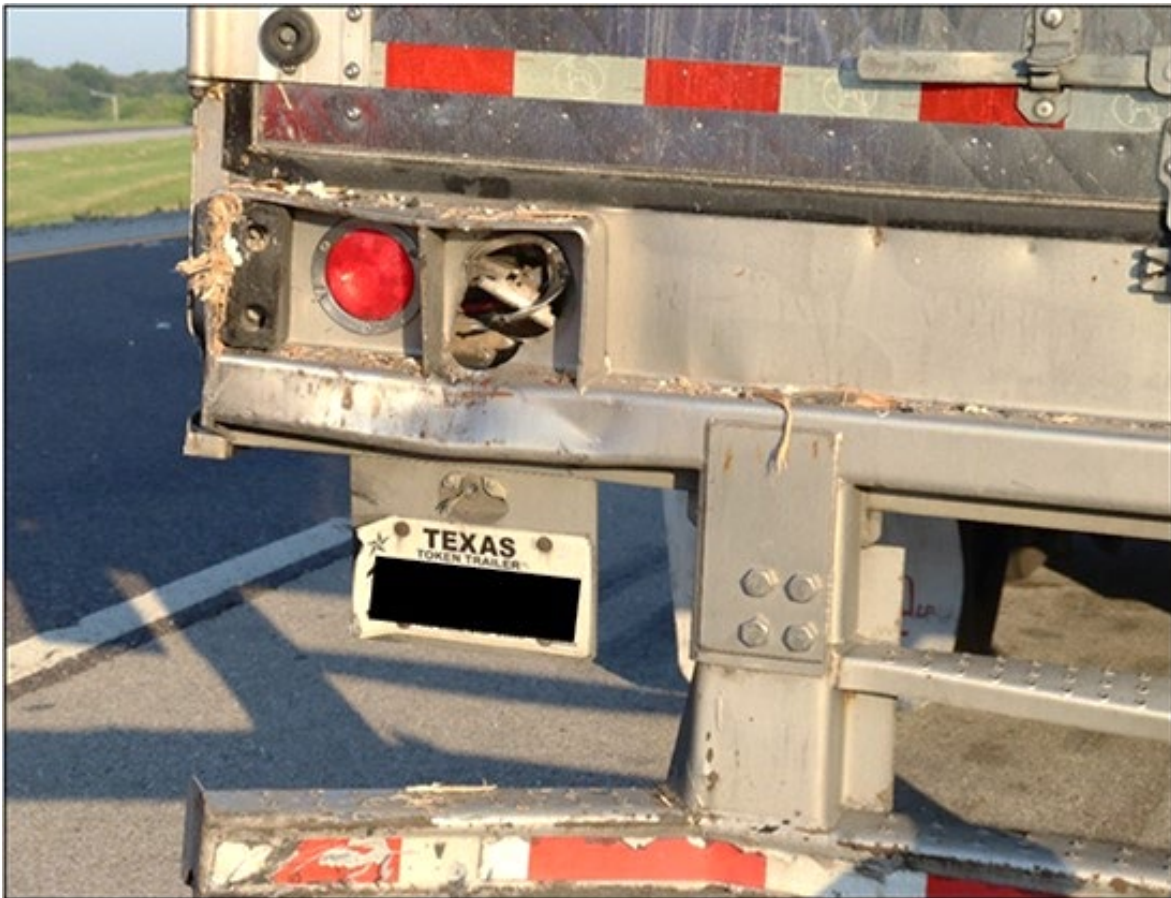
The Mack vehicle consisted of a 2023 Mack truck-tractor in combination with a 2019 Great Dane semitrailer; the semitrailer was refrigerated and carried food items. This vehicle was the third vehicle parked along the exit ramp and was struck on the left rear of the semitrailer by the motorcoach. The Mack vehicle was removed from the scene and released before the NTSB's arrival at the crash location. Investigators therefore used ISP-provided photographs to determine the damage (figure 13), which was localized to the rear left of the semitrailer, where the motorcoach's front right struck it. The left side of the semitrailer's rear underride protection guard was bent, and the left rear portion of the trailer body sustained a horizontal tear about 2 feet long. At final rest, the motorcoach and the Mack vehicle's semitrailer remained in contact, with the semitrailer intruding into the motorcoach.

**Figure 13.** Damage to the left rear of the Mack vehicle's semitrailer. (Source: ISP)

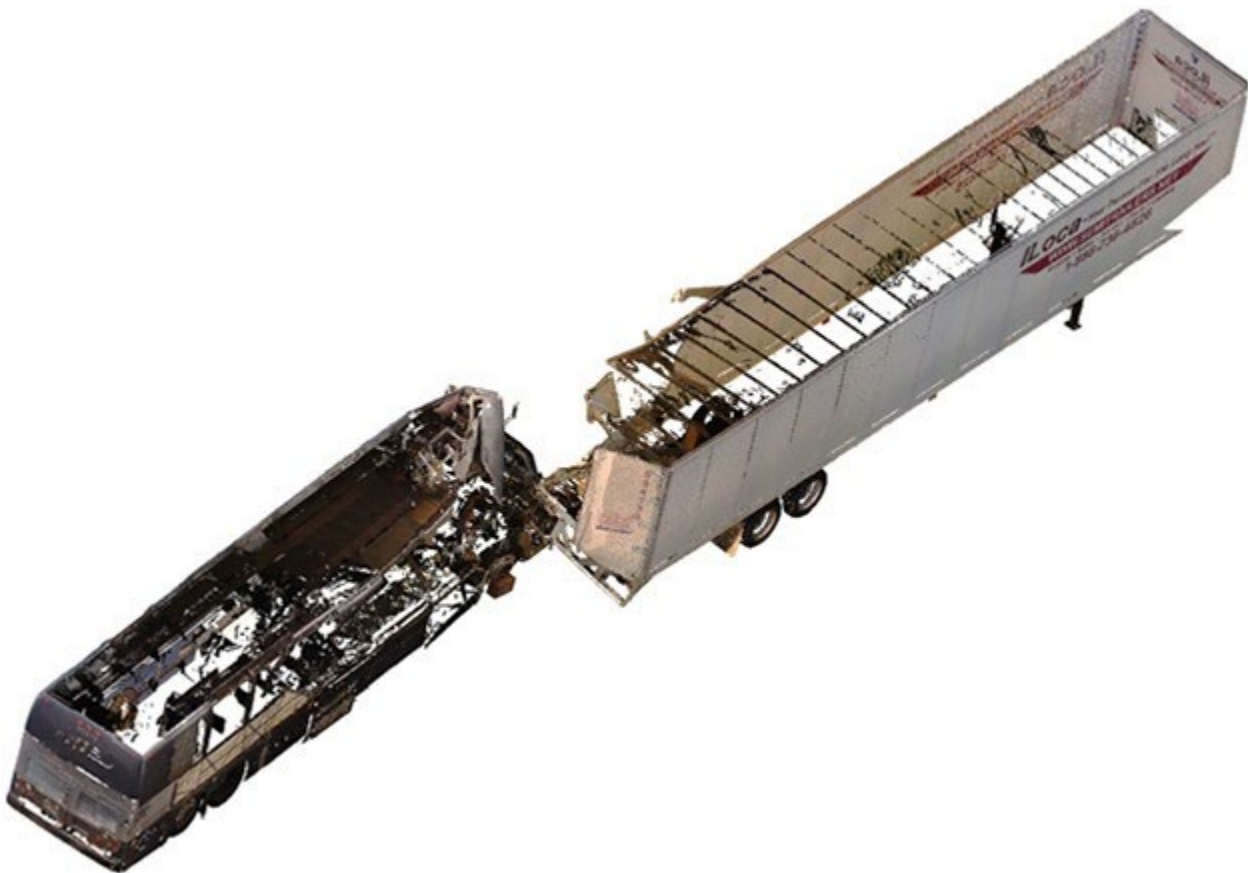
motorcoach crossed about 3 feet onto the paved shoulder and then struck the first parked combination vehicle in an offset fashion. Figure 17, a 3-dimensional scan image of the damaged vehicles, shows the likely positions of the motorcoach and the Freightliner vehicle at impact. The offset strike indicates that the motorcoach driver was not “following” the parked trucks and would not have experienced a visual looming cue from the rear of the trailer.<sup>51</sup> Roadway evidence indicated that, just before this initial collision, the motorcoach driver made a leftward steering maneuver. No braking was noted. The motorcoach’s drift from the travel lane is consistent with the driver being in a diminished state of alertness, such as while impaired or fatigued. No evidence exists of impairment from alcohol or other drugs or of an incapacitating medical event; therefore, fatigue is the more likely cause.

**Figure 17.** Illustration of vehicle impact orientation, using 3-dimensional scans.

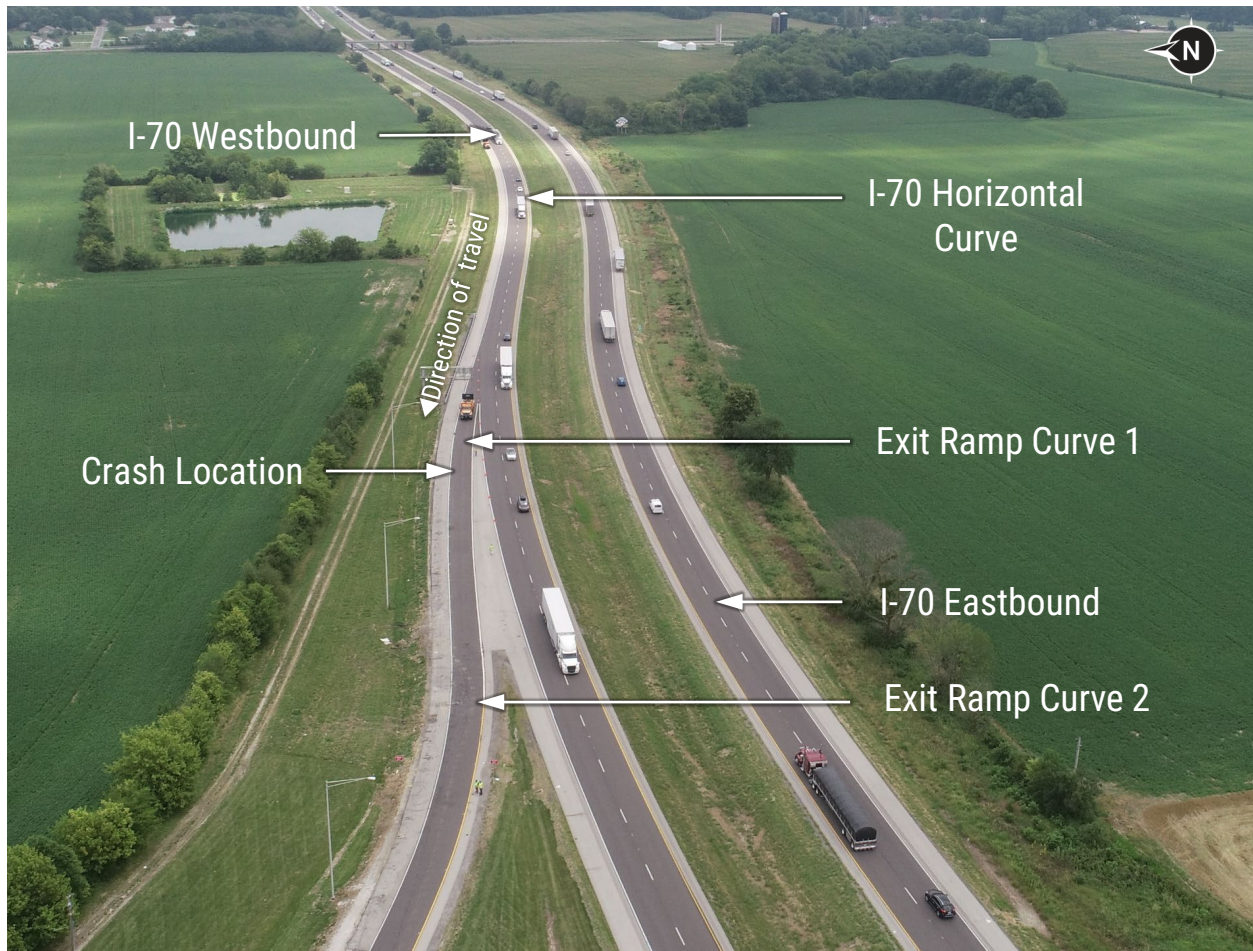
The I-70 road geometry may explain how the fatigued motorcoach driver could follow the exit ramp instead of staying on I-70. Just before the exit ramp, I-70 makes a horizontal curve to drivers' right. The travel lanes of I-70 continue past the exit ramp to the rest area, curving back to the driver's left; however, continuing straight will take a vehicle onto the exit ramp to the rest area. The motorcoach driver successfully navigated the first curve, but failed to follow the second, instead proceeding straight and onto the offramp (both horizontal curves were noted in figure 5). Figure 18 shows an overhead photo of the crash location, facing east, toward the direction of the motorcoach's travel. The crash site is located immediately after exit ramp curve 1, as shown in figure 18, which the motorcoach driver also failed to navigate, leaving the exit ramp travel lane onto the paved shoulder where the combination vehicles were parked. The illuminated parking lights may have resembled highway traffic, particularly if the driver had lapses in attention due to his fatigued state. The NTSB concludes that the crash dynamics, failure to navigate the roadway geometry, and passenger statements are consistent with a fatigued motorcoach driver.

**Figure 18.** Overhead photo of I-70 and the exit ramp to the Silver Lake Rest Area in the vicinity of the crash. Annotations of the horizontal curves on I-70 and the exit ramp leading up to the crash location are included.
