Railroad Investigation Report RIR-26-07

# Canadian Pacific Kansas City Railroad Derailment with Subsequent Hazardous Materials Release and Fire

Bordulac, North Dakota  
July 5, 2024

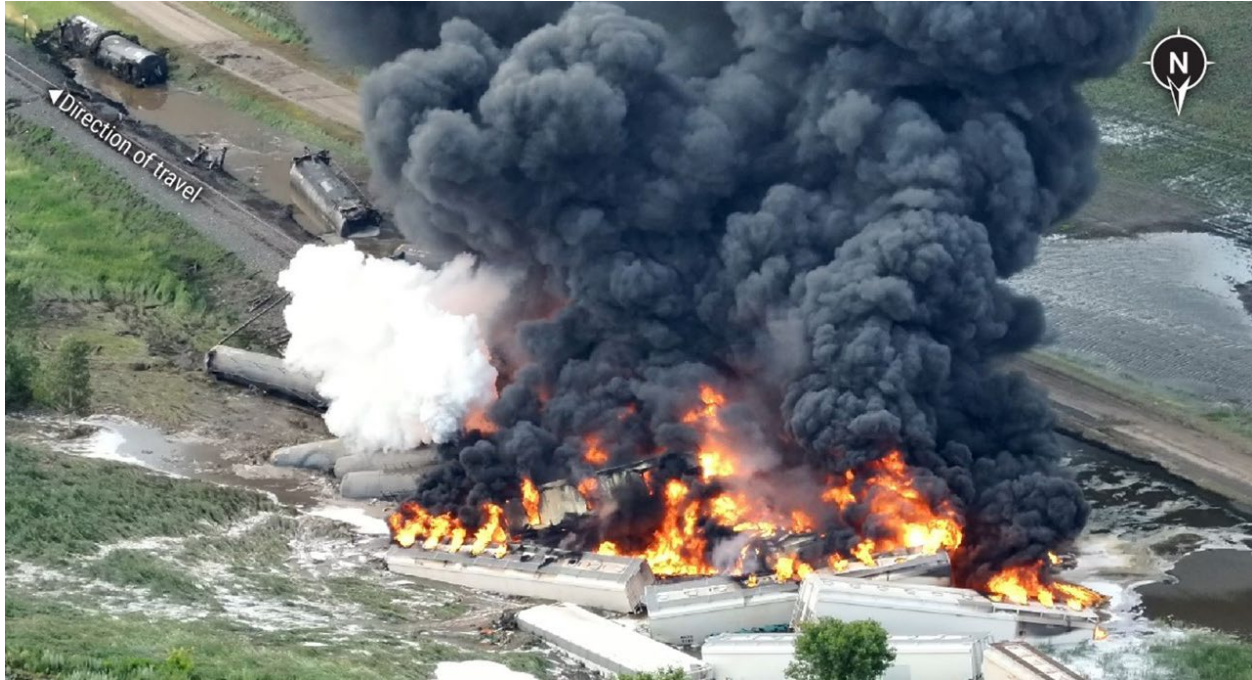
Methanol—a flammable hazardous material—released from five of the breached tank cars and collected in a pool with standing water, resulting in a pool fire surrounding the derailed railcars.<sup>4</sup> (See figure 1.) Anhydrous ammonia released from the other four breached railcars. There were no reported injuries from the accident, although first responders initiated a voluntary evacuation for 2 days of a nearby home. CPKC estimated damages to be about \$3.6 million. At the time of the accident, visibility conditions were dark and clear; the weather was 59°F with no precipitation. The track and the surrounding area were wet from rainfall; about 2 inches of rain had fallen the previous day, concluding by about 9:00 p.m. on July 4, 2024.

**Figure 1.** Aerial view of the derailment site. (Source: Foster County Emergency Management.)

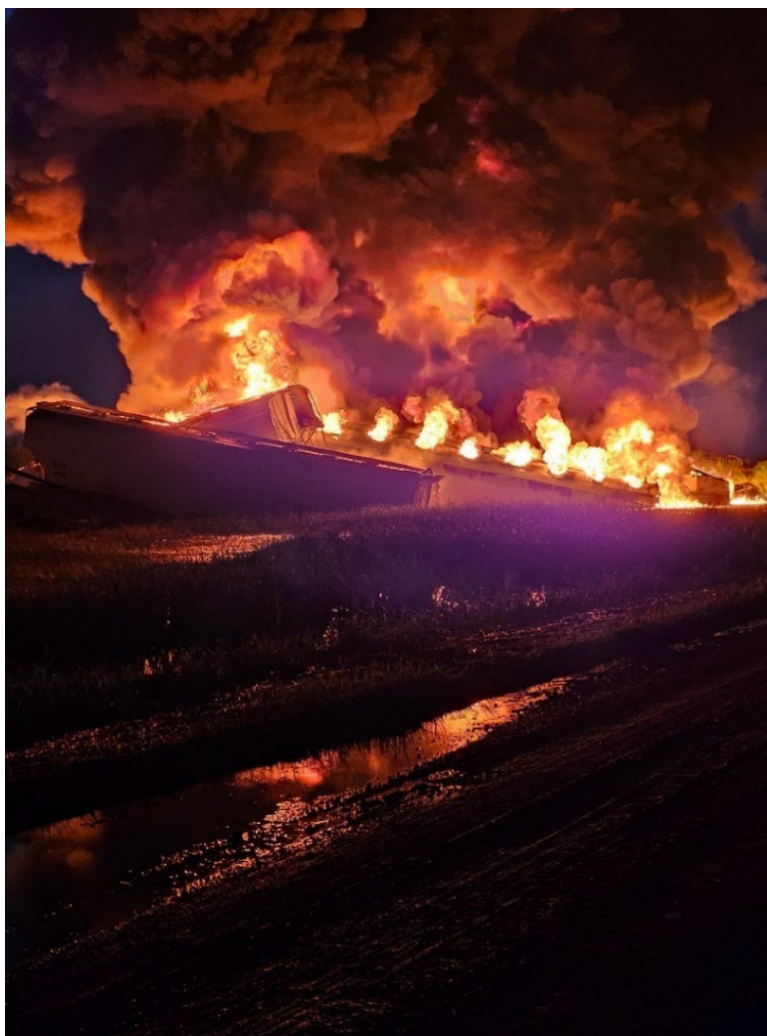
Local CPKC representatives began arriving on scene soon after the fire department personnel. In an interview, the IC told NTSB investigators that he did not immediately obtain a train consist from CPKC but that he knew from his conversation with State Radio that the consist contained flammable materials.<sup>16</sup> Around 4:15 a.m., the IC told the NTSB that he heard pressure relief devices (PRDs) on derailed tank cars releasing material and saw methanol burning on water that was pooled around the derailed cars, along with black smoke from burning plastics.<sup>17</sup> (See figure 4.)

**Figure 4.** Derailement scene and pool fire around 4:58 a.m. (Photo courtesy CFD.)

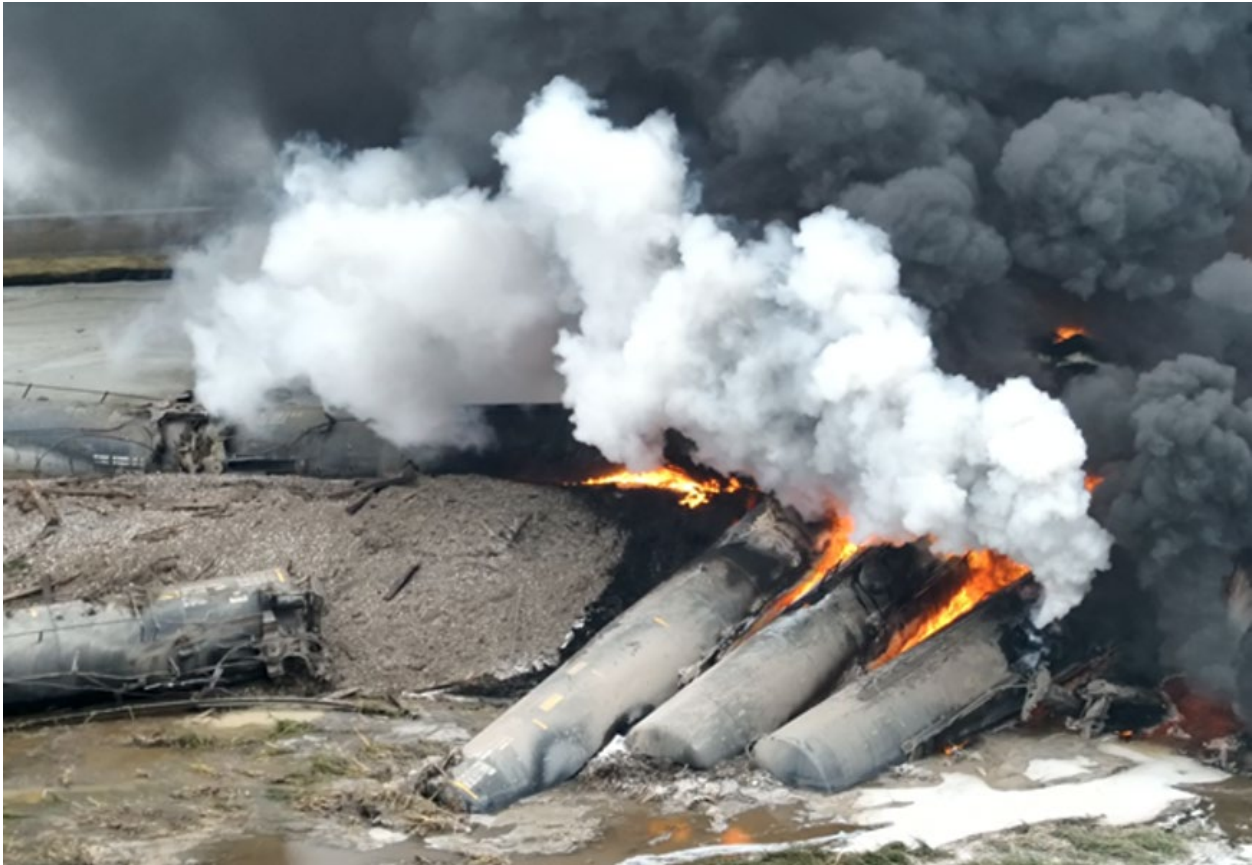
ends of the pileup to help identify which of the derailed tank cars were actively releasing hazardous materials or were breached. Subsequently, emergency responders identified a shell breach on anhydrous ammonia tank car (59) SHQX10805.

**Figure 5.** Anhydrous ammonia releases. (Photo courtesy Foster County Emergency Management.)

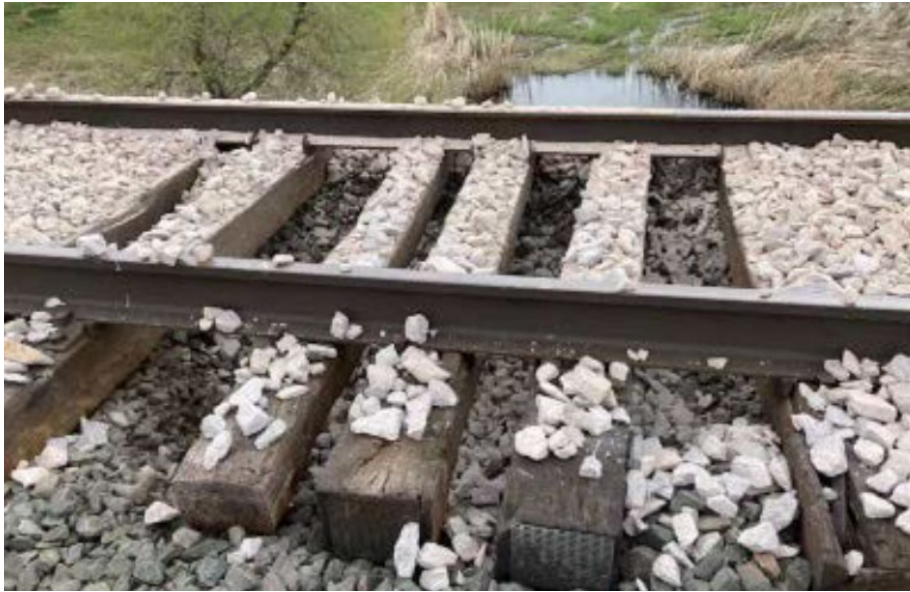
To repair the crosslevel defect, CPKC crews added additional ballast (rock) at the site and attempted to raise and level the track with a tamper. In interviews with the NTSB, crew members recalled that as they began tamping the ballast, a section of the track bed surface suddenly dropped vertically where they were tamping. The low section extended beneath five crossties and was the width of the track. (See figure 8.)

**Figure 8.** Low section of track bed at MP 343.4 on May 17, 2023. (Source: CPKC.)

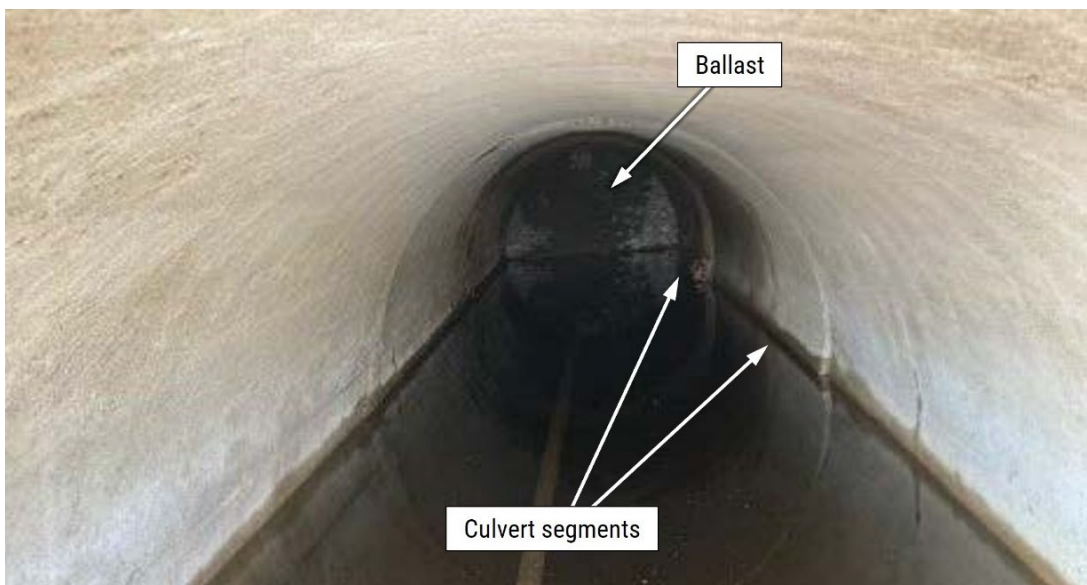
The crew members alerted the CPKC bridge maintenance manager, who oversaw maintenance of bridge structures along about 700 miles of track in Minnesota and North Dakota, including about 2,000 culverts. The bridge maintenance manager told the NTSB that he and his team observed the east culvert during the May 17 work and noted partial separation of two culvert segments. Photos taken at this time show extensive debris and ballast inside it, blocking water flow. (See figure 9.)

**Figure 9.** View looking north through the east culvert on May 17, 2023. (Source: CPKC.)

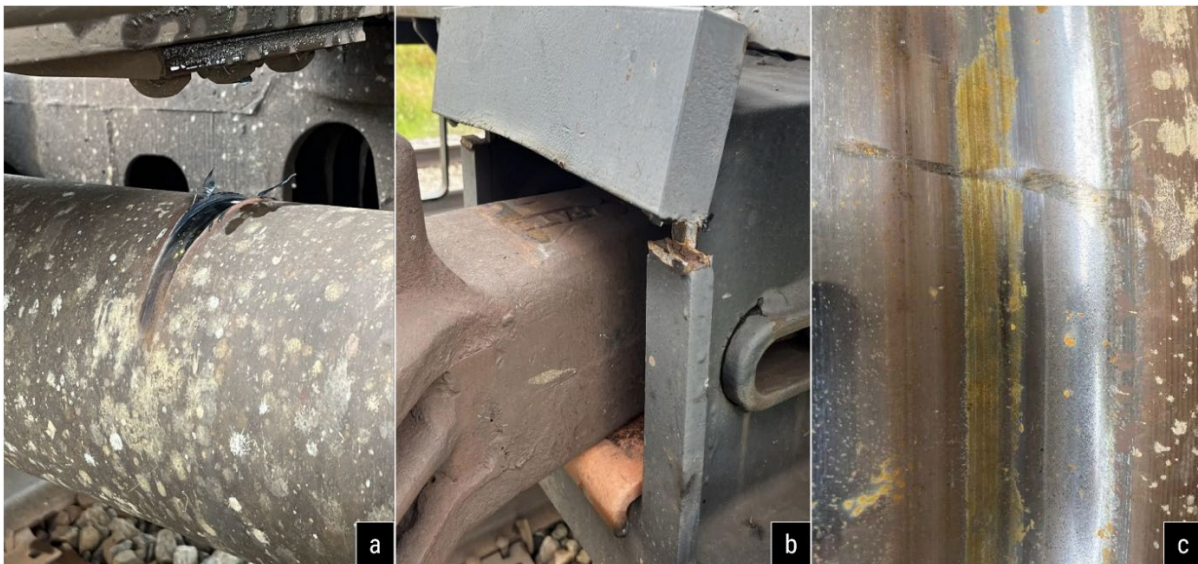
**Figure 10.** Damage to non-derailed equipment: (a) axle contact with draft sill, (39) TILX500825; (b) damaged buffer casting, (46) PROX43474; and (c) broken-rail witness mark on wheel, (41) SHQX10687.

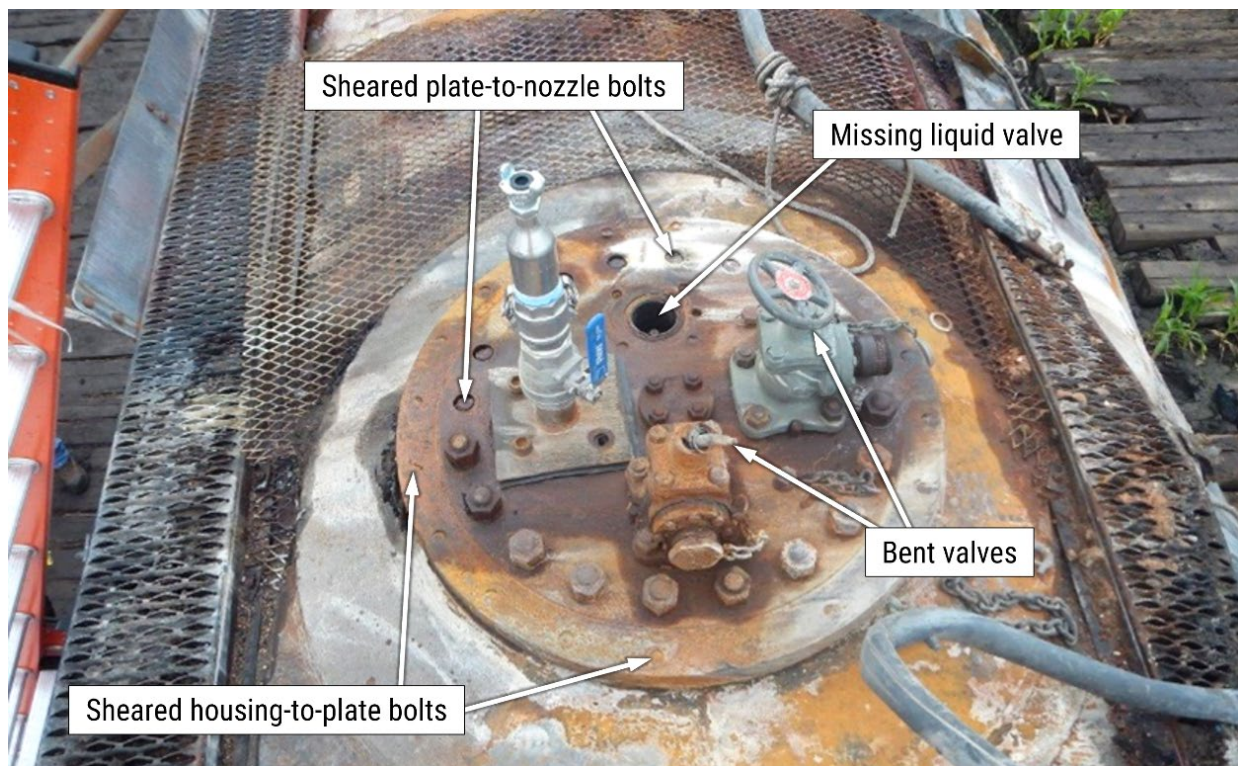
Tank car (54) TILX500730 came to rest north of the tracks and rolled about 90° onto its right side, with its B end elevated above the A end.<sup>41</sup> The protective housing and valves sheared off the car during the derailment.<sup>42</sup> Nine of the bolts attaching the pressure plate to the manway nozzle had sheared off, as had all 20 of the pressure plate's 0.75-inch bolt studs attaching the protective housing to the pressure plate.<sup>43</sup> The liquid valve was missing from the pressure plate, and the vapor valve was bent. (See figure 13.) A CPKC remediation contractor observed anhydrous ammonia vapor leaking from the pressure plate.

**Figure 13.** Damaged pressure plate and valves on (54) TILX500730. (Note: The PRD had been removed, and a transloading valve was installed in its place after the derailment.)

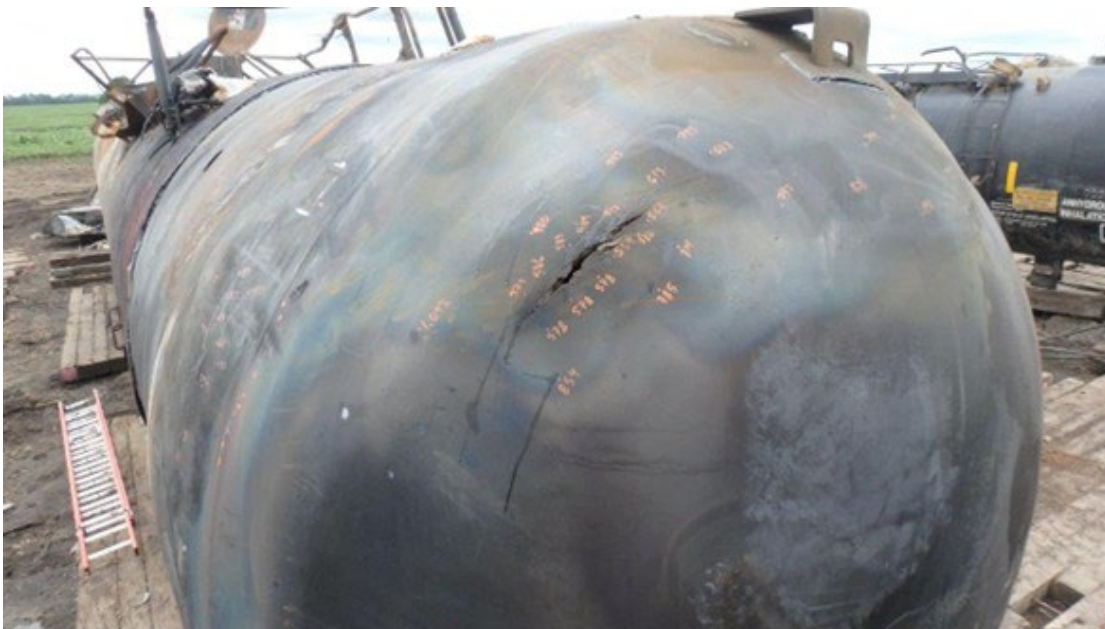
Tank car (55) TILX501050 came to rest south of the tracks, rolled about 10° onto its right side with its B end elevated above its A end. NTSB investigators observed a bulge and an 8-inch thermal tear in the shell on the tank car's B end. (See figure 14.) Additionally, blued steel was observed on the tank head and interior jacket surfaces near the thermal tear.<sup>44</sup> The paint was scorched on the top and sides of the tank shell and the left side of the B-end tank head. The FRA conducted ultrasonic thickness mapping of the tank steel at various points in the area of the tear. These measurements ranged from 1.092 inches to 0.479 inches closest to the tear.<sup>45</sup>

**Figure 14.** B-end head bulge and tear.

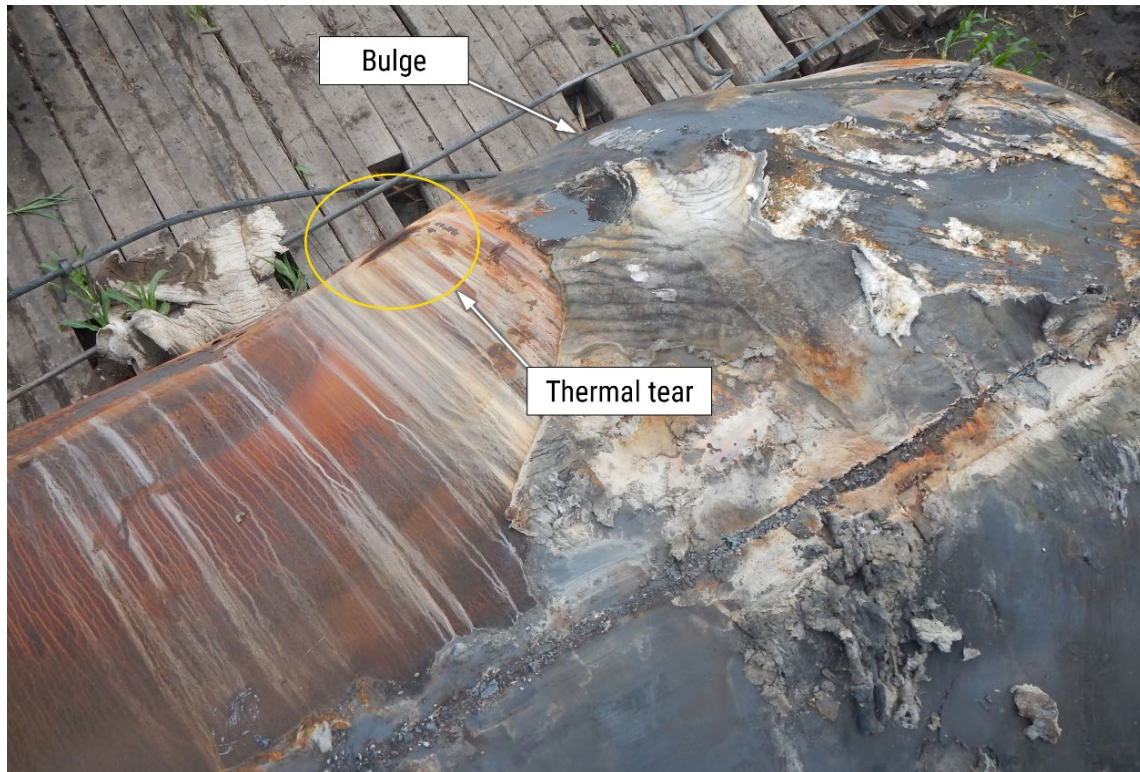
Tank car (56) UTLX971273 came to rest north of the tracks 20° on its left side, with its B end elevated above its A end, underneath a hopper car. NTSB investigators noted a bulge about 74 inches across the top and right side of the tank shell and an 8.5-inch thermal tear at the top of the tank shell. (See figure 15.) Ultrasonic thickness measurements near the thermal tear ranged from 0.905 inches to 0.474 inches.<sup>47</sup>

**Figure 15.** (56) UTLX971273 tear and bulge.

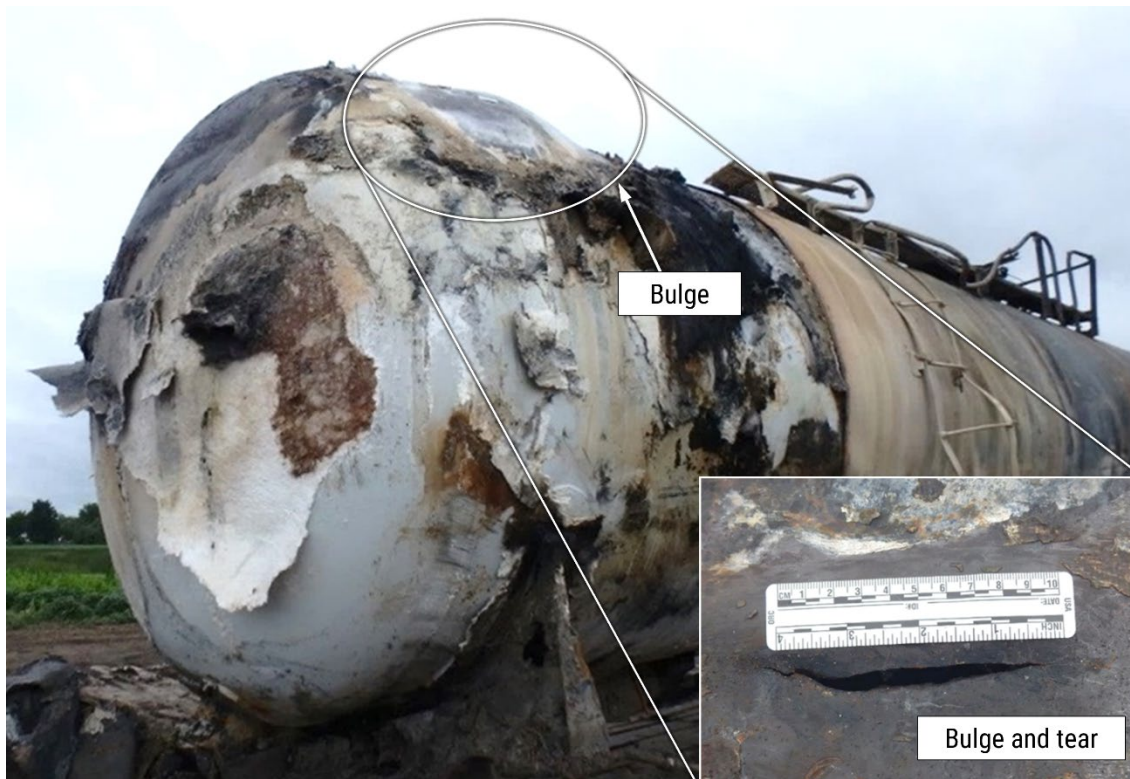
torn and its thermal blanket missing.<sup>48</sup> Ultrasonic thickness measurements of the tank shell near the tear ranged from 0.948 inches to 0.415 inches.<sup>49</sup>

**Figure 16.** Bulge in tank car (59) SHQX10805 (*upper left*) and thermal tear (*inset*).

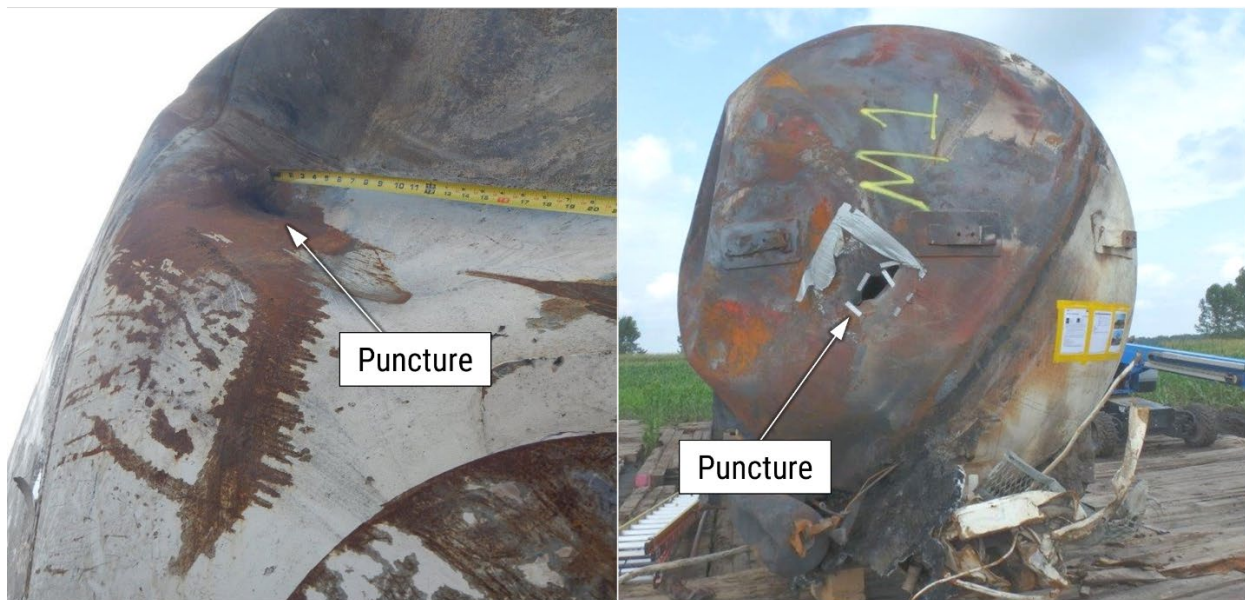
Tank car (62) MFCX132265, a CPC-1232 specification tank car, came to rest rolled about 45° onto its right side and with a hopper car laying across the B end. NTSB investigators observed a 3.5-inch puncture within a circular dent on the tank car's A-end head, above the half-height head shield, and a 4- by 13-inch, irregularly shaped puncture on the B end, just below where the half-height head shield had been. The B-end head shield was missing. (See figure 17.)

**Figure 17.** Punctures on the A end (*left*) and B end (*right*) of tank car (62) MFCX132265.

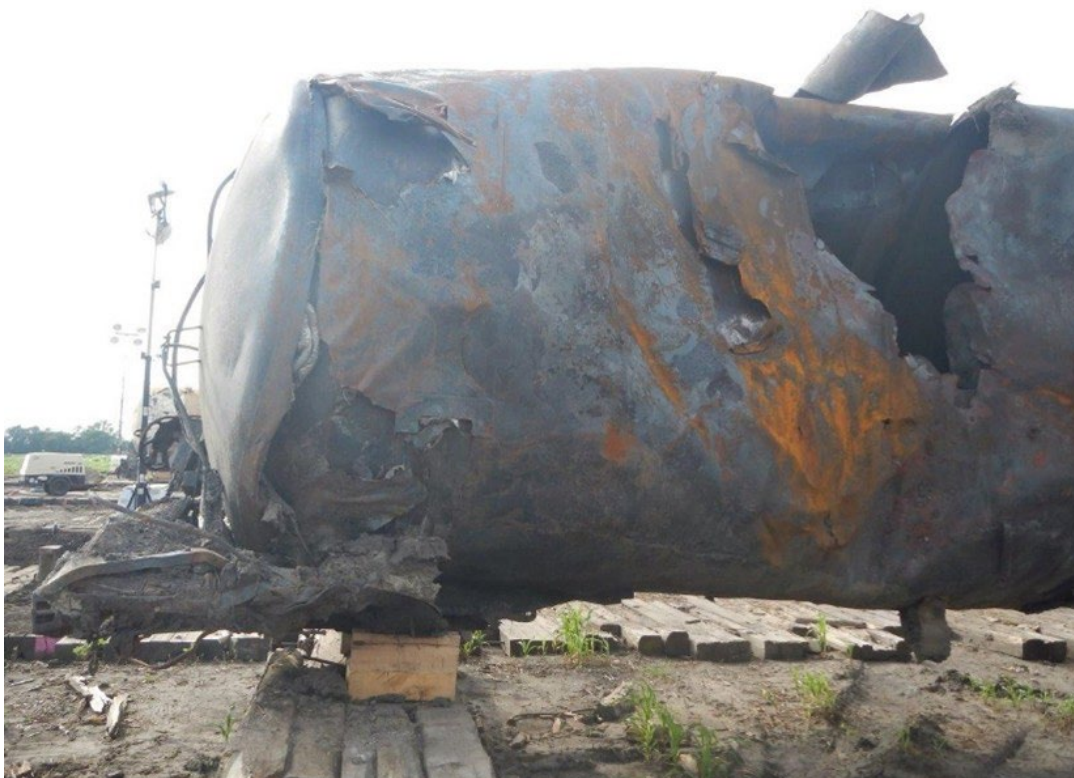
Tank car (61) TILX355610 came to rest about 45° on its left side, with a hopper car on top of it. The tank car had a 4- by 8-foot irregular fracture along one side of the tank shell, with a mass of melted plastic pellets inside of it, and a 6- by 8-inch puncture on the other side. (Figure 19 shows the shell fracture.) The PRD and vacuum relief valve were sheared off and missing from the car along with the top fittings' protective housing. More than half of the tank had been exposed to fire, and the tank car's placards were destroyed.

**Figure 19.** Shell fracture on tank car (61) TILX355610.

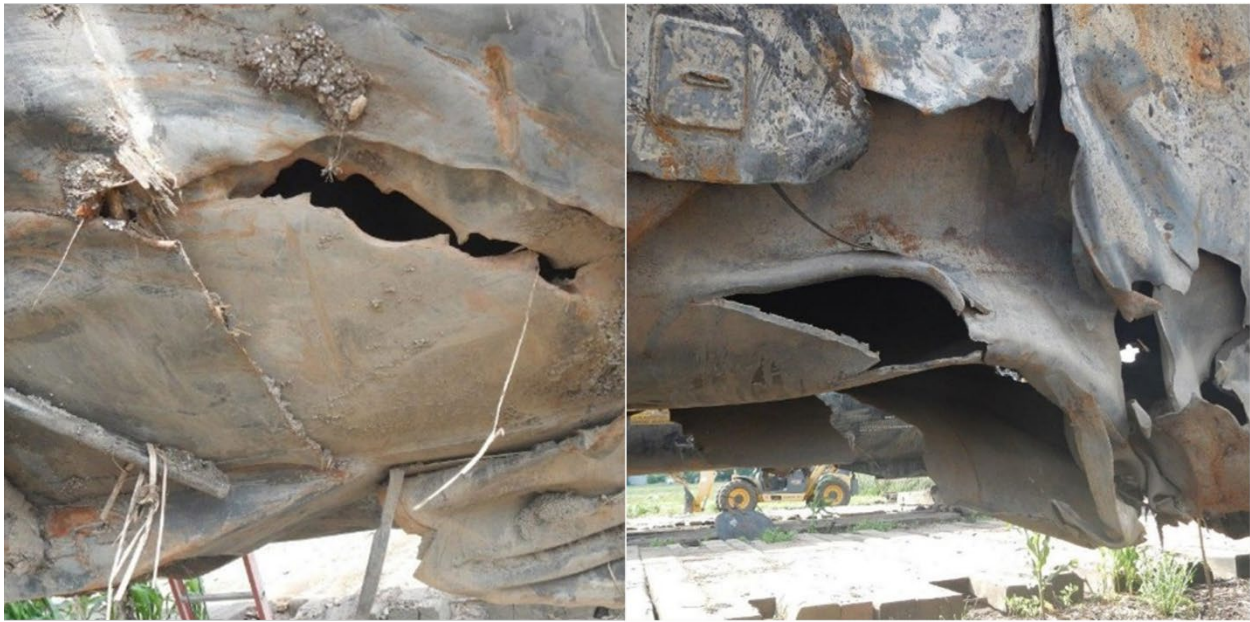
Tank car (63) CTCX300358 came to rest about 90° on its right side, generally parallel to the direction of travel. One side of the tank car had a 21-inch-long, irregularly shaped shell tear. The tank jacket was torn, and the thermal blanket was missing around the breach. The tank car also had 17- and 27-inch-long shell tears on the bottom of the tank, with a torn jacket and missing thermal blanket for several inches around the tears. (See figure 20.) More than 50% of the tank shell had been exposed to fire.

**Figure 20.** Tank car (63) CTCX300358 shell tears.

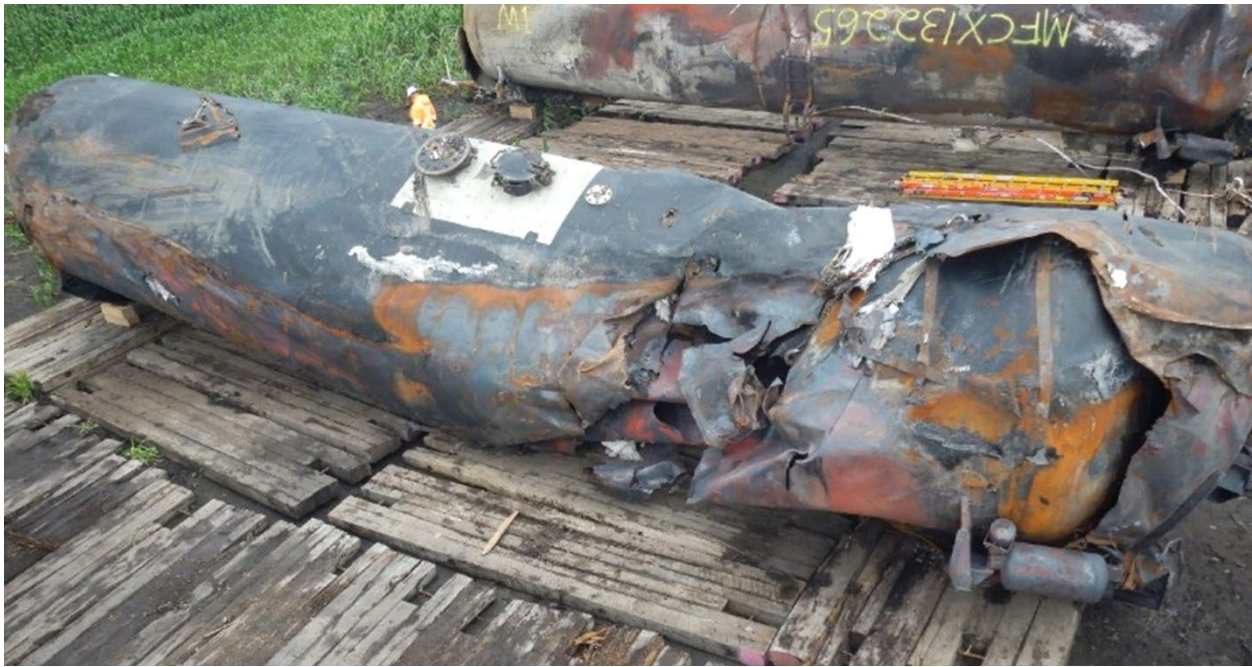
The final tank car to derail, (64) CTCX732476 came to rest about 90° on its right side across the track at the back (west) end of the pileup, its B end underneath a hopper car and its A end in contact with another hopper car. NTSB investigators noted irregularly shaped shell tears on the shell's side and bottom stretching the length of the tank car. (See figure 21.) The bottom of the tank car was deeply dented and compressed upward and its left side compressed toward its right side. The tank jacket was torn and peeled back, and the thermal protection blanket was missing in the same area, with the tank and tank shell exposed to fire.

**Figure 21.** Shell tear, torn jacket, and missing thermal blanket on CTCX732476.

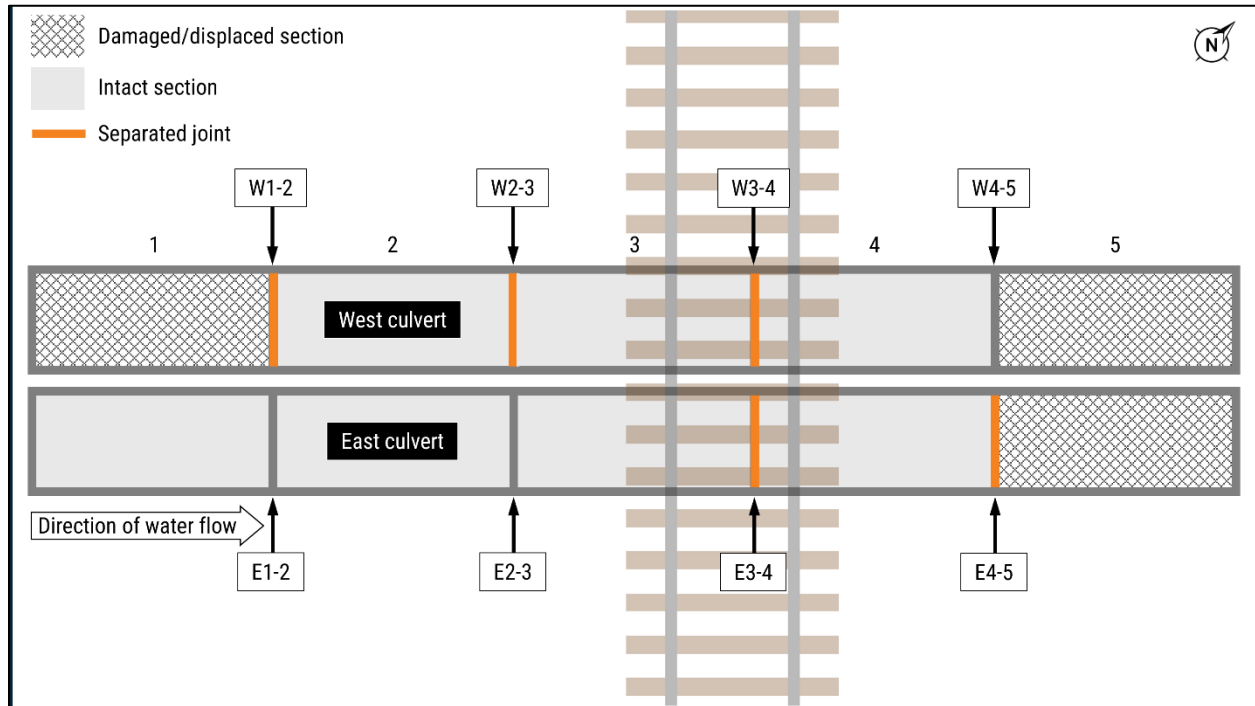
end of the west culvert and one segment on the north end of the east culvert. These damaged segments, numbered 1 through 5 from south to north in this report, were cleared away so the culverts could be examined further. Joints between the segments are labeled by culvert and by adjoining segments, for example, joint W1-2 is between segments 1 and 2 in the west culvert. (See figure 22.)

**Figure 22.** Layout of culverts at accident location, with damaged or displaced sections and separated joints noted.

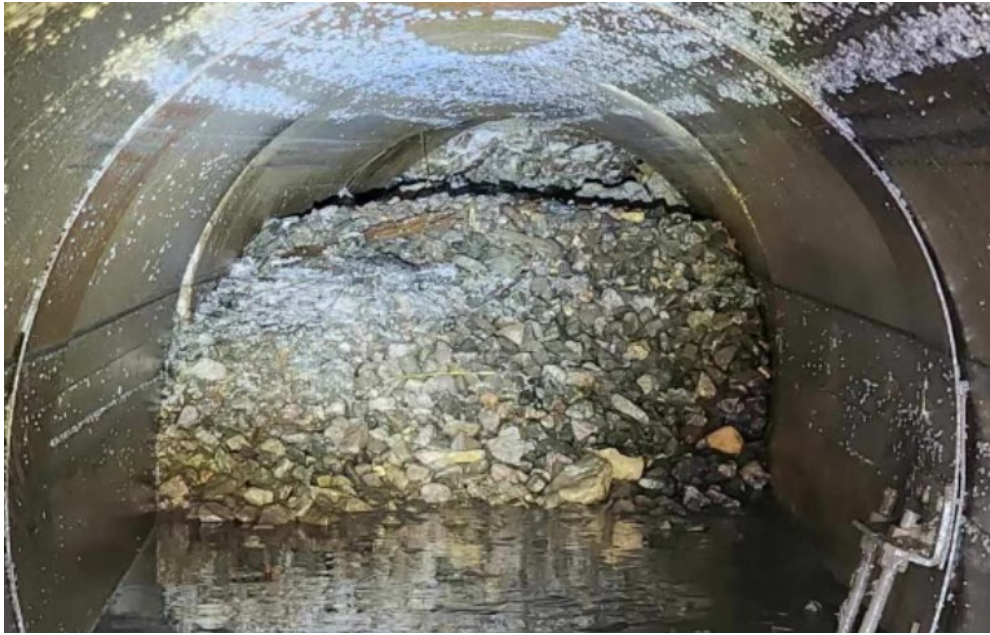
type was found near joint E3-4 during the examination. Joint E4-5 was also open and displaced, with the rocks and soil of the track bed visible through the separated joint.

**Figure 23.** East culvert upon examination and before cleanout.

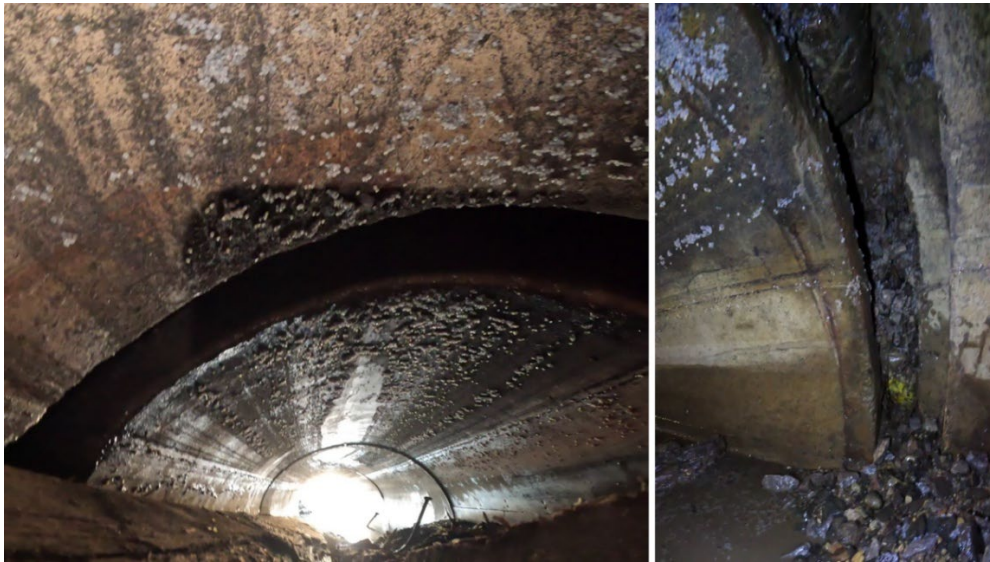
**Figure 24.** East culvert at joint E3-4 looking south (*left*) and west (*right*). (Source: CPKC.)

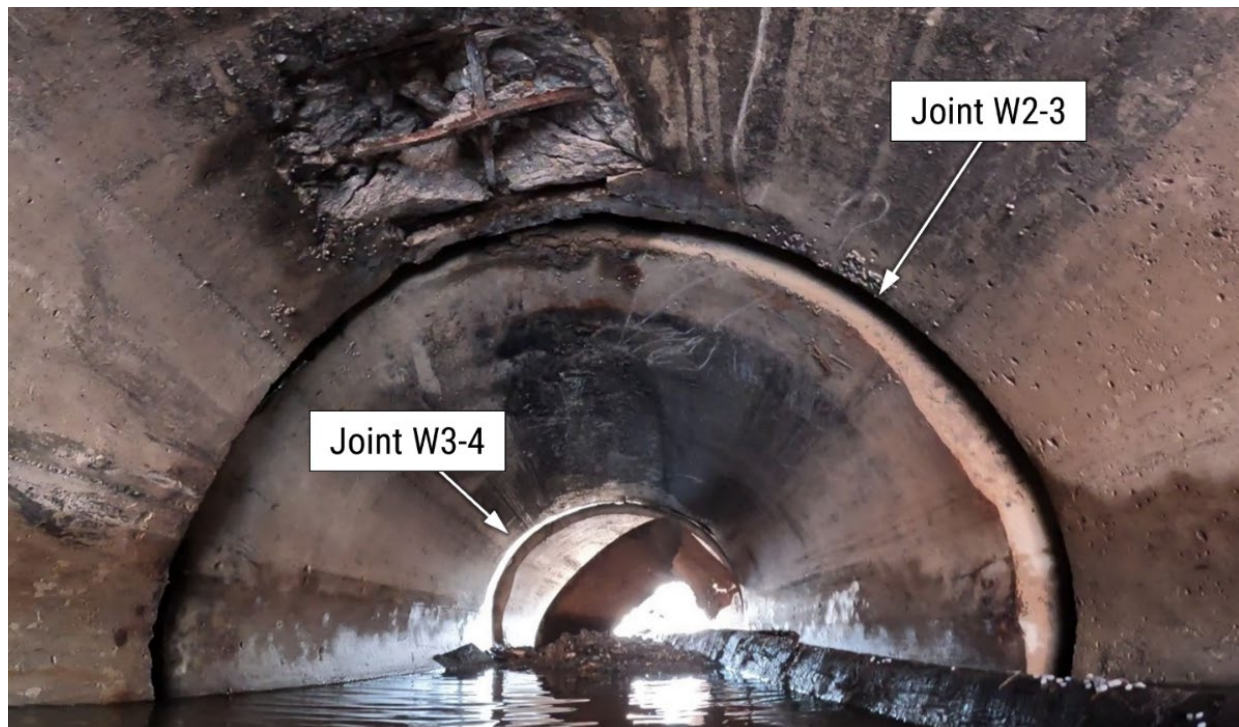
steel could be seen in the hole, though some of the concrete cracking was light in color with clean fracture surfaces. (See figure 25.) Joint W2-3 was open about the length of the bell and displaced. As in the east culvert, a displaced and corroded metal band was loose near the north end of segment 3. The north end of segment 3 displayed some rust staining and circumferential cracking, which appeared to extend completely through the culvert wall. Further north in the west culvert, joint W3-4 was also open and displaced with extensive visible voids and signs of infiltration of ballast, rock, and soil. (See figure 26.) Portions of segment 4 near the top of the culvert were also missing.

**Figure 25.** Interior of west culvert looking north. (Source: CPKC.)

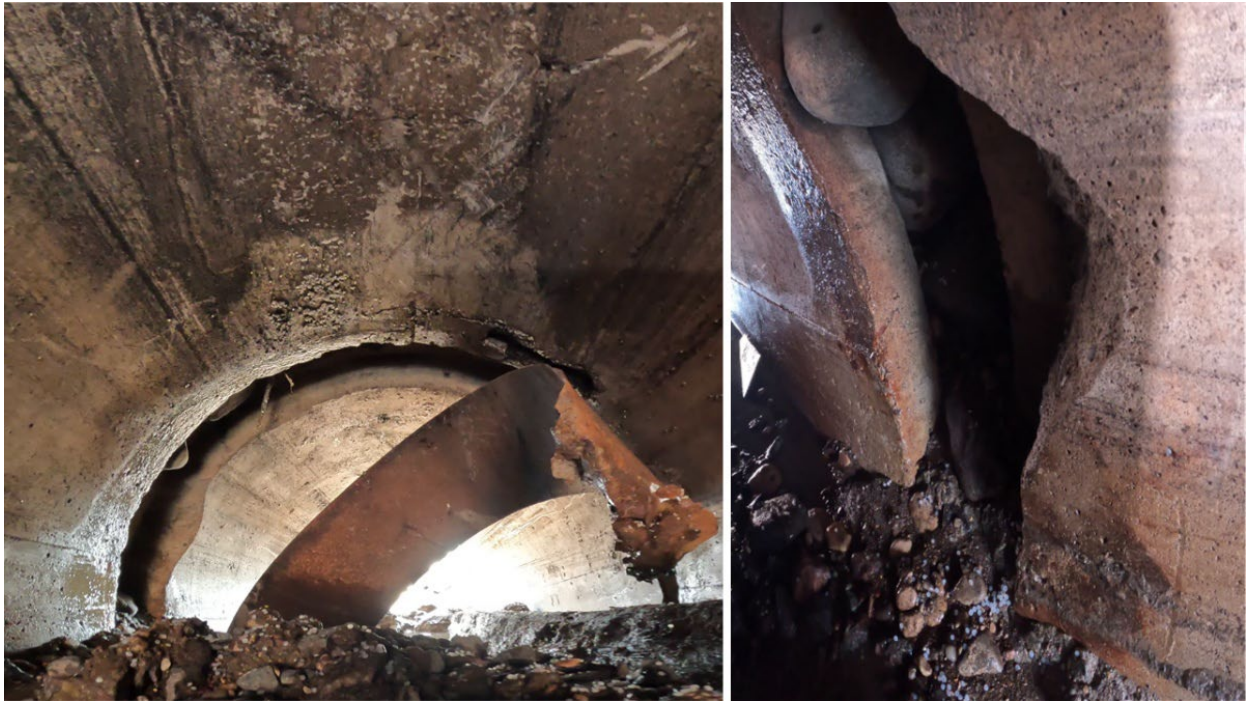
**Figure 26.** Interior of west culvert looking north (*left*) and west (*right*). (Source: CPKC.)

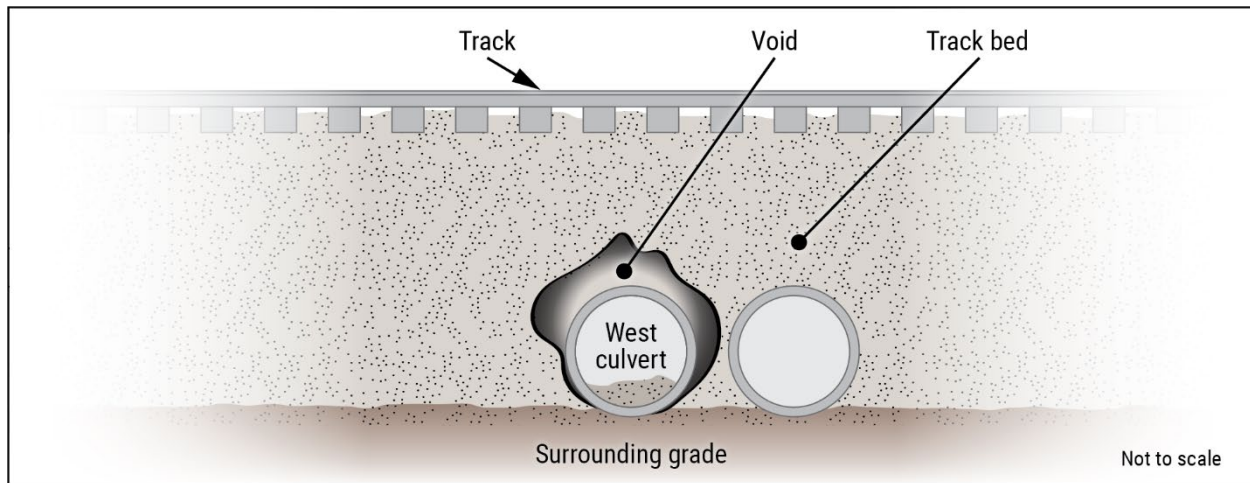
Data from locomotive CP8882's outward-facing camera and from earlier ATI inspections showed no apparent surface defects in the track bed itself as the train approached the derailment site on July 5, 2024, suggesting that the loss of ballast and subgrade was concentrated beneath the track structure. (See figure 27.) The sudden downward collapse of the track bed as the train passed over the culvert at the time of the accident indicated that the loss of ballast material through a separation in the culvert sections had at some point created a subgrade void above the culvert which gave way as the train went over it.

**Figure 27.** Illustration of subgrade void and culverts.

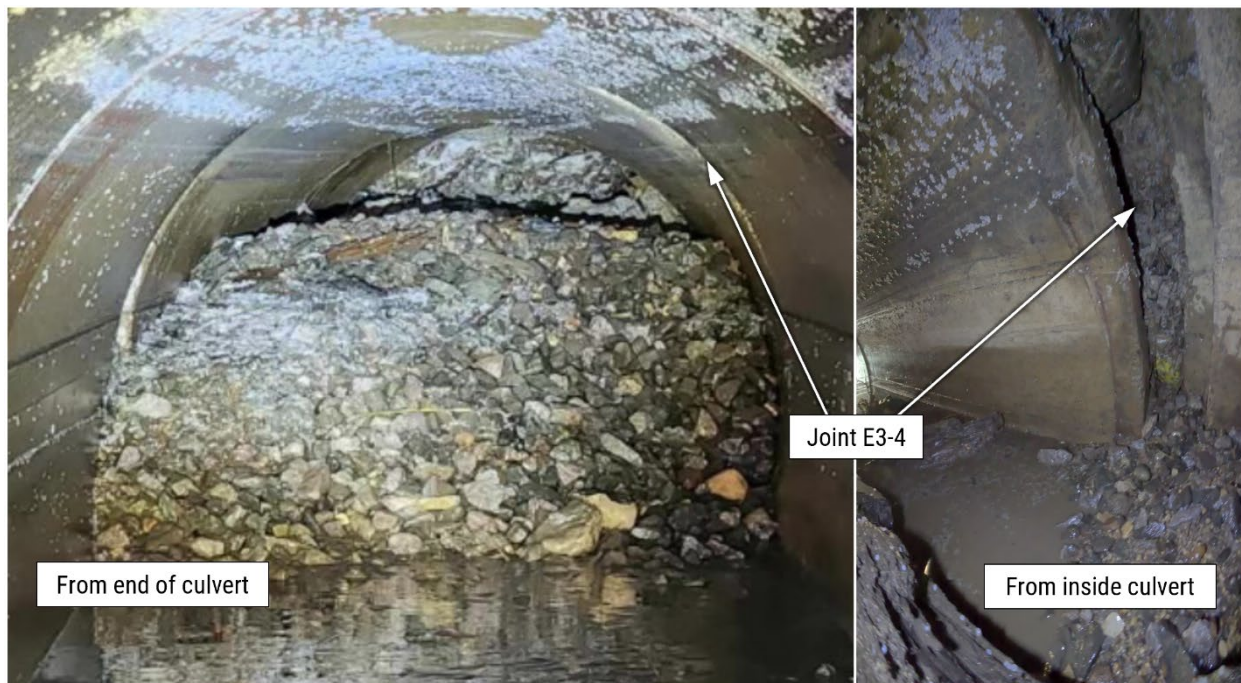
The typical culvert inspection practice, as defined by the CPKC bridge maintenance manager, was to peer into the ends of the culvert with a flashlight to assess their condition, as well as inspecting the condition of culverts inlets, outlets, and flow channels. The culverts at the accident location were 48 feet long. Because of the culverts' length, a view from their ends would be limited to a narrow angle, and the middle of the structure would be obscured by distance. Figure 29 shows how the view from the end of the culvert does not offer a view of the culvert joints and could prevent an inspector from seeing the joint separation.

**Figure 29.** Joint E3-4 viewed from the end (*left*) and inside (*right*) the east culvert.

As a result of this investigation, the NTSB issued 11 new recommendations and reiterated six recommendations. We recommended that Canadian Pacific Kansas City Railroad revise its culvert inspection procedures to require internal inspections, either in person or assisted by technology, and that the railroad provide detailed guidance to culvert inspectors on proper ratings for degraded culverts and require remedial actions to fix such culverts.
