November 18, 2025

Marine Investigation Report MIR-25-40

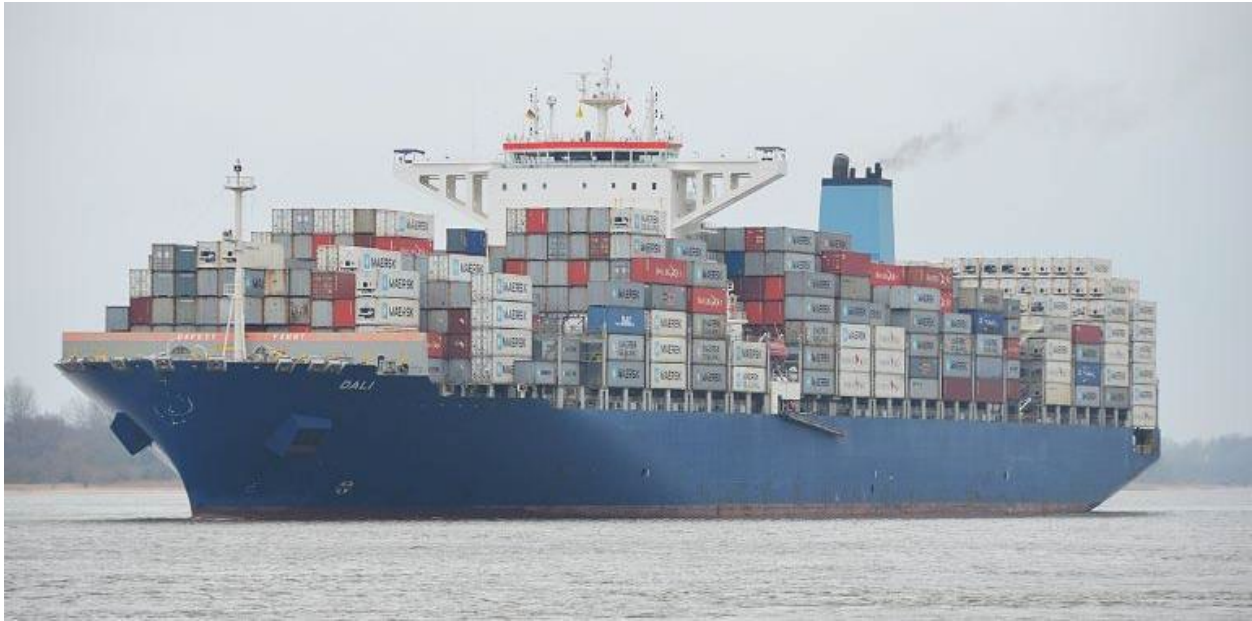
Figure 1. Containership *Dali* in 2019. (Source: Buggi Porschien, vesselfinder.com)

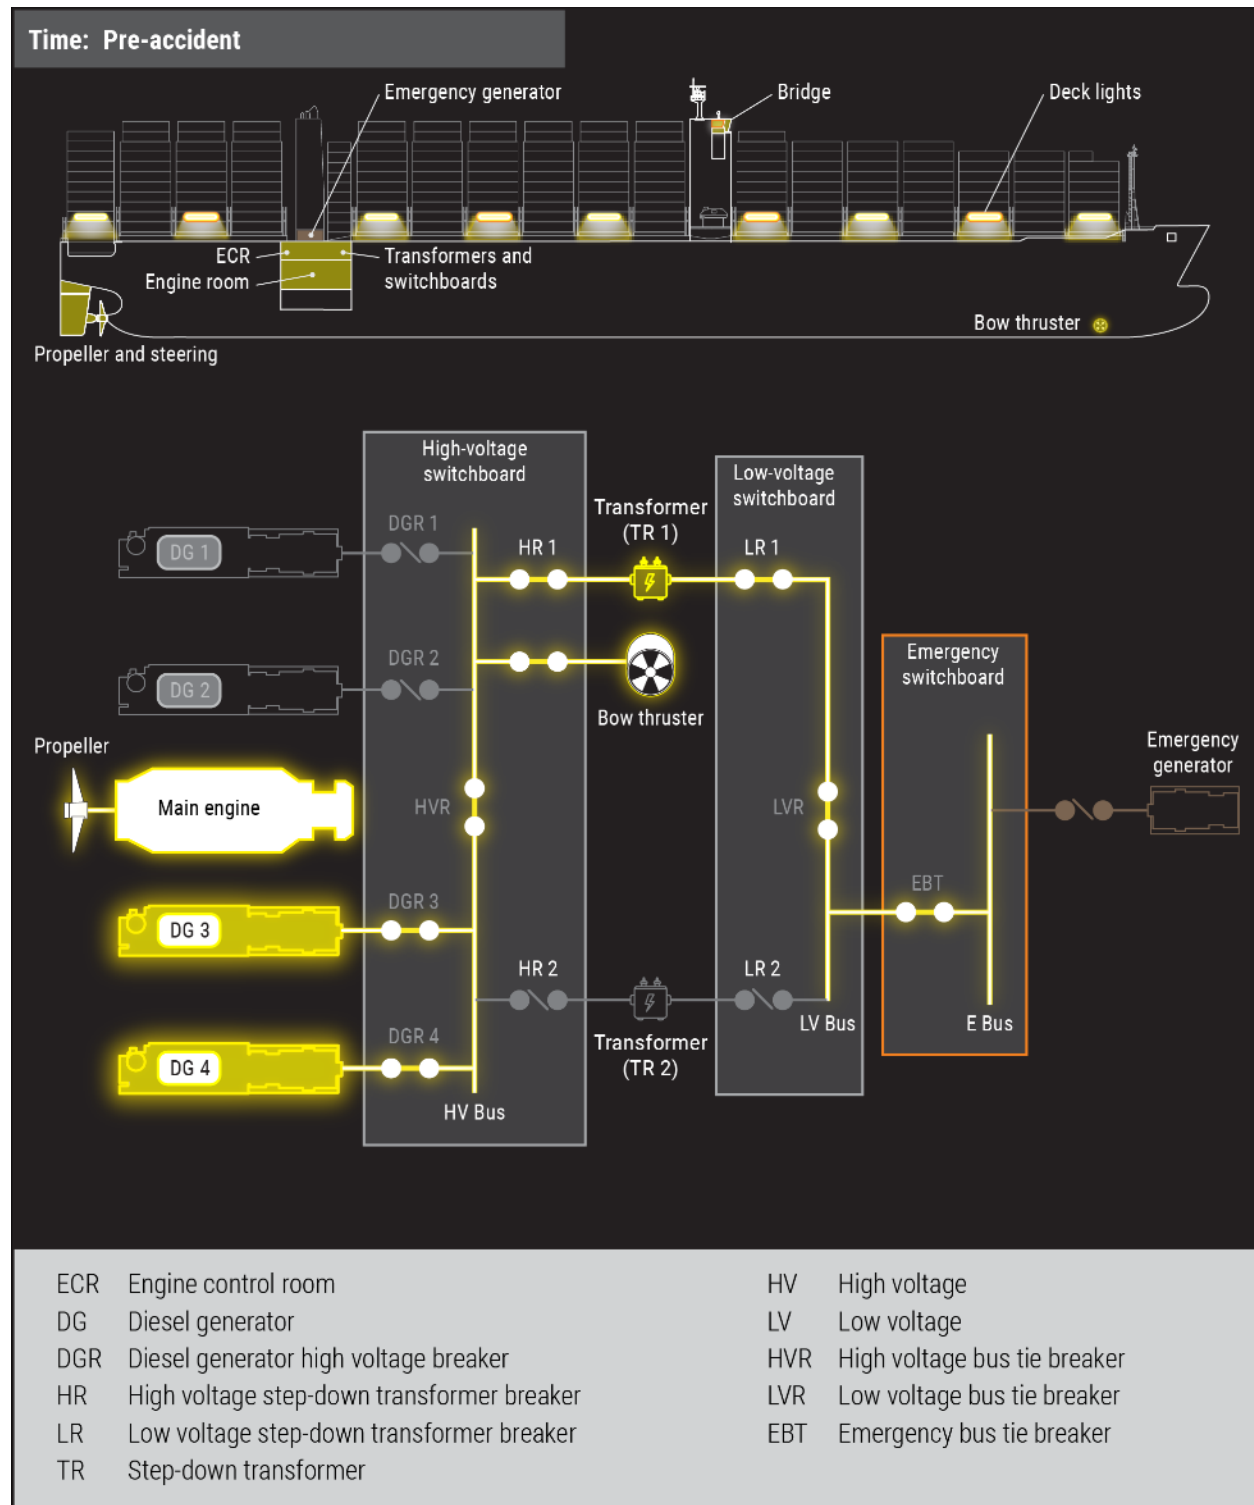
Figure 5. Configuration of *Dali* plant at time the *Dali* left the dock at Seagirt Marine Terminal on March 26, with DG3 and DG4 energized. (DG1 was offline, while DG2 was in standby.) As the vessel maneuvered away from the terminal and out through the Seagirt Marine Terminal West Channel, about 0048, the senior pilot told the master to have one

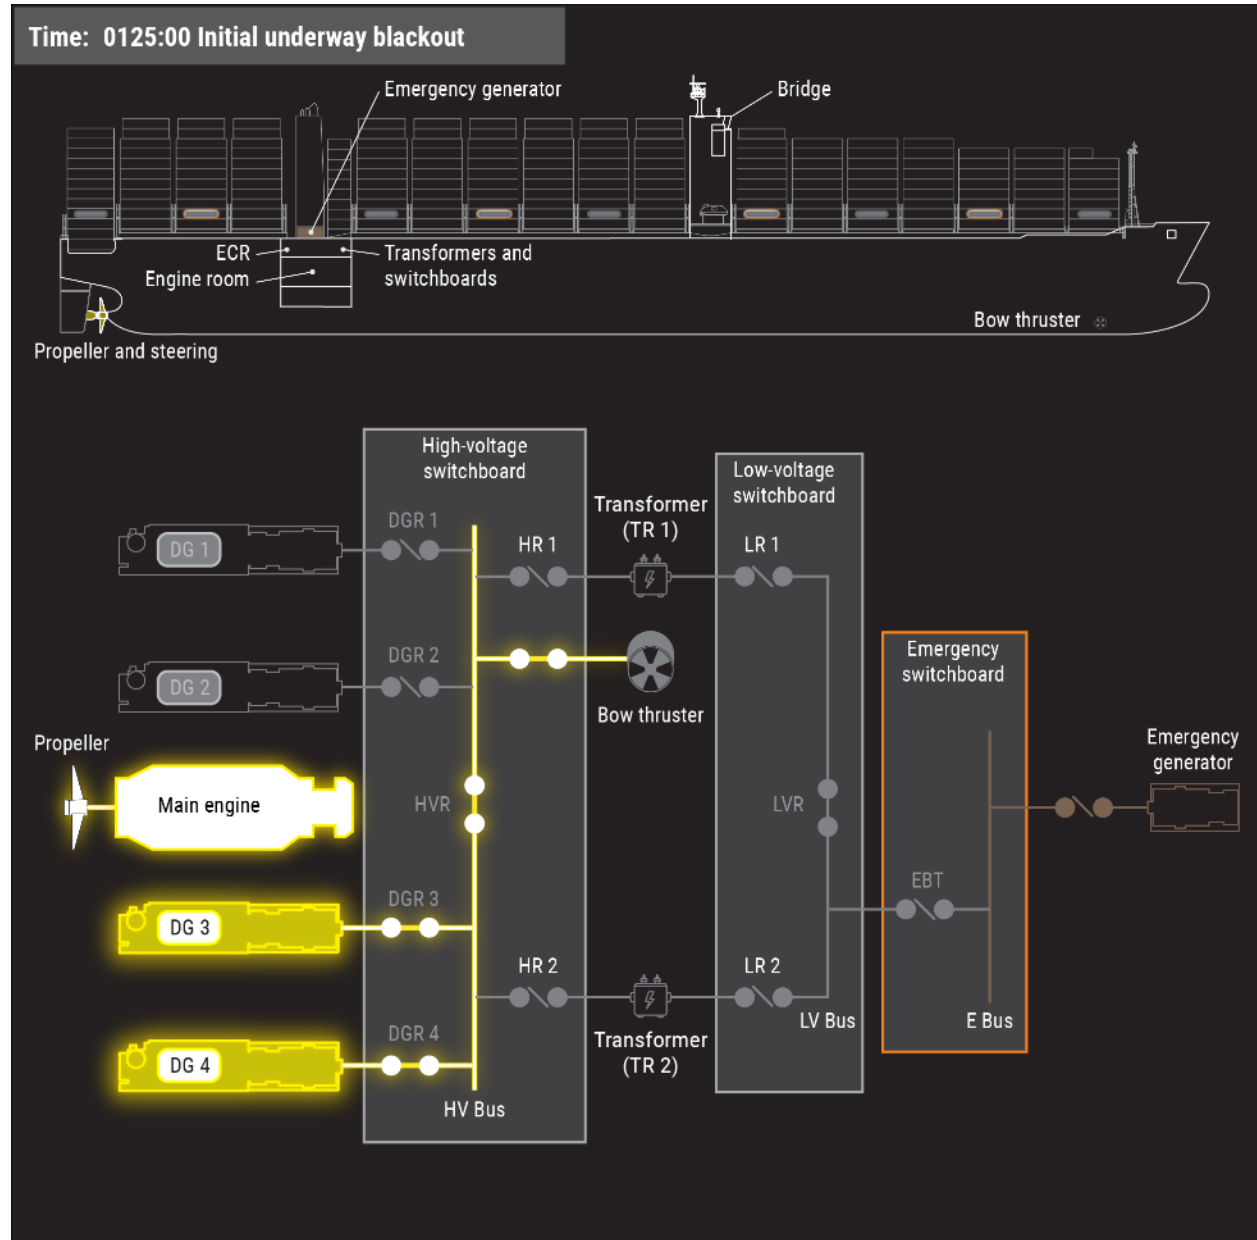
Figure 8. Configuration of *Dali* plant at 0125:00, the time of the initial loss of power (blackout) while the vessel was underway.

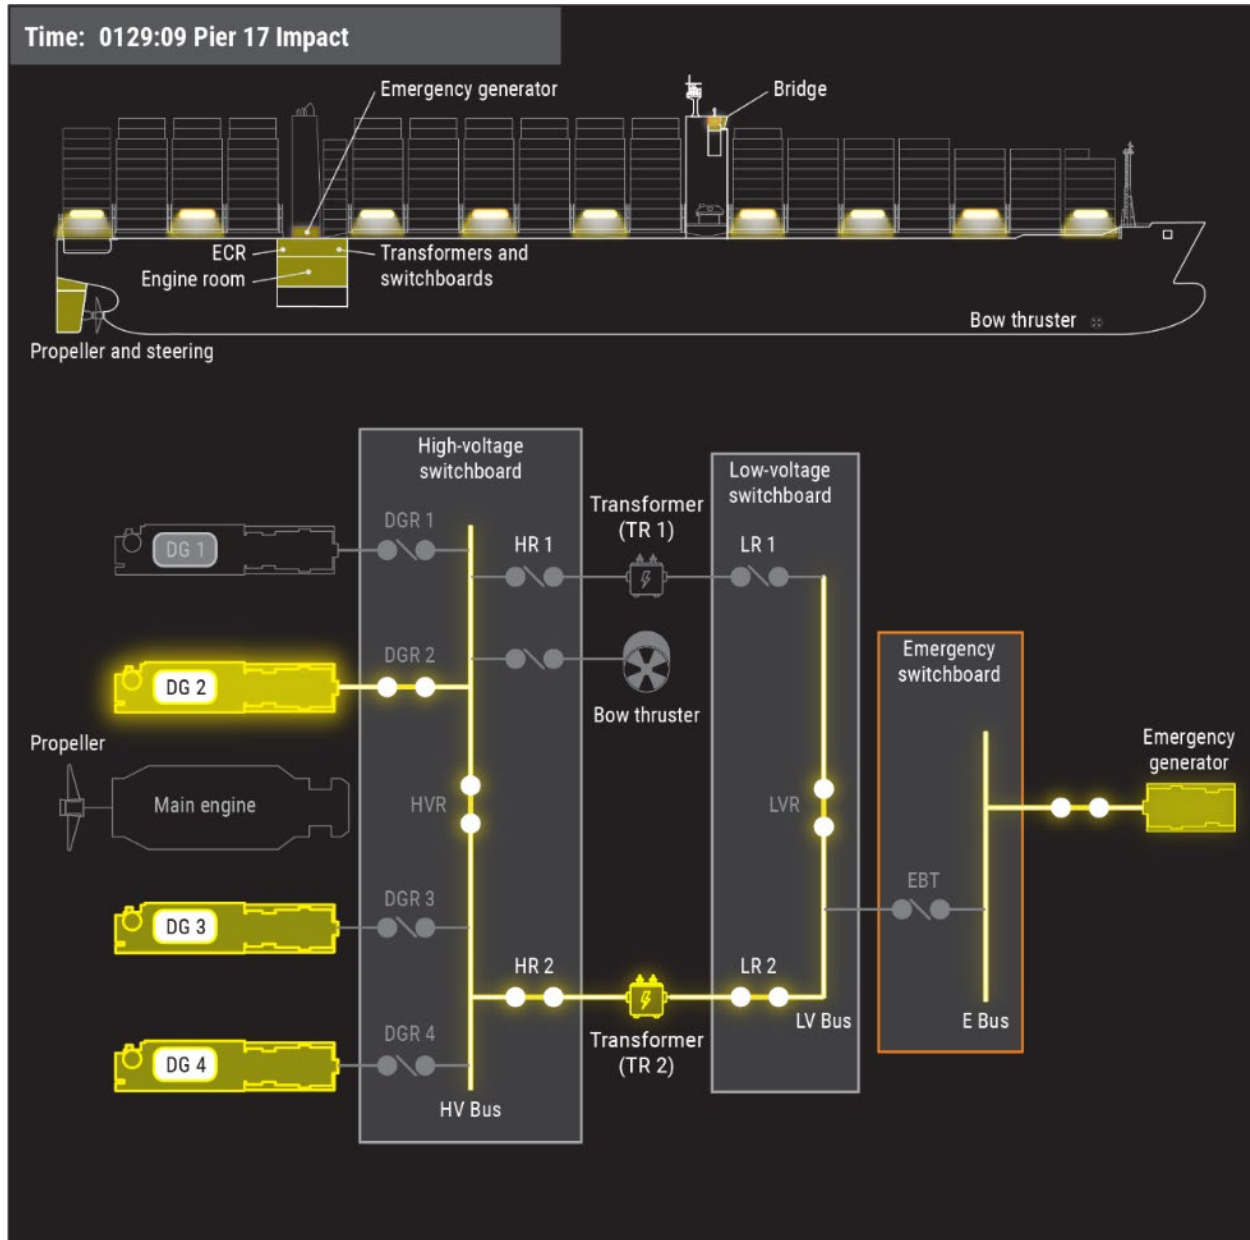
Figure 16. Configuration of *Dali* plant at 0129:09 when the vessel struck Pier 17 of the Key Bridge.

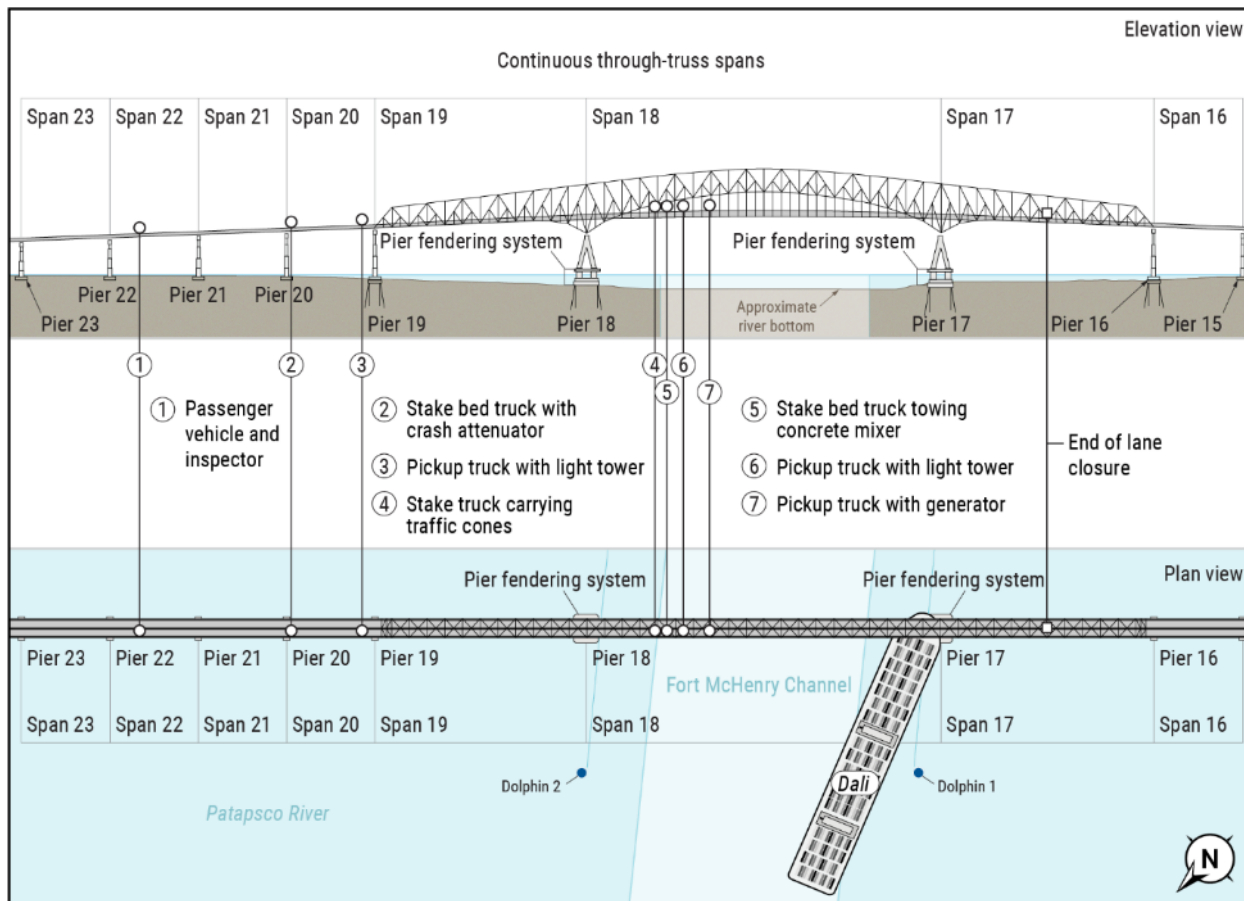
Figure 17. From top: Elevation view and plan view of the main spans of the Key Bridge, showing locations of highway maintenance vehicles at the time of the vessel’s impact.

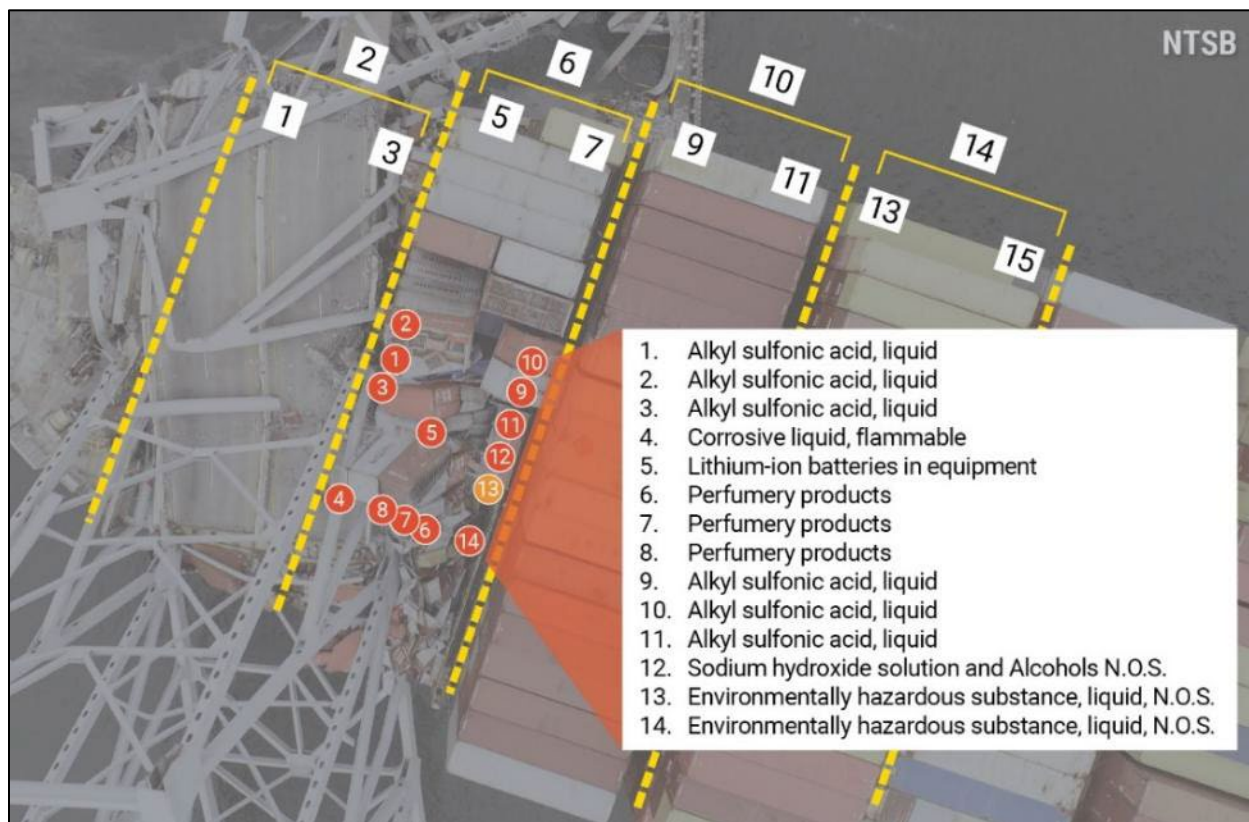
Figure 18. Overhead view of the forward portion of the *Dali* showing the approximate locations of cargo bays and the 14 impacted hazardous materials shipping containers. Yellow dashed lines with numbers in squares show the approximate locations of cargo bays and orange circles with numbers mark the approximate location of the 14 impacted hazardous materials shipping containers. Hazardous material container no. 13 was in a portable tank, stored in the hold, below the deck.

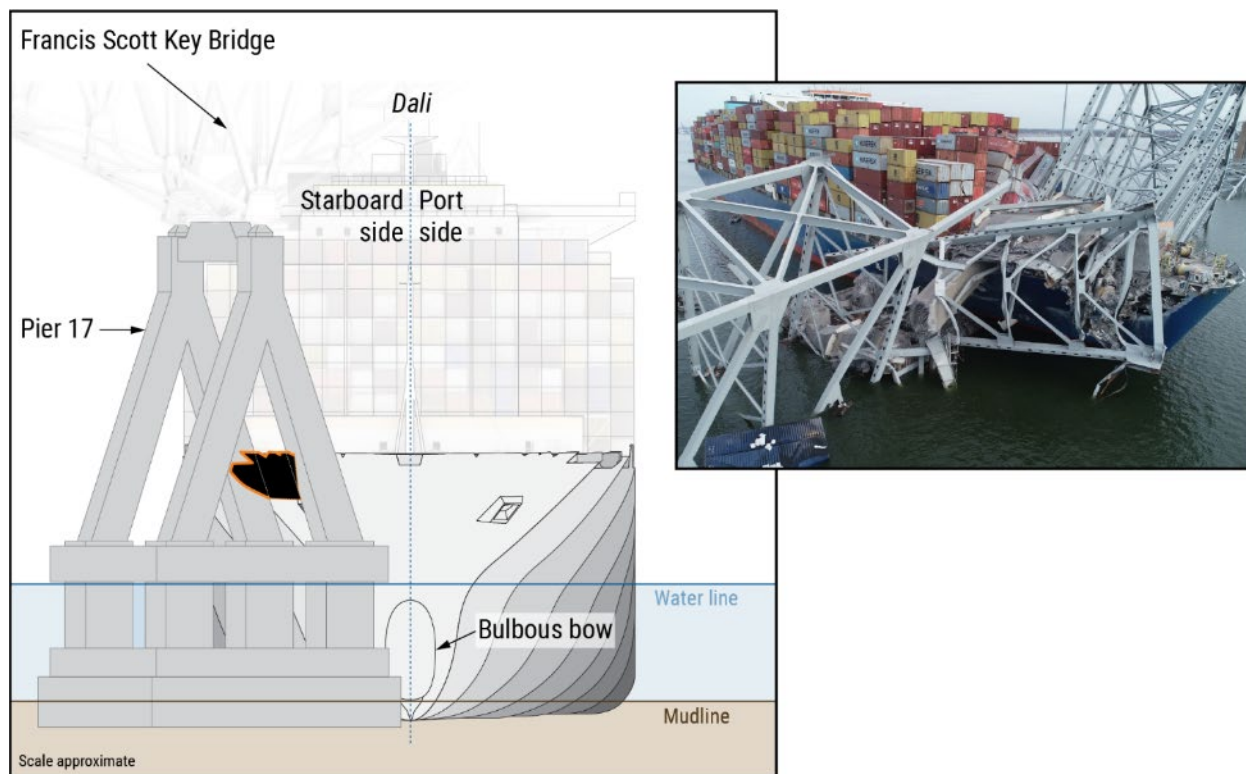
Figure 19. Representation of *Dali*'s starboard-side bow striking Pier 17. Inset shows damage to the vessel's starboard-side bow, with the bridge lying on the fo'c'sle deck, breakwater and container hold no. 1.

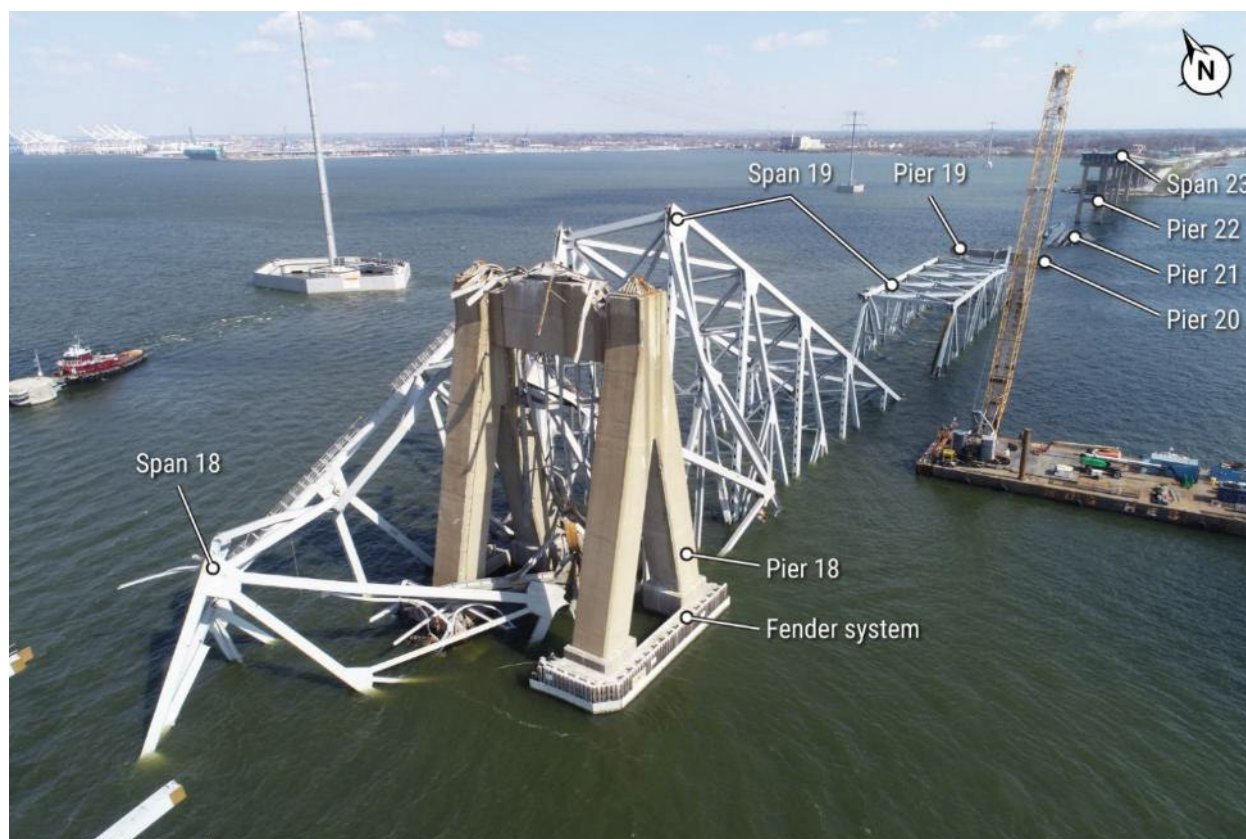
Figure 20. Damage to Spans 18 and 19, and Piers 18–22.

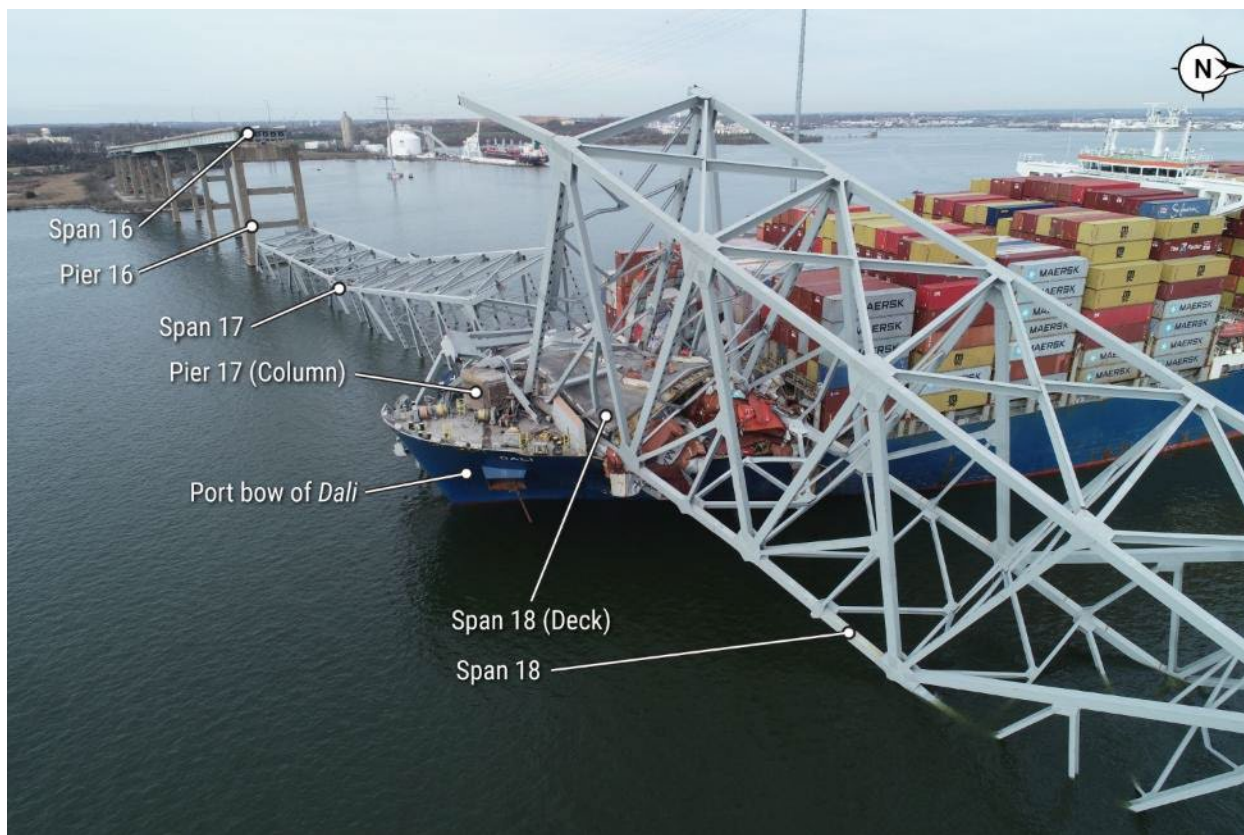
Figure 21. Damage to Spans 16-18 and Pier 17, as seen looking toward the port side of the *Dali*.

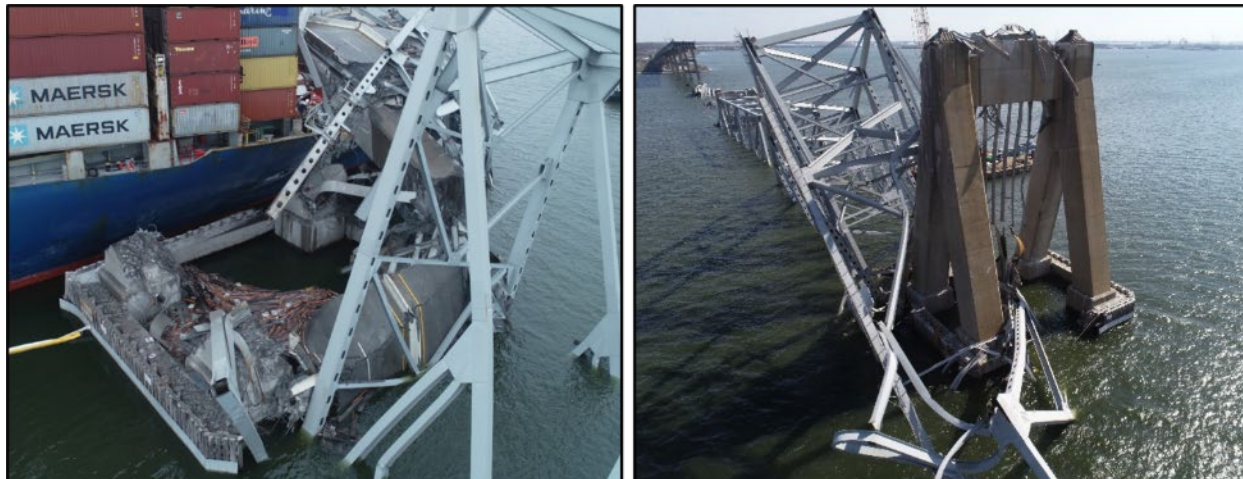
Figure 22. Left to right: Damage to fendering surrounding Pier 17 and Pier 18.

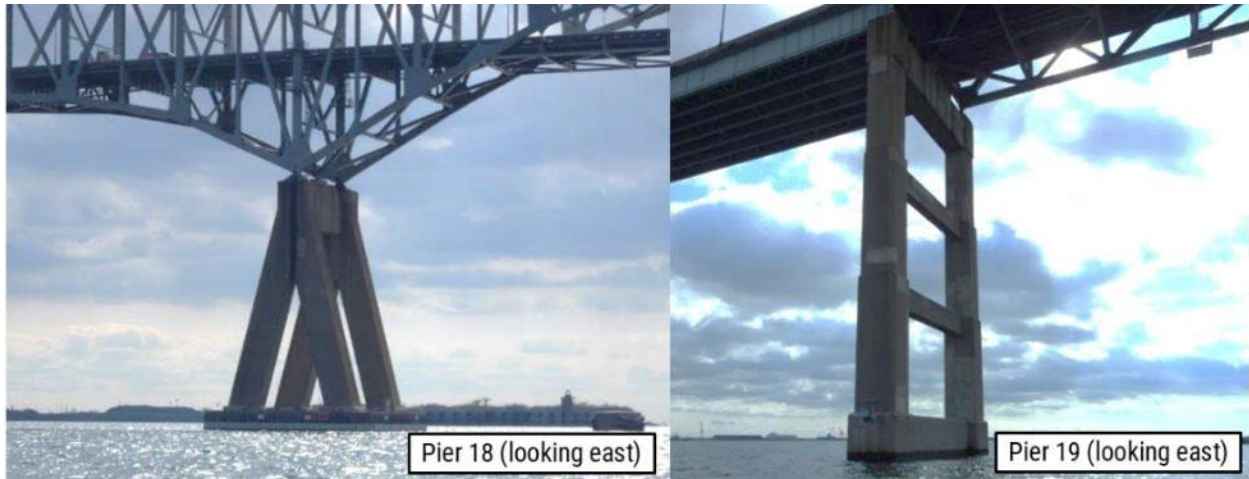
Figure 24. Left to right: Rigid-frame reinforced concrete pier, and two-column pier. (Background sources: MDTA)

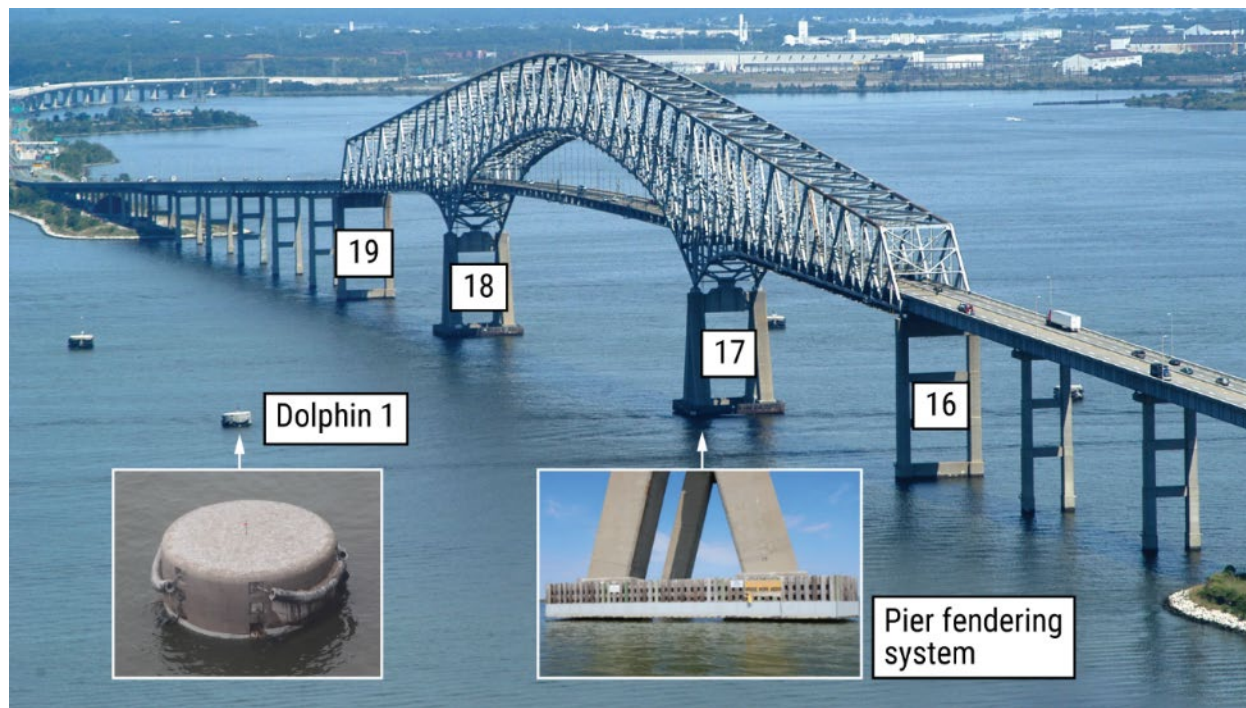
Figure 27. The Key Bridge and the physical protection systems (Dolphin 1 and the pier fendering system) protecting Pier 17 from vessels transiting outbound under the Key Bridge. (Background source: MDTA)

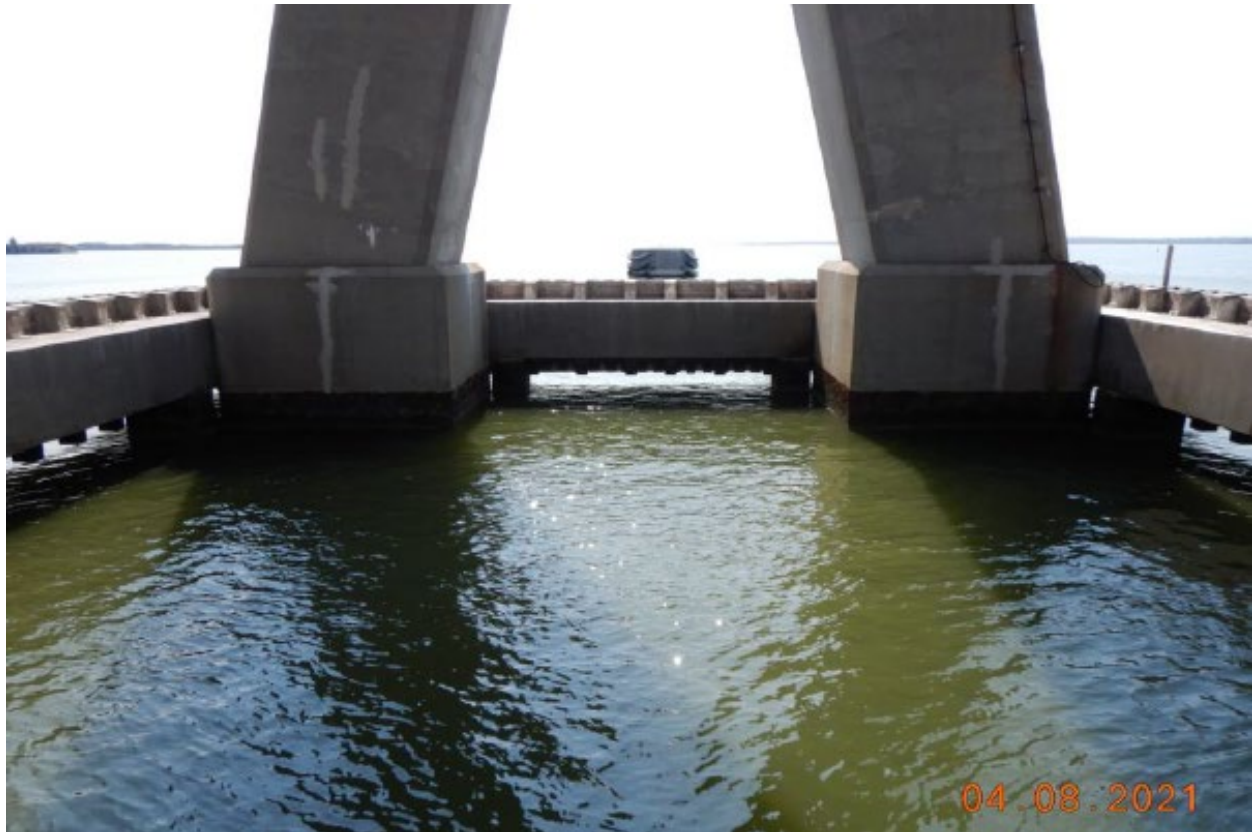
Figure 32. Pier 17, looking north, showing the interior side of the fender system. (Source: MDTA)

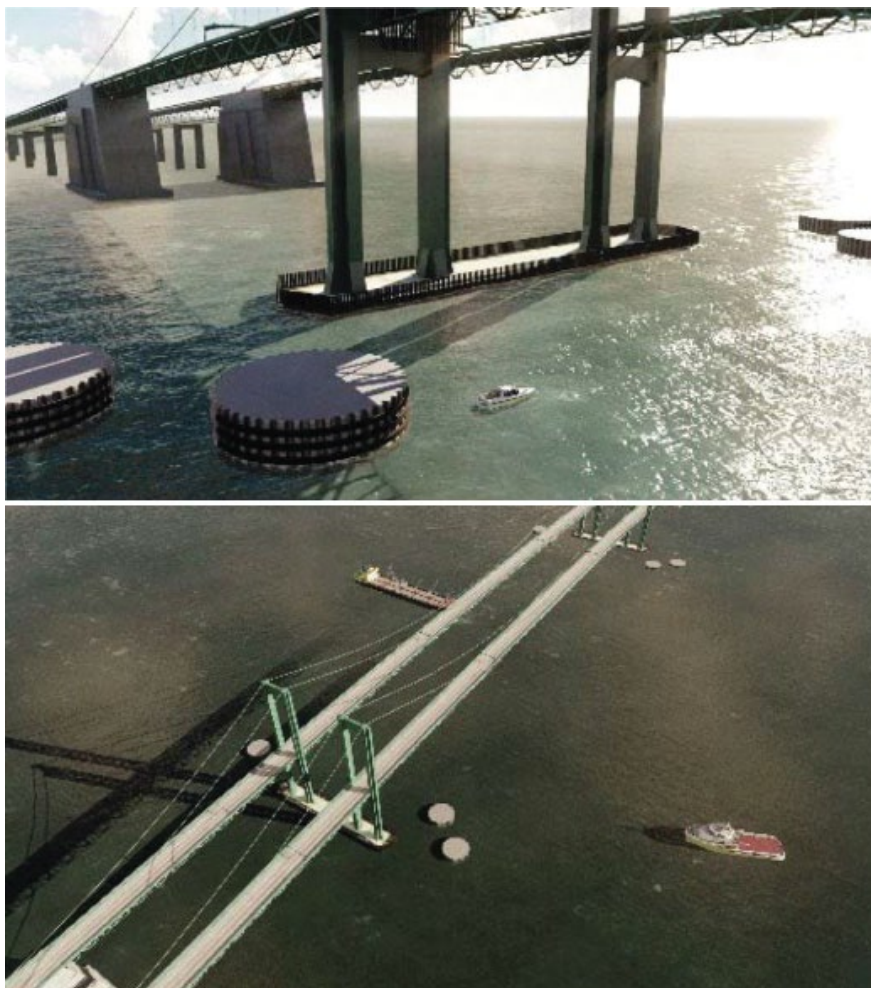
Figure 34. *Top to bottom:* Rendering of four of the proposed eight new dolphins added to the protection system for the Delaware Memorial Bridge. Rendering of an aerial view of the eight proposed new dolphins. (Source: Richard E. Pierson Construction Co., Inc)

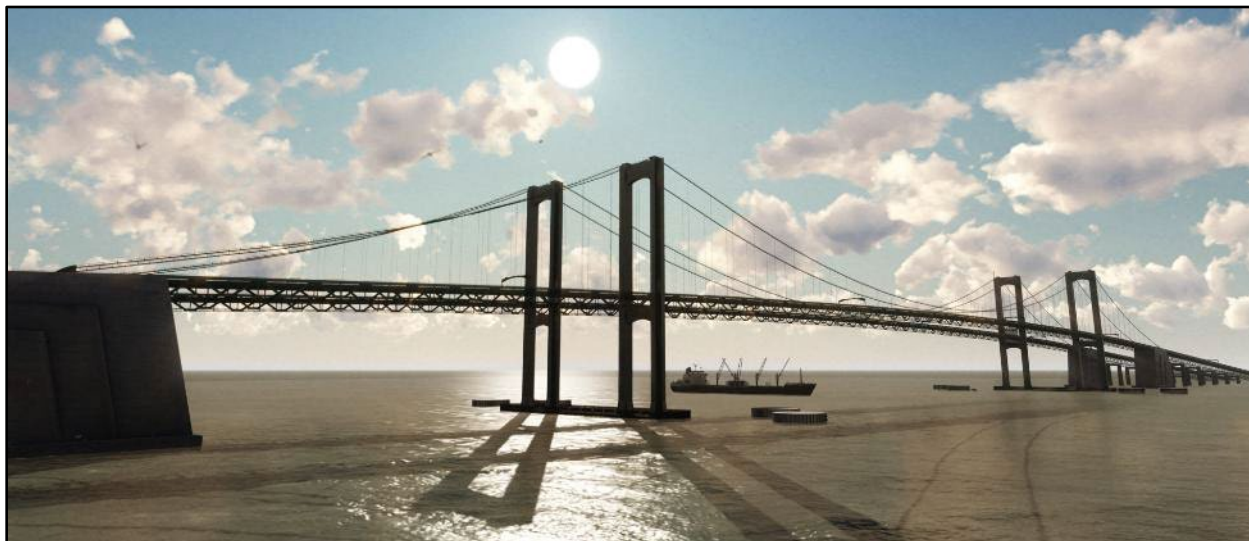
Figure 35: Rendering of the proposed eight new dolphins added to the protection system for the Delaware Memorial Bridge. (Source: Richard E. Pierson Construction Co., Inc)

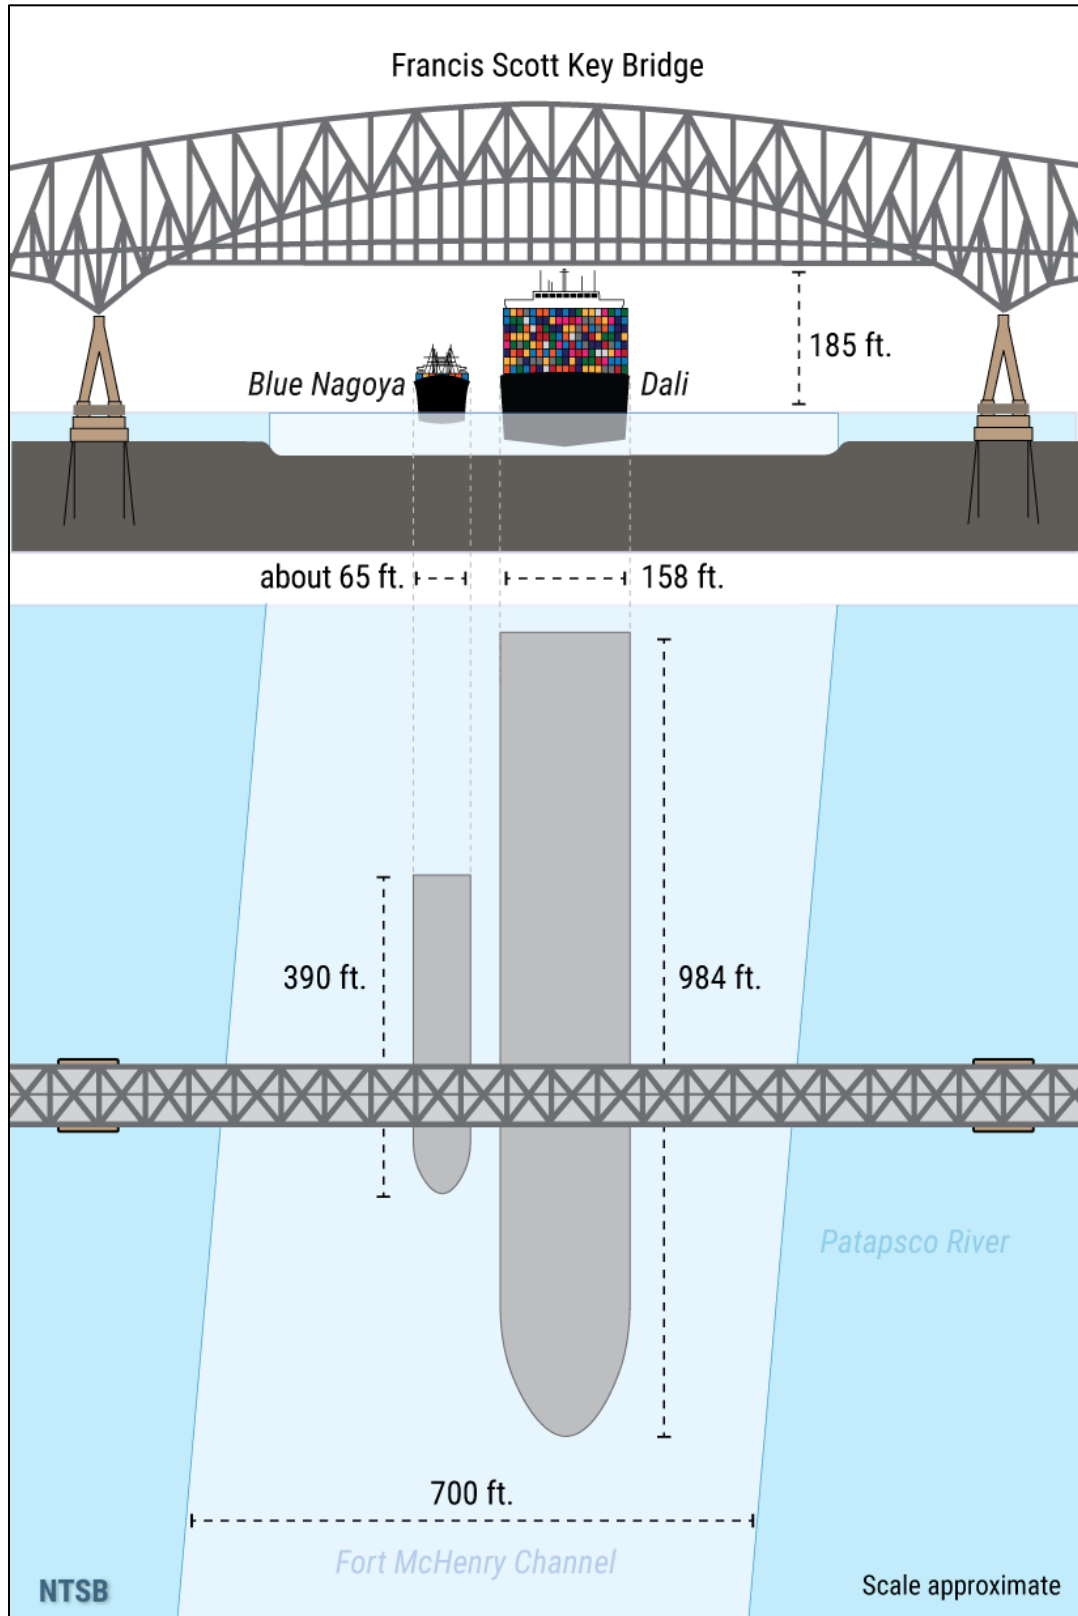
Figure 36. The comparative sizes of the *Blue Nagoya* and the *Dali* relative to the Key Bridge.

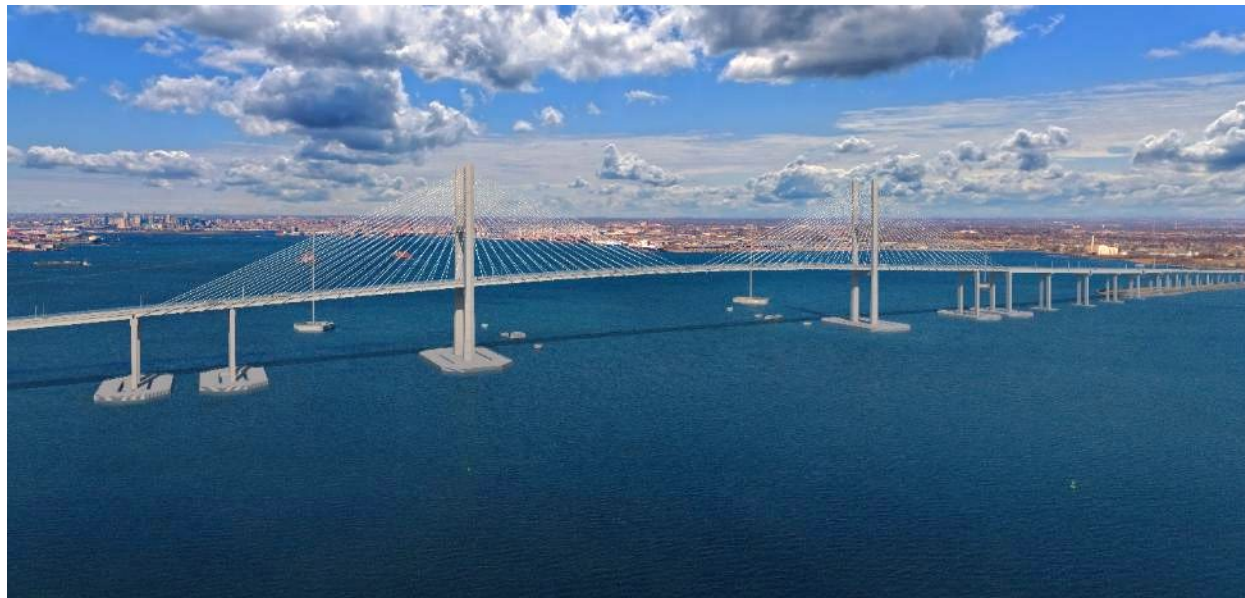
Figure 37. Rendering of the cable-stayed replacement for the Key Bridge. (Source: Key Bridge Rebuild, MDTA)

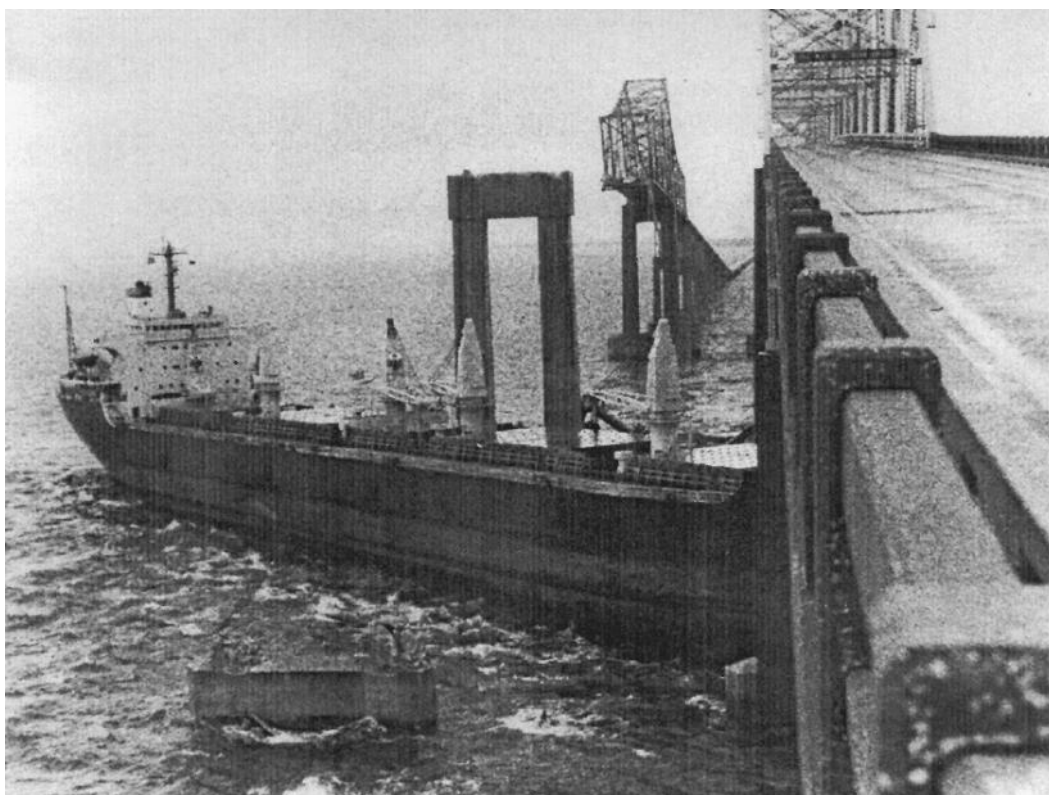
Figure 38. View of the collapsed western span of the Sunshine Skyway Bridge, looking to the north.

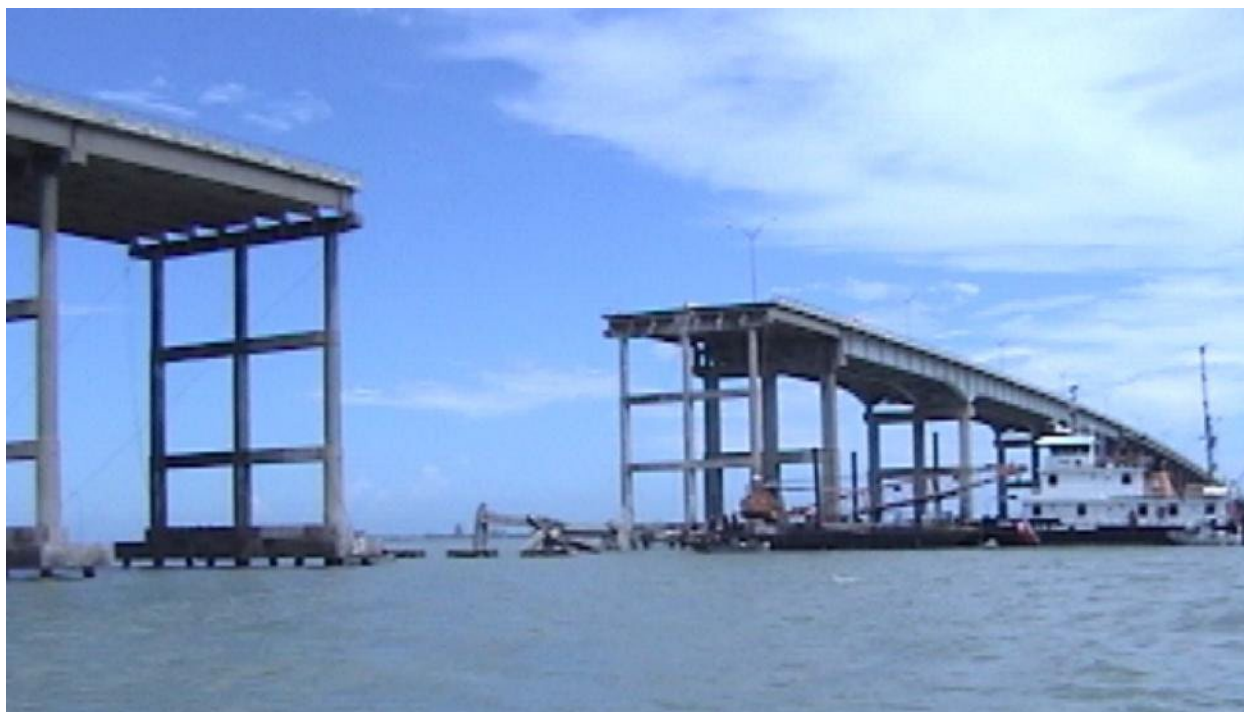
Figure 39. View of the collapsed Queen Isabella Causeway bridge pier and adjacent undamaged piers looking to the northeast.

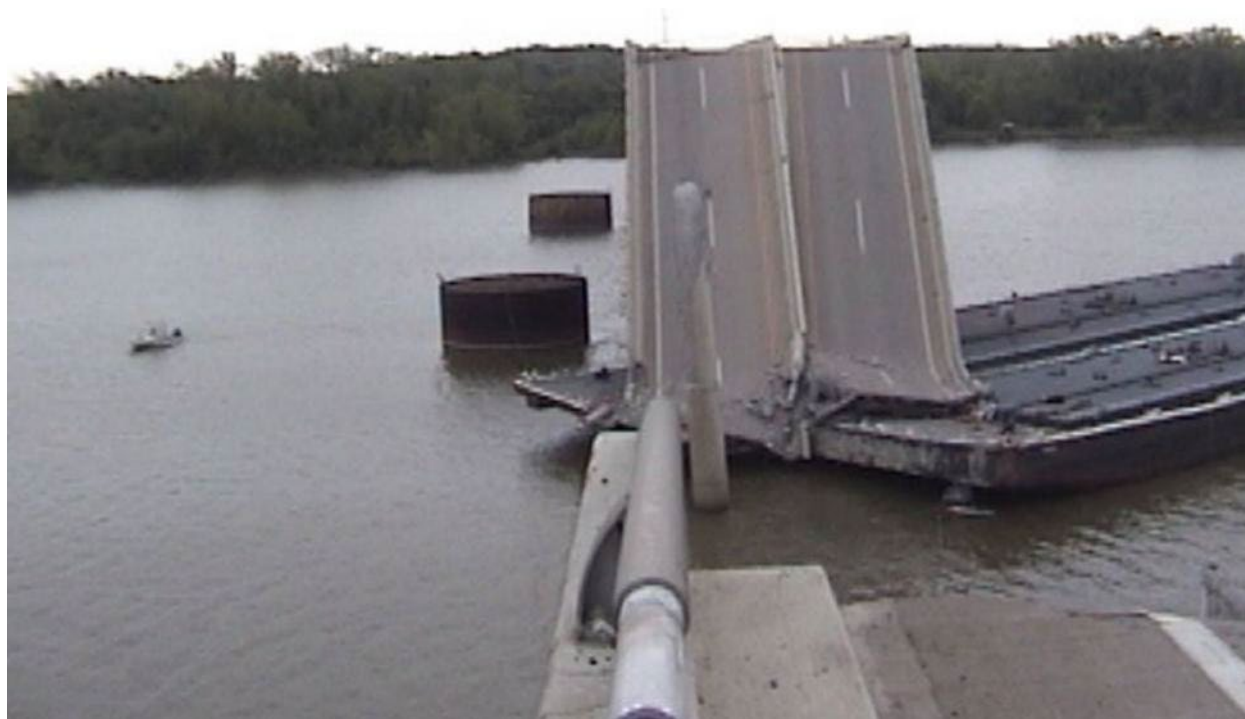
Figure 40. Collapsed portion of the Interstate 40 bridge, with dolphins protecting the piers.

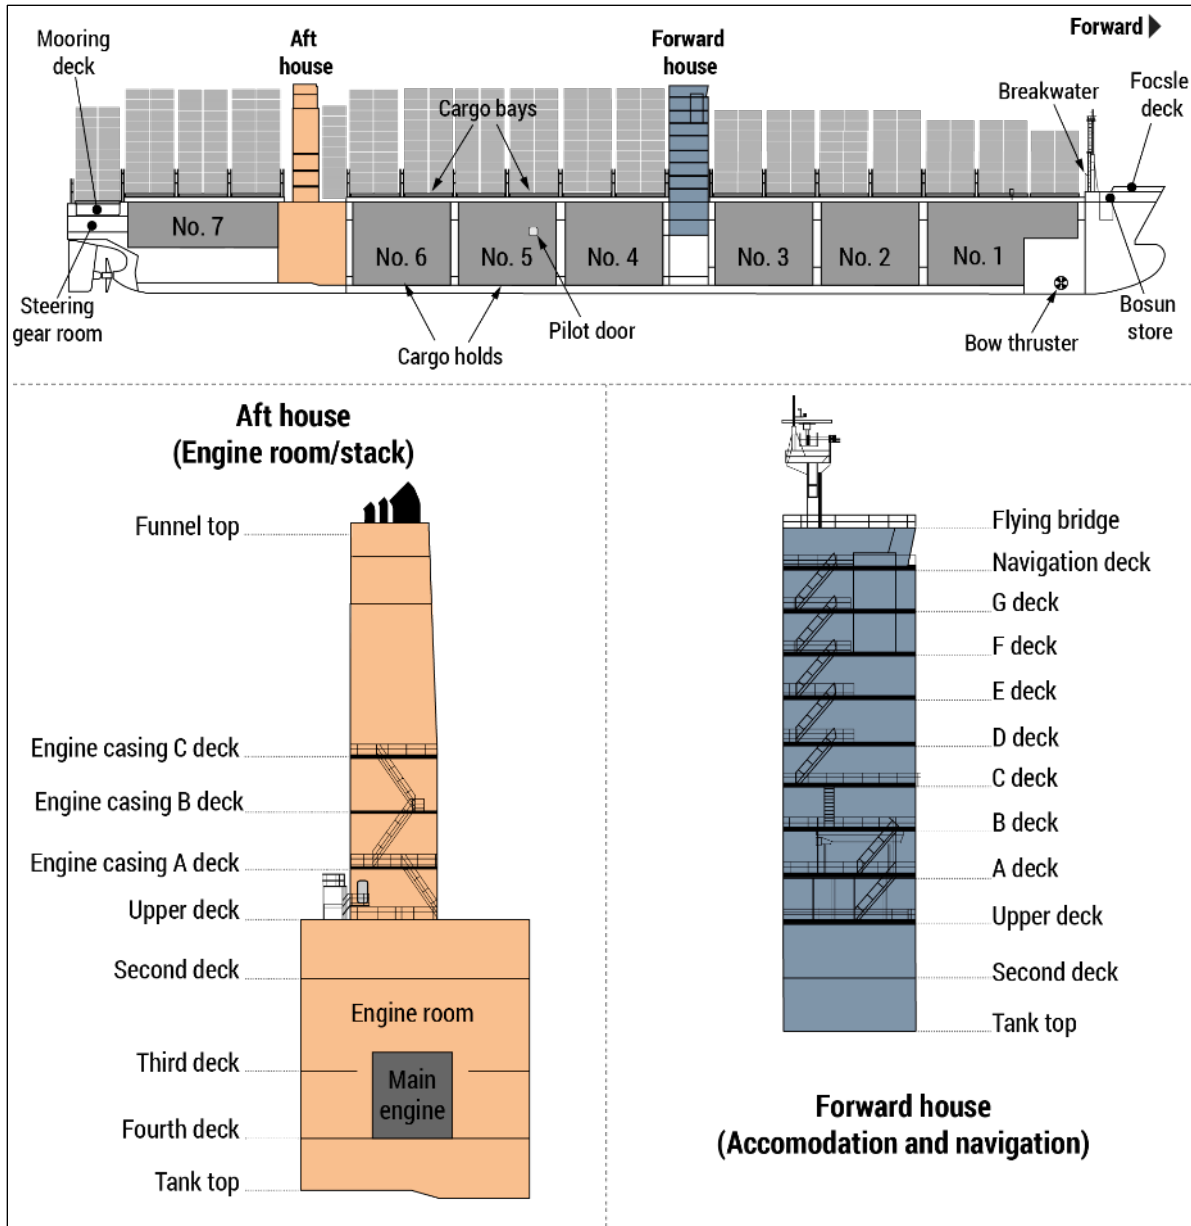
Figure 41. Profile view of the *Dali*, showing cargo holds and bays. Insets show the decks of the aft and forward houses.
