November 18, 2025

Marine Investigation Report MIR-25-40

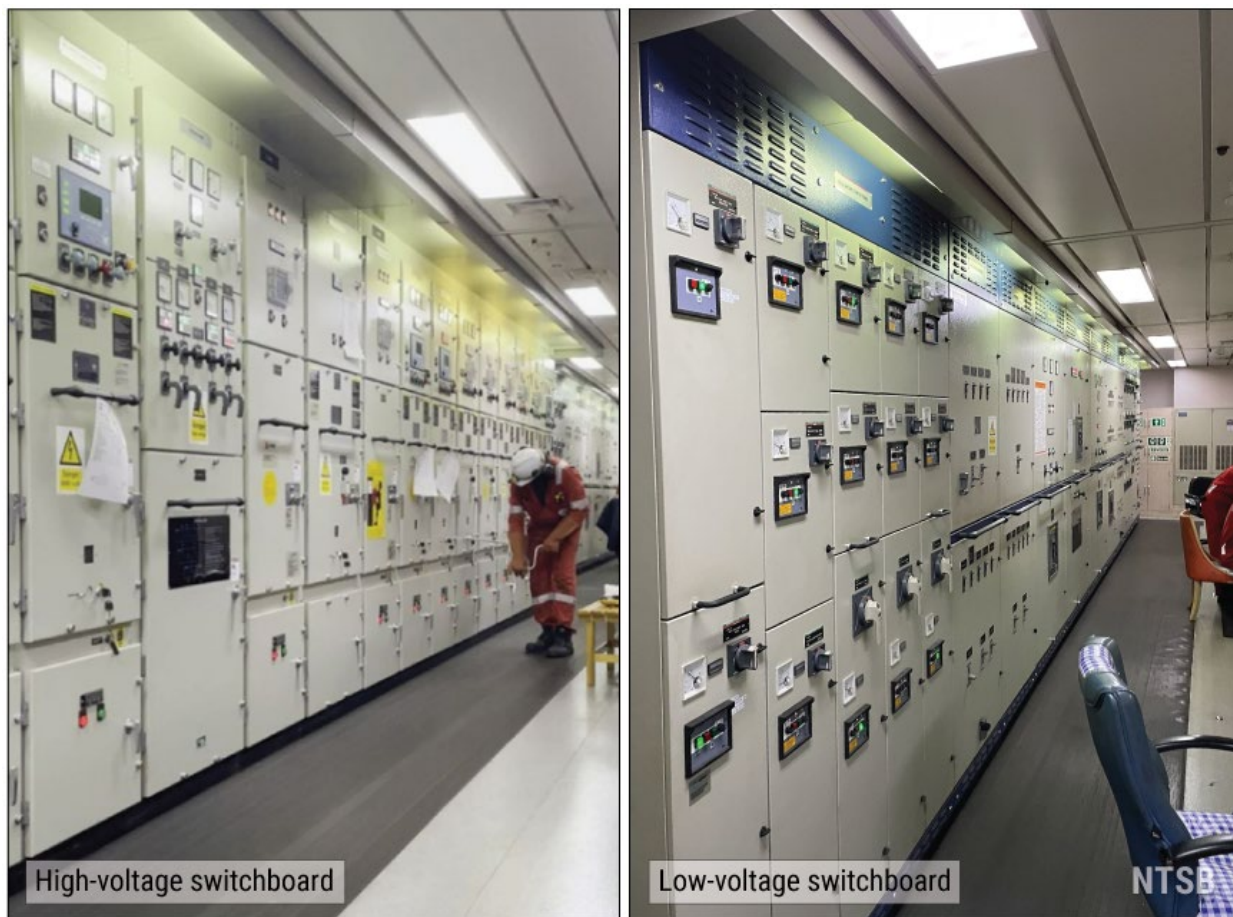
Figure 42. Left to right: The *Dali*'s HV switchboard (which housed the HV bus) and breakers, and the LV switchboard (which housed the LV bus) and breakers.

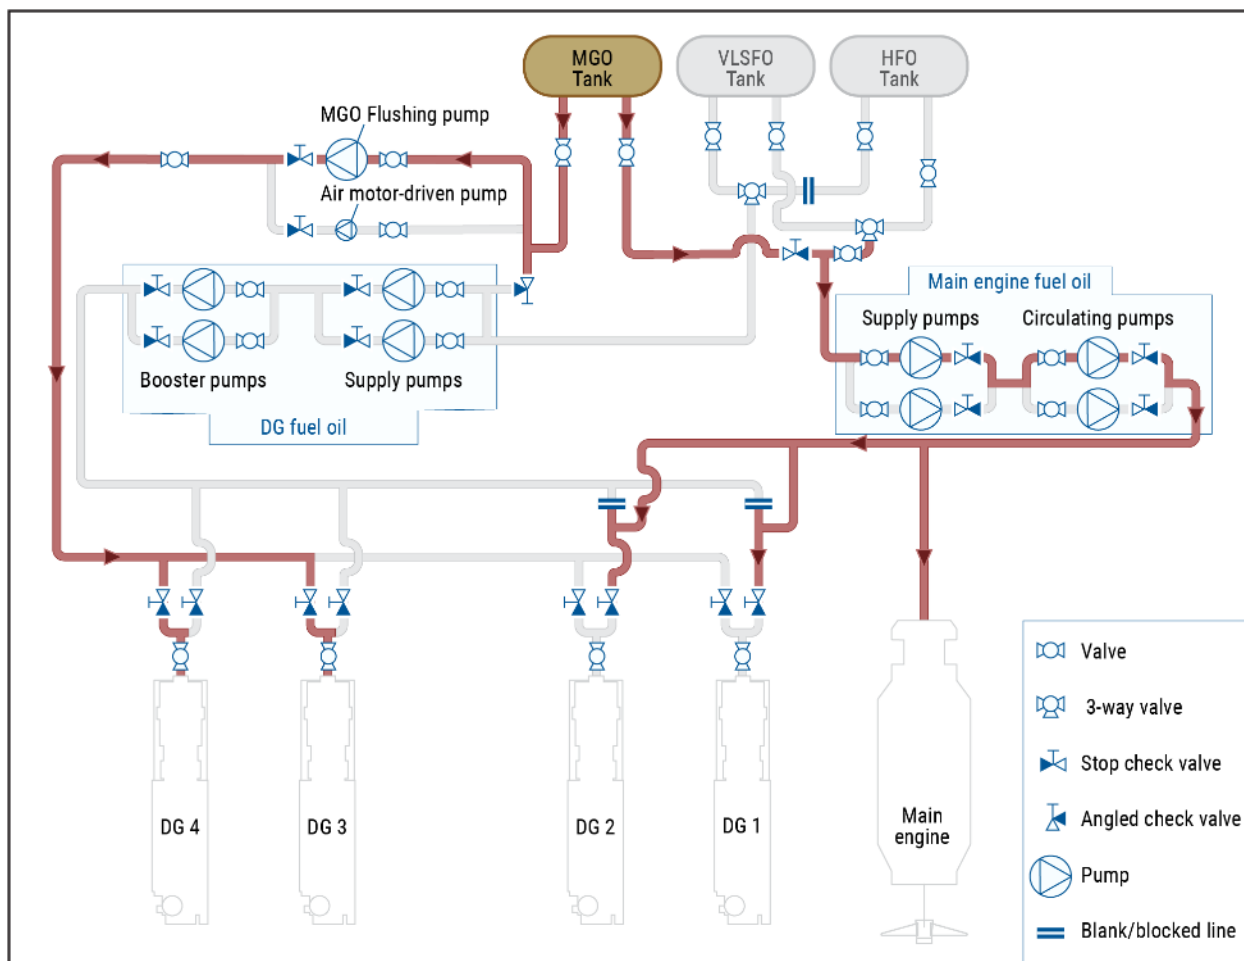
Figure 45. Simplified diagram of *Dali*'s main engine and DG fuel oil service system. The lineup in use at the time of the accident is shown in red.⁹⁰

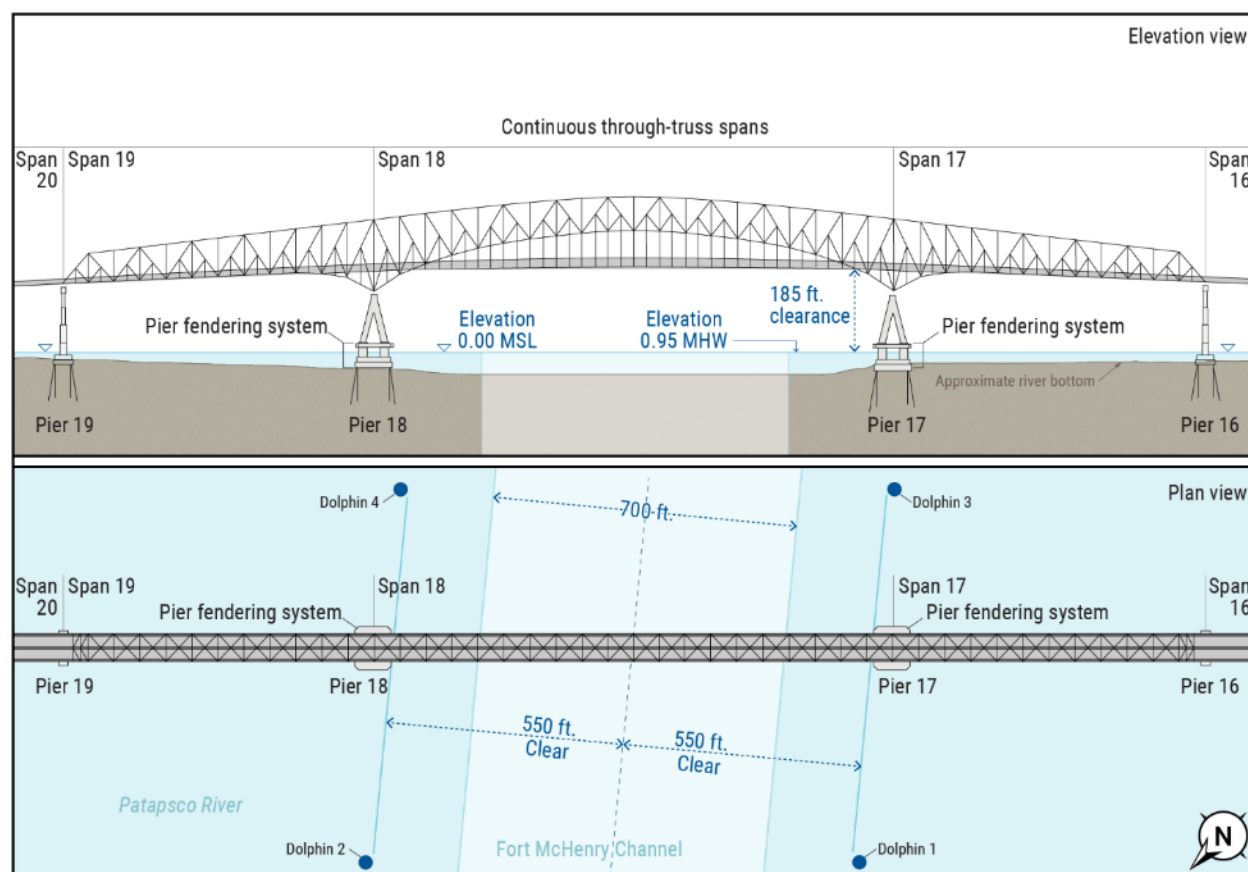
Figure 46. From top: Elevation view (from north looking south toward bridge) and plan view of the main spans of the Key Bridge over Fort McHenry Channel.

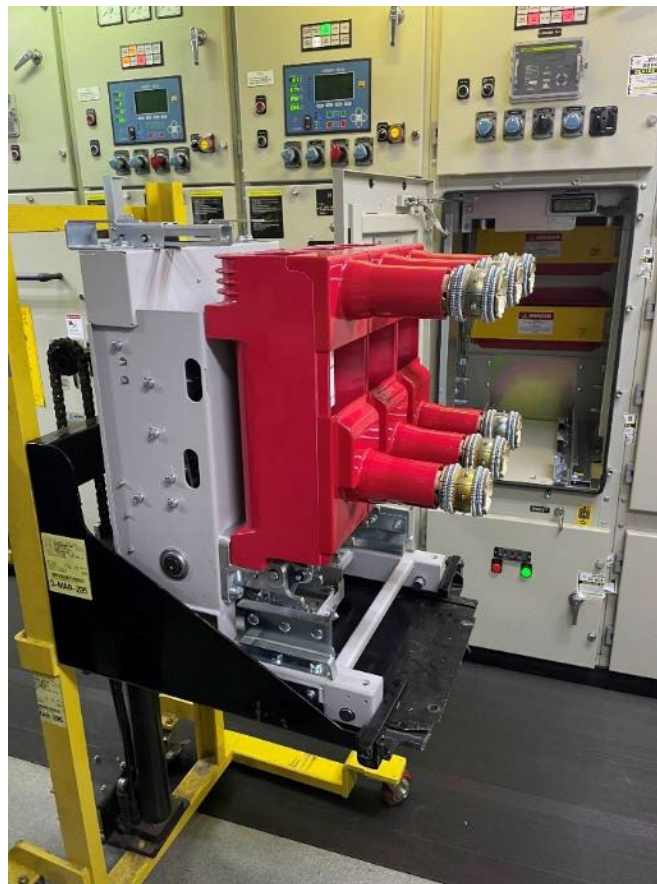
Figure 47. HR1 disconnected and removed from HV switchboard for inspection on April 10, 2024.

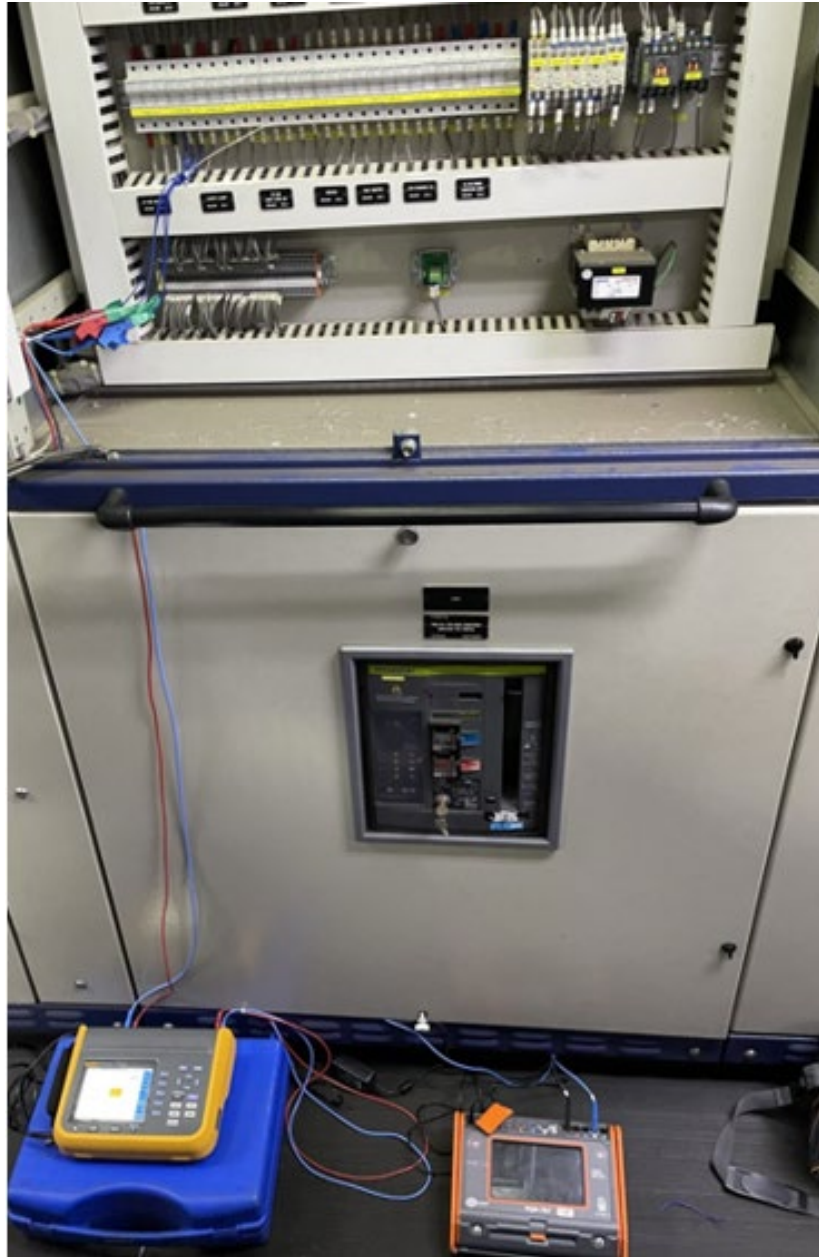
Figure 48. Power analyzers installed on LV switchboard.

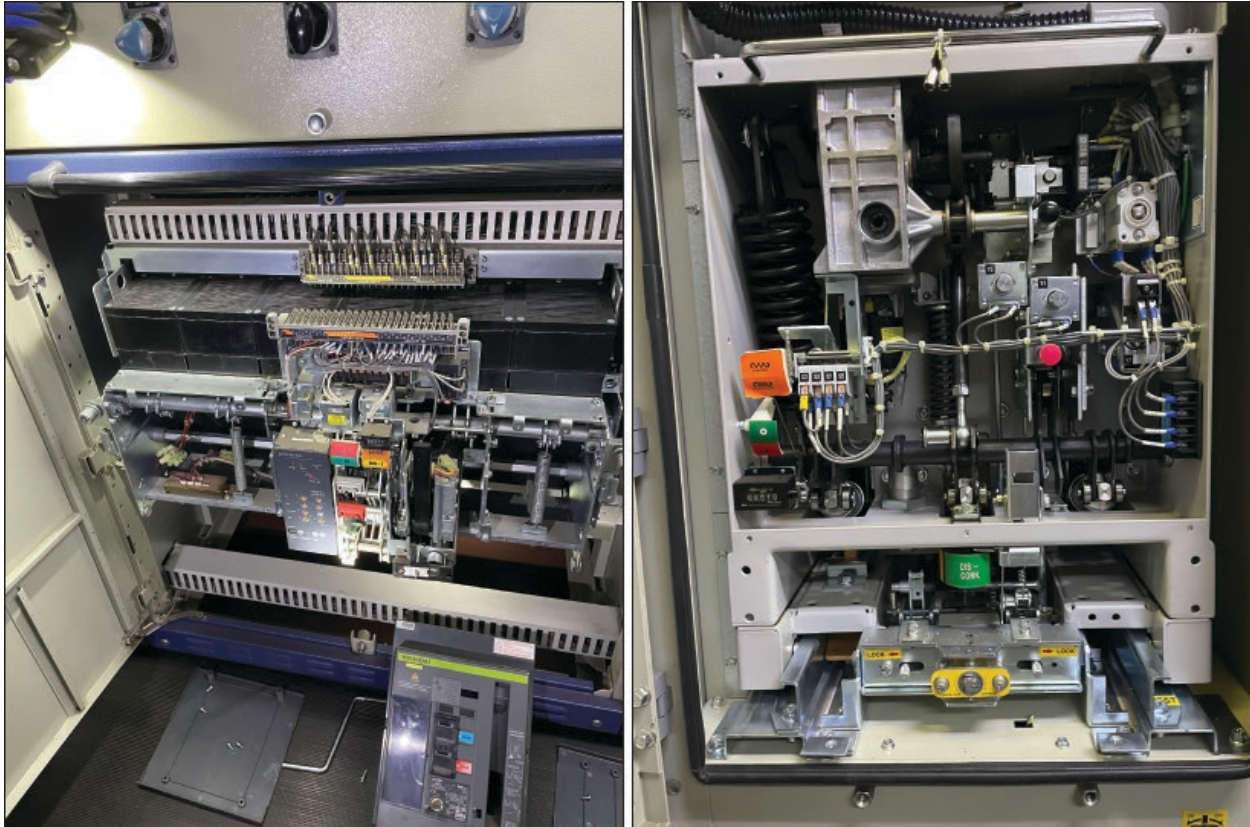
Figure 49. Left to right: The *Dali*'s LR1 breaker (face cover removed) during examination, and the *Dali*'s HR1 circuit breaker racked out in the test position during examination.

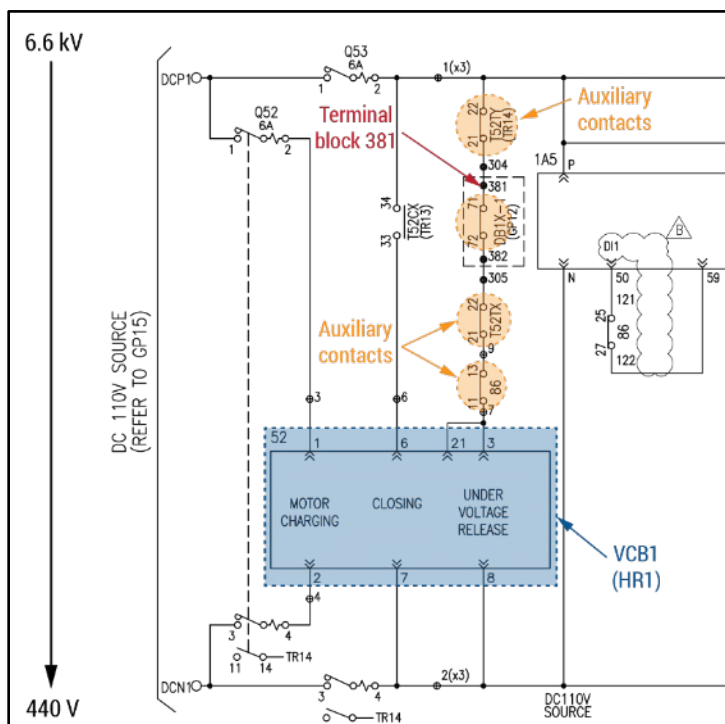
Figure 50. HR1 UVR control circuit, showing HR1 (blue), terminal Block 381 (red), and auxiliary contacts (orange). (Background source: HHI)

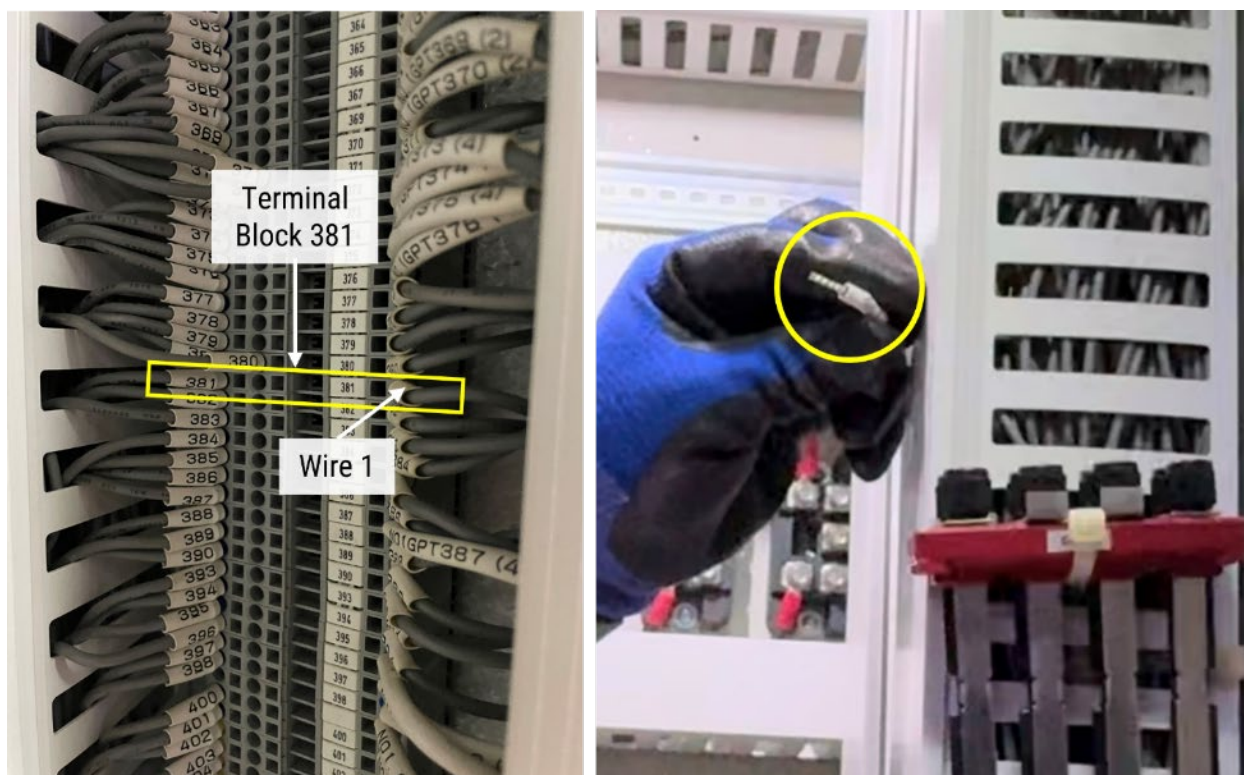
Figure 51. Left to right: Terminal Block 381 shown amongst a stack of other terminal blocks, and HHI field engineer displaying Wire 1 after discovering its loose and inadequate connection to Terminal Block 381.

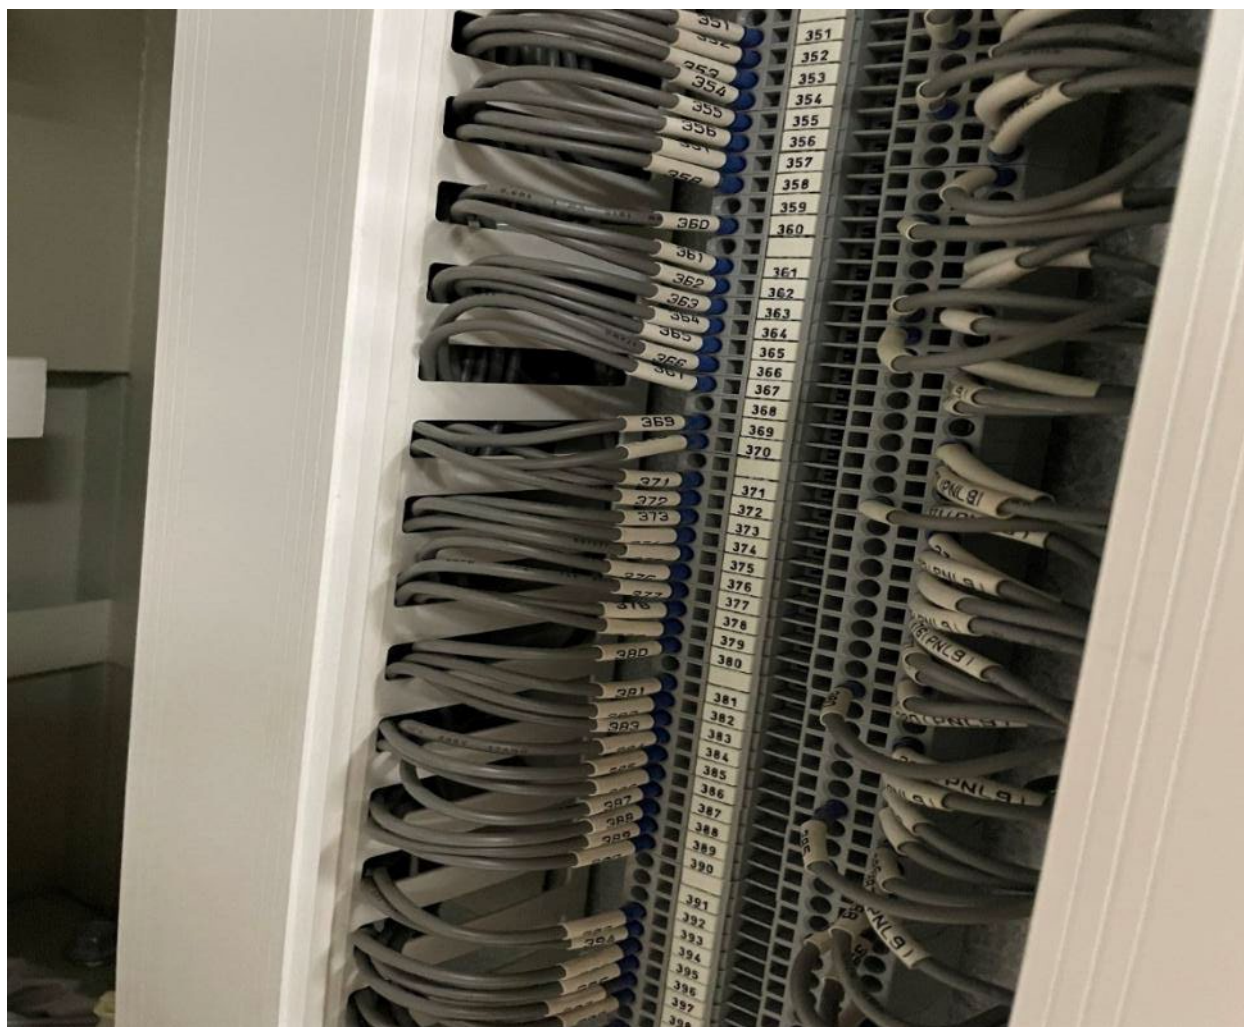
Figure 55. The *Cezanne*'s HV control panel, with terminal blocks with signal wires attached.

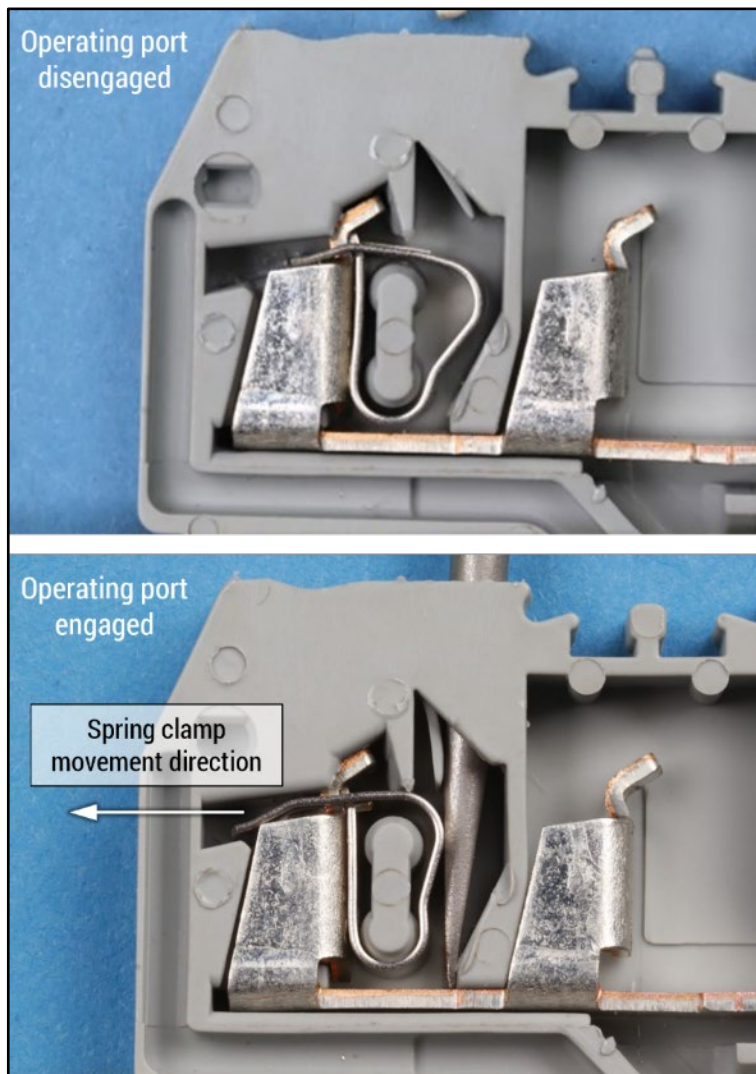
Figure 57. From top: The operating port of an exemplar terminal block with nothing inserted (disengaged), and the operating port of an exemplar terminal block when a tool is inserted, resulting in spring-clamp movement.

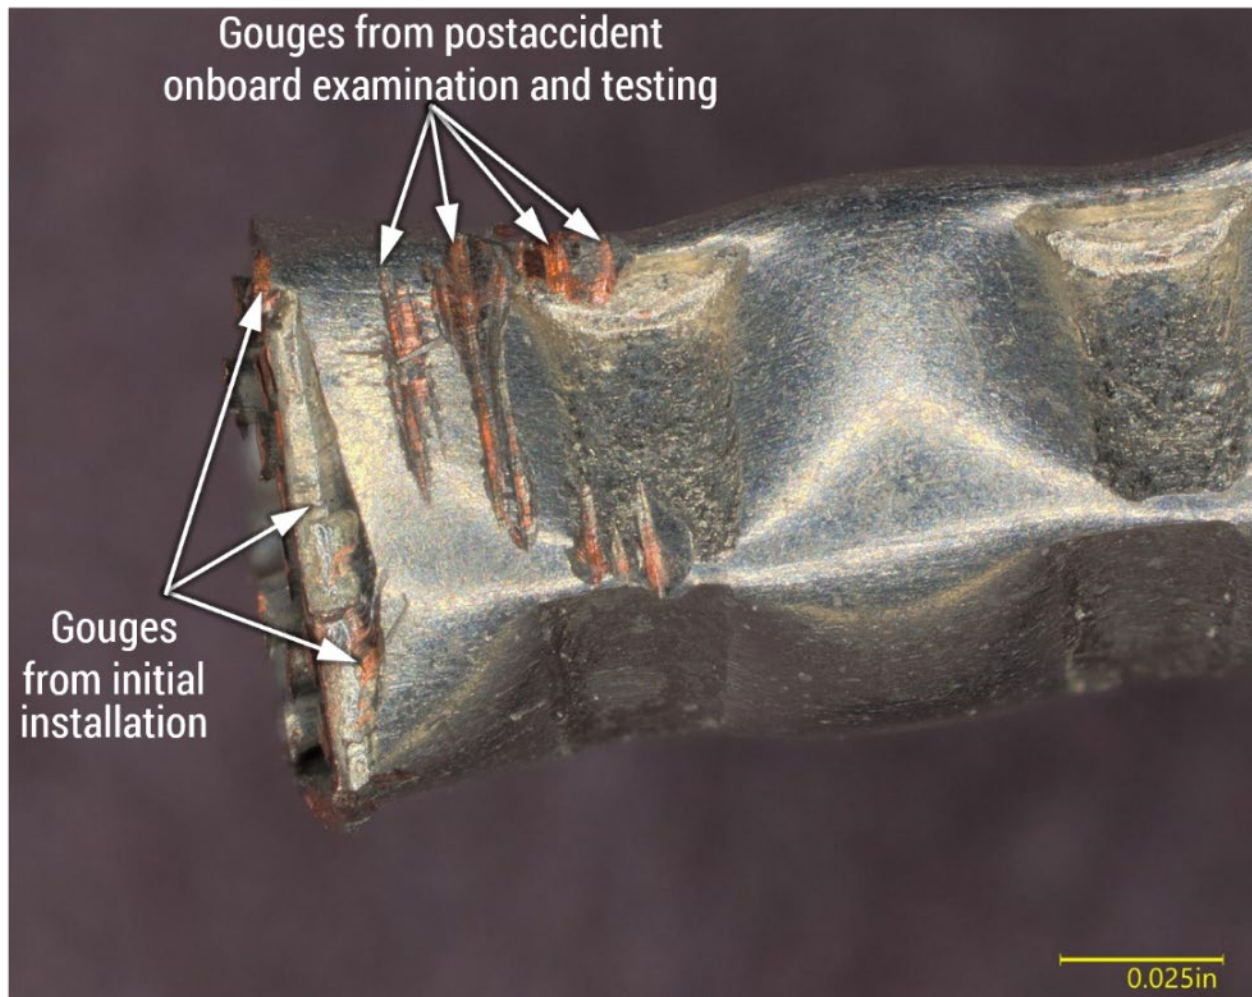
Figure 58. Digital microscope images of one side of the Wire 1 ferrule from Terminal Block 381 with multiple distinct linear gouges (white arrows).

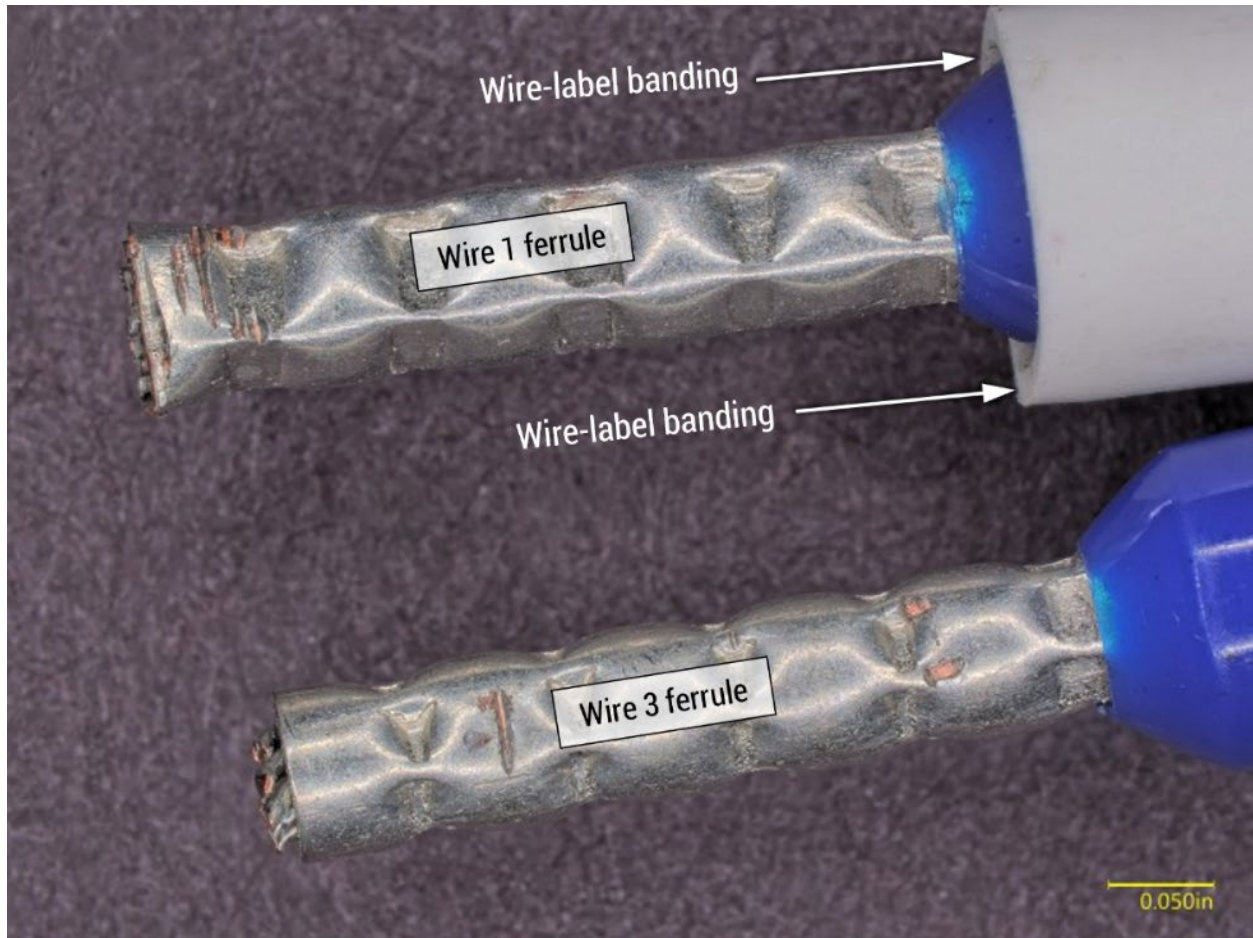
Figure 59. Close up of the Wire 1 and Wire 3 ferrules, with wire-label banding on Wire 1. Wire 3 does not have wire-label banding because the banding was removed and reused on another terminal block wire when Wire 3 was removed from the vessel.

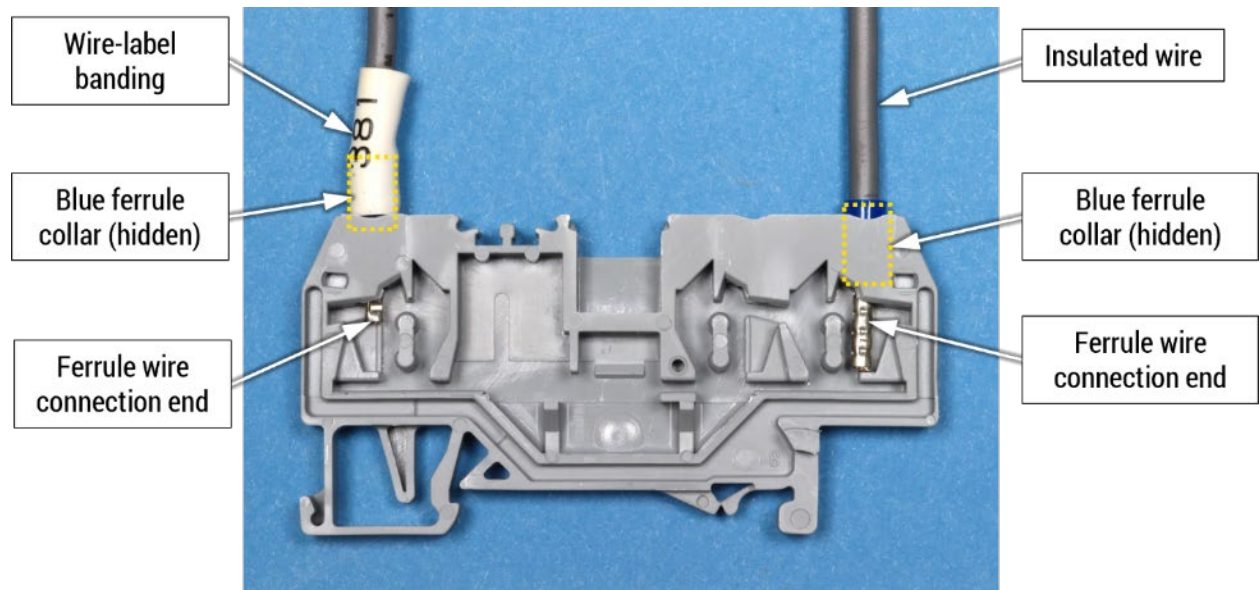
Figure 60. Wires 1 and 3 from Terminal Block 381, inserted inside the corresponding connection points, in a disassembled polymer form from an exemplar terminal block. Both wires were inserted to the maximum depth possible, without force, into the cage areas of the connection points.

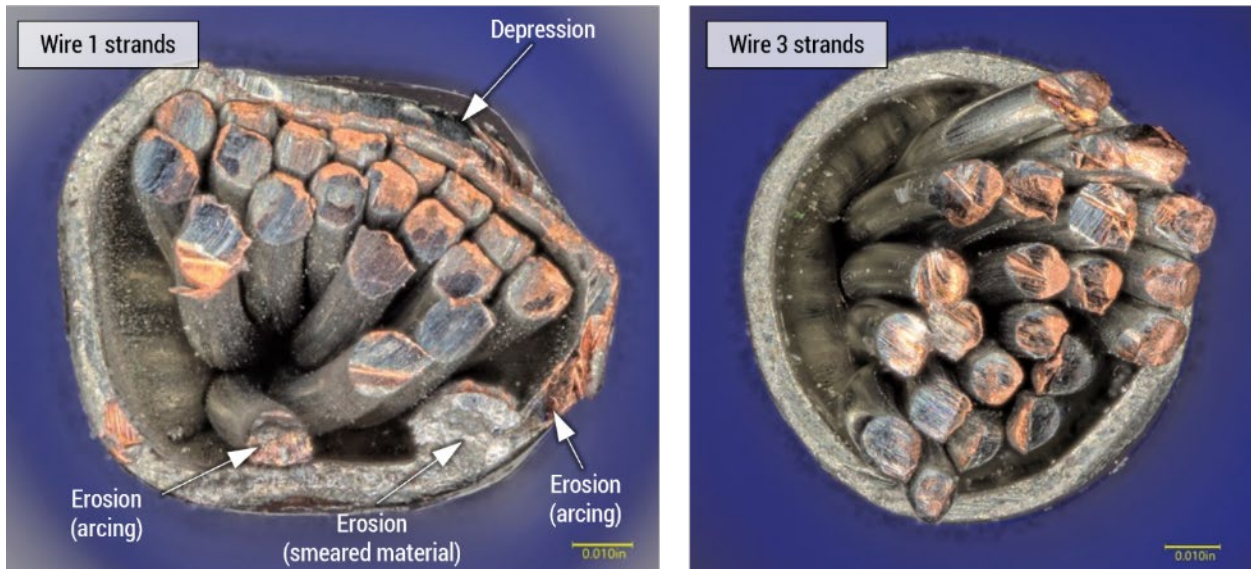
Figure 61. Left to right: Digital microscope images of end views comparing the ferrules from Wires 1 and 3 from Terminal Block 381, showing depression in one corner of the Wire 1 ferrule, as well as erosion consistent with arcing and smeared material.

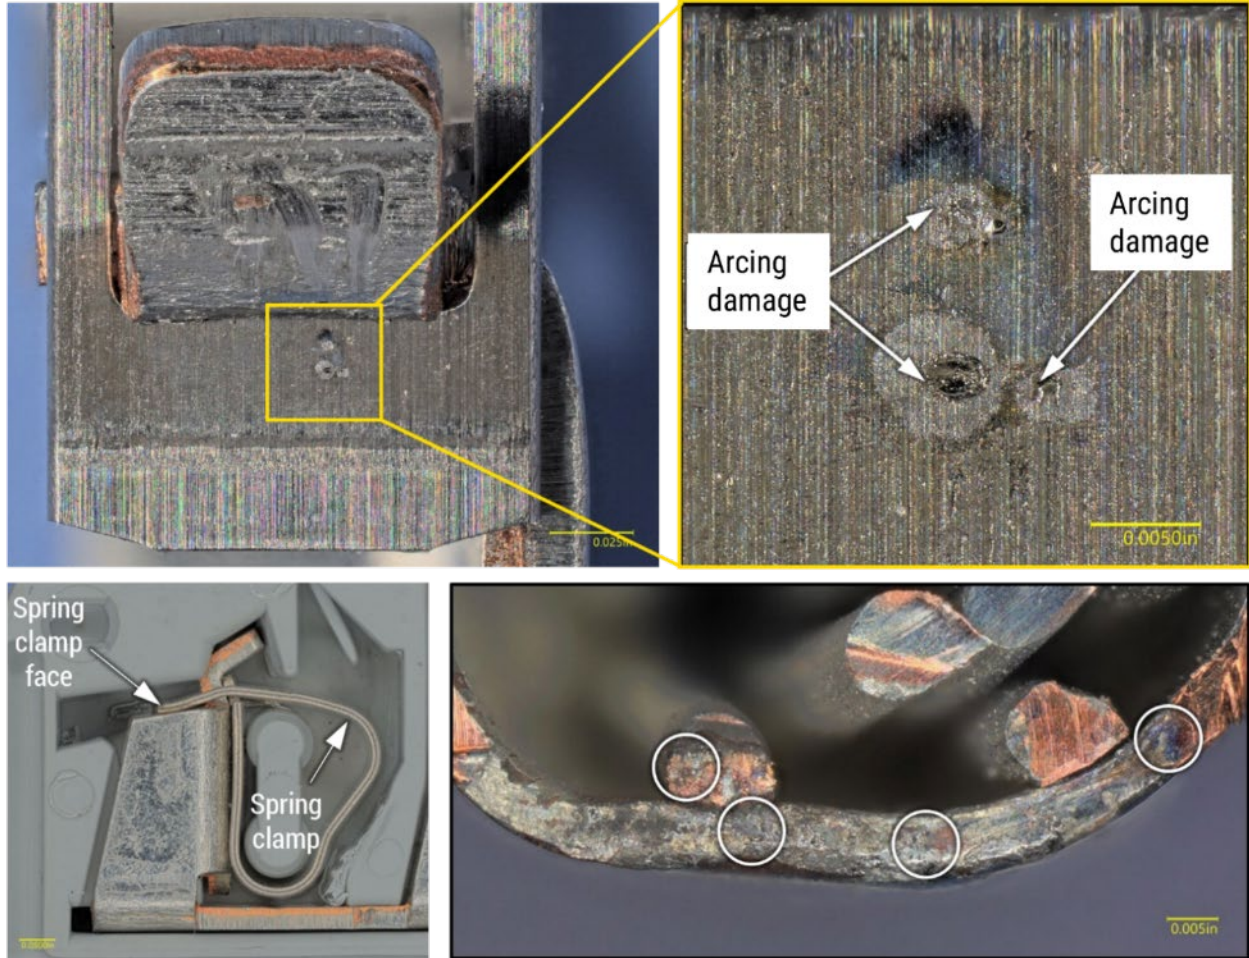
Figure 62. Clockwise from top left: Electrical arcing damage on the spring-clamp gate face from Connection Point 1 in Terminal Block 381, and erosion (circled) consistent with arcing on the ferrule edge and one adjacent strand face of the Wire 1 ferrule. Spring clamp shown in exemplar terminal block for reference.

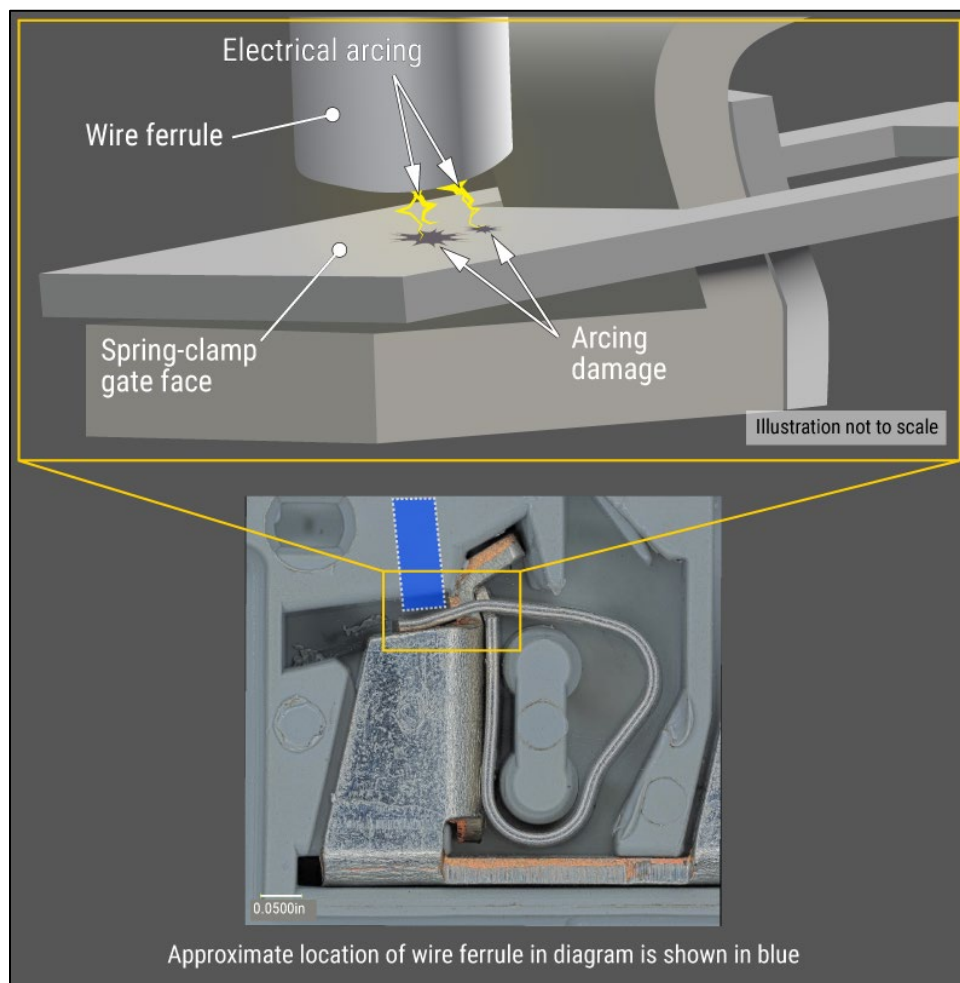
Figure 64. How arcing could occur within the gap between the wire ferrule (shown as backed of the spring-clamp gate, with the spring-clamp gate disengaged) and the spring-clamp gate face after the wire ferrule, creating arcing damage with Terminal Block 381 for comparison.

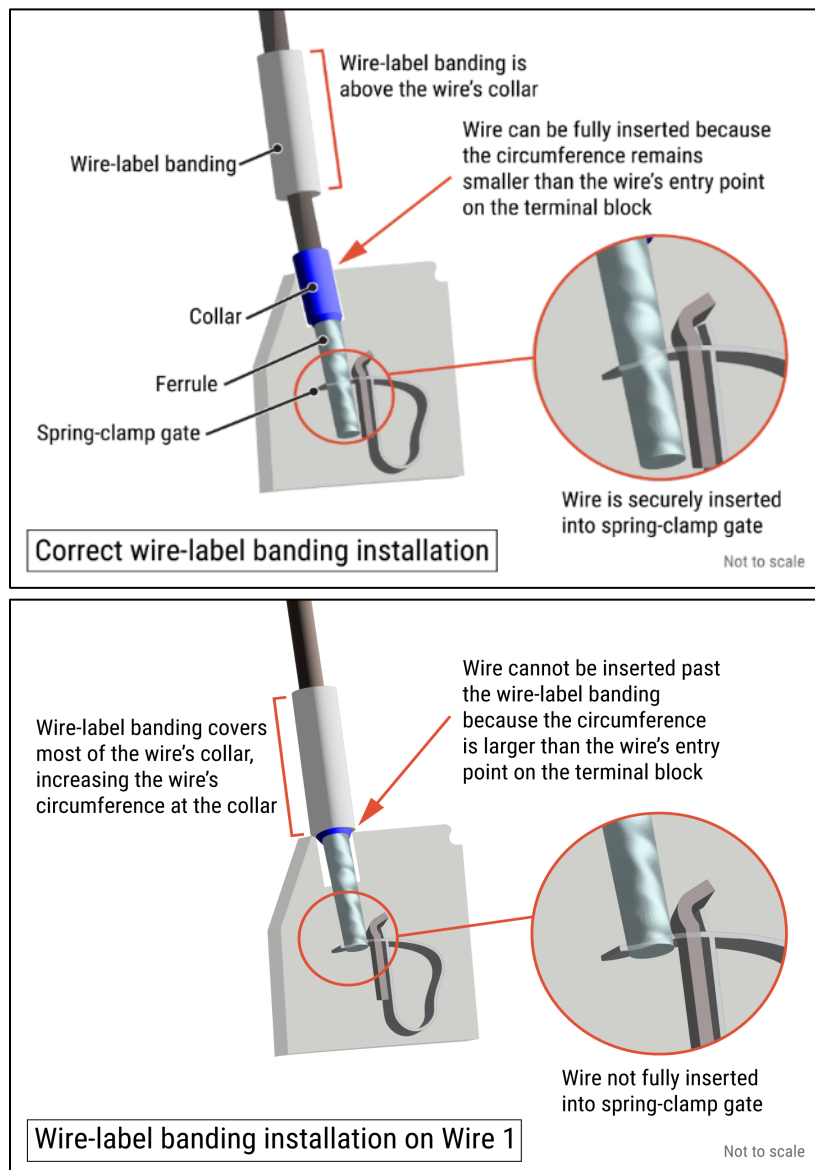
Figure 65. Top to bottom: Correctly installed wire-label banding compared to Wire 1's wire-label banding installation, showing how placement of wire-label banding affects the way wires are seated in their terminal blocks.

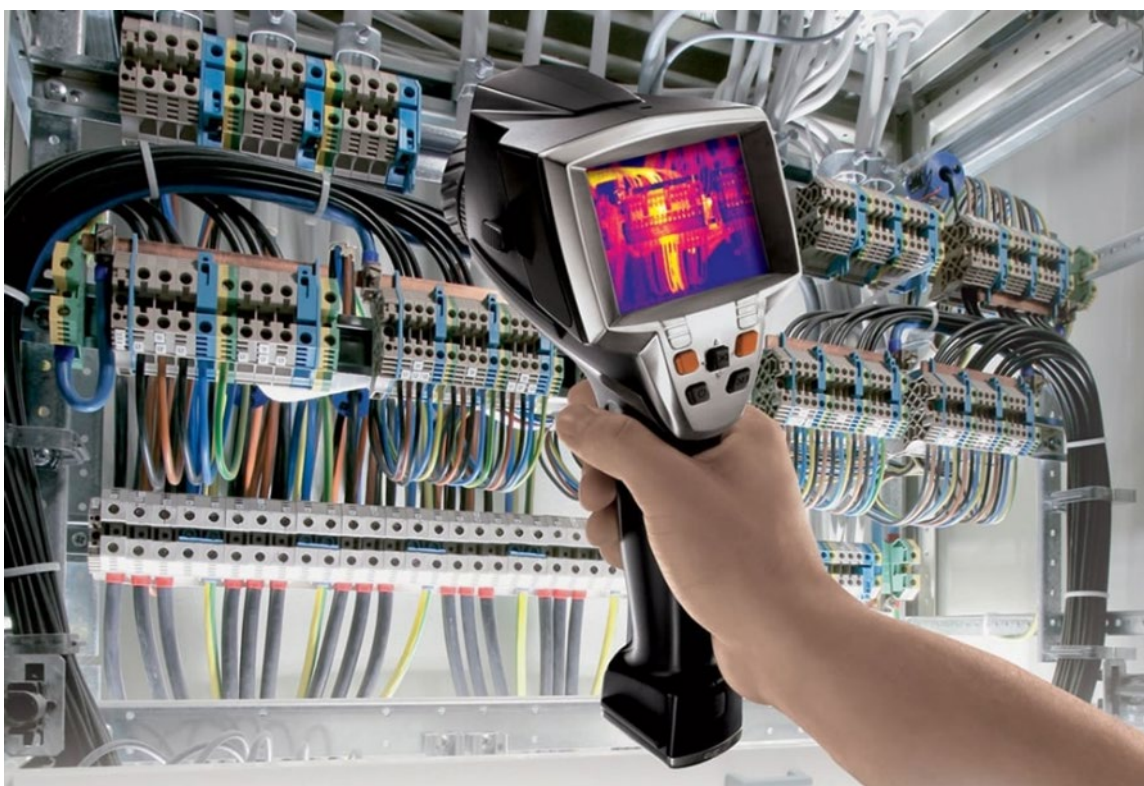
Figure 66. Exemplar infrared thermal imaging camera being used on control circuitry. The lighter colors indicate warmer temperatures. (Source: ThermoElite Inc.)

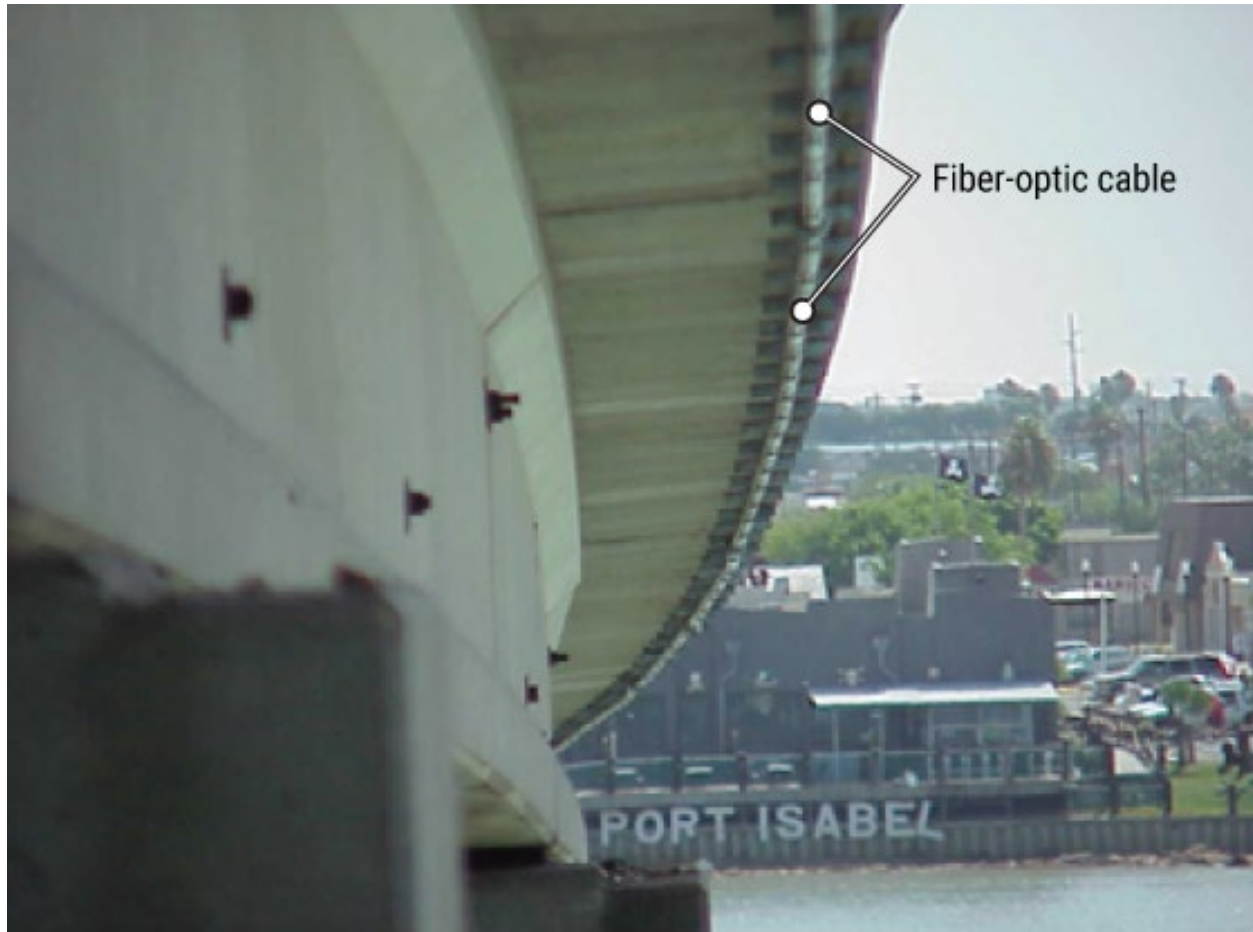
Figure 70. Fiber-optic cable installed on the rebuilt Queen Isabella Causeway bridge.
(Background source: Texas Department of Transportation)

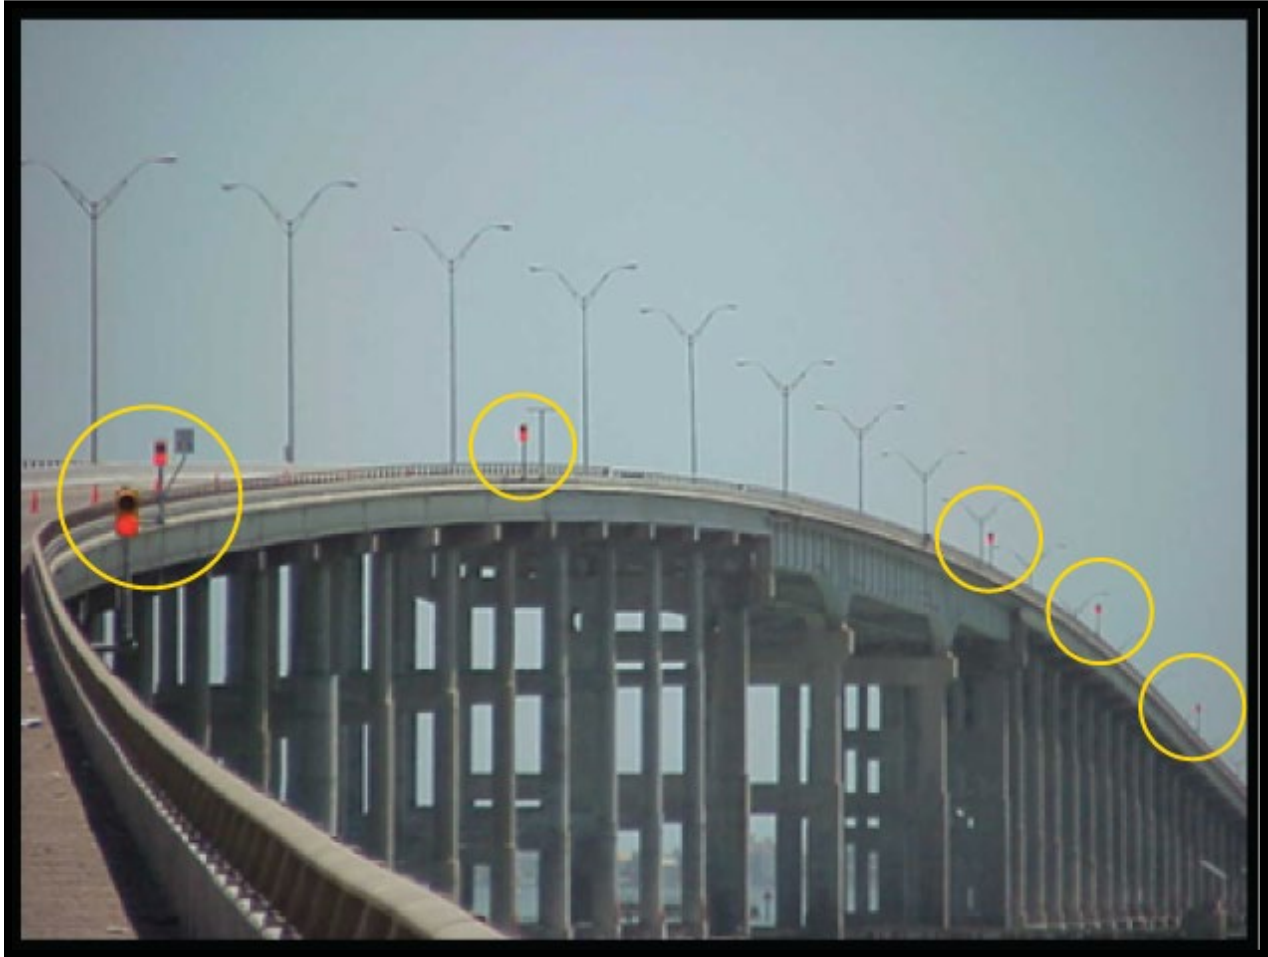
Figure 71. Red flashing motorist warning lights (*circled*) installed on the rebuilt Queen Isabella Causeway bridge. (Background source: Texas DOT)

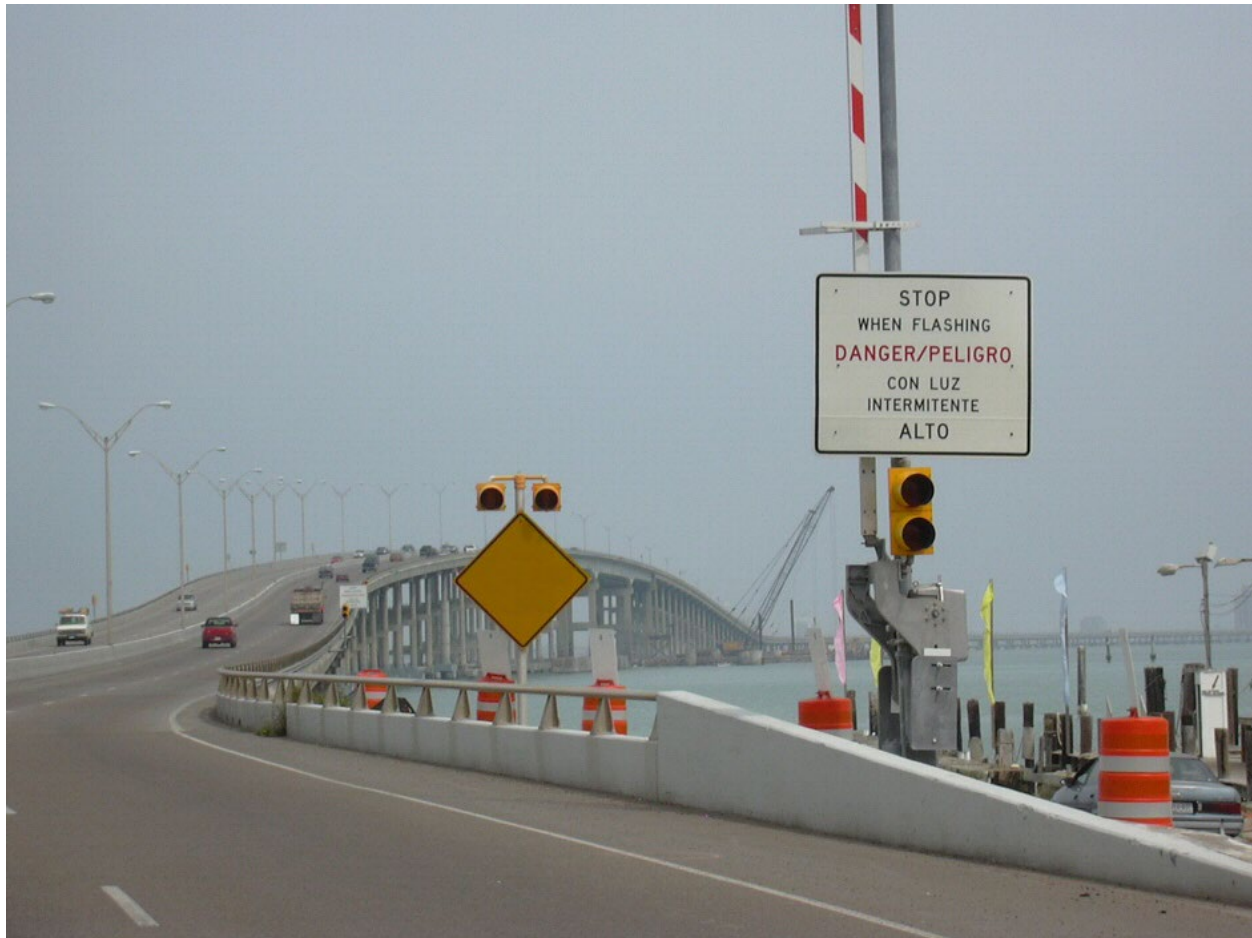
Figure 72. Traffic gates, warning signs, and motorist warning lights installed on the rebuilt Queen Isabella Causeway bridge. (Source: Texas DOT)

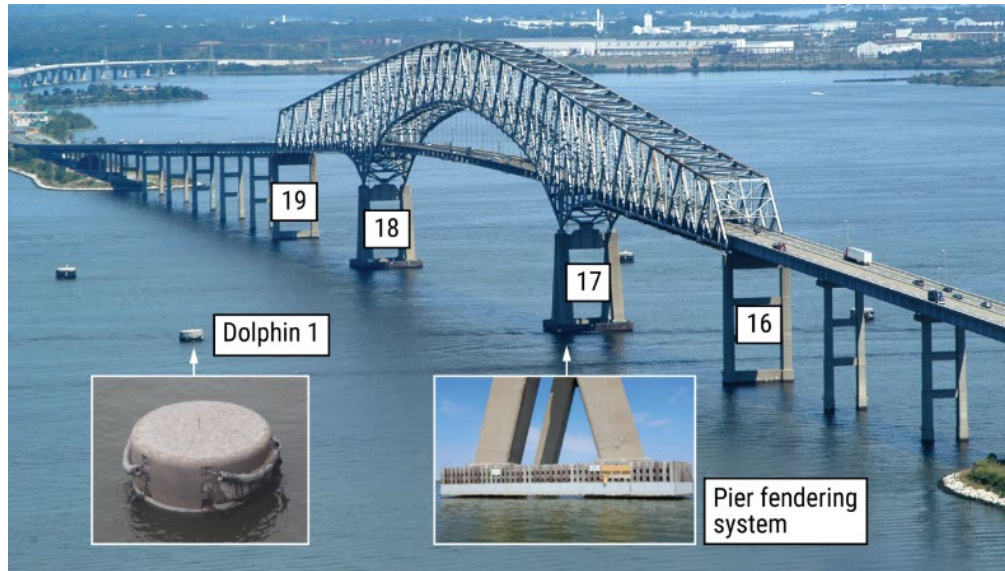
Figure E-2. The Key Bridge and the physical protection systems (Dolphin 1 and the pier fendering system) protecting Pier 17 from vessels transiting outbound under the Key Bridge. (Background source: MDTA)
