November 18, 2025

Marine Investigation Report MIR-25-40

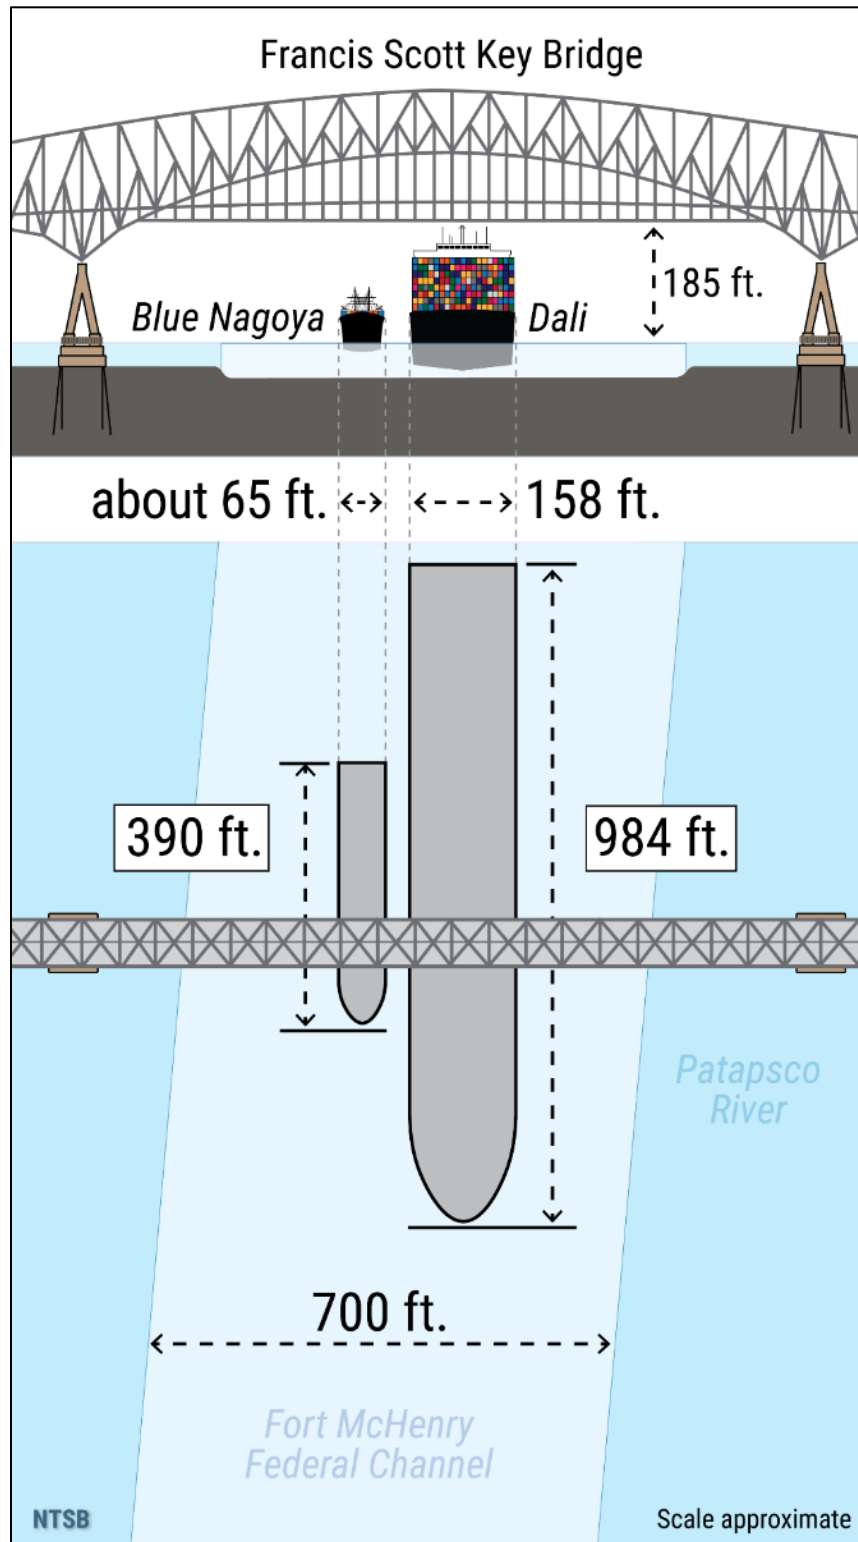
Figure E-4. The comparative sizes of the *Blue Nagoya* and the *Dali* relative to the Key Bridge.
