NATIONAL TRANSPORTATION SAFETY BOARD

2024

SAFER SEAS Digest

Lessons Learned from
Marine Investigations

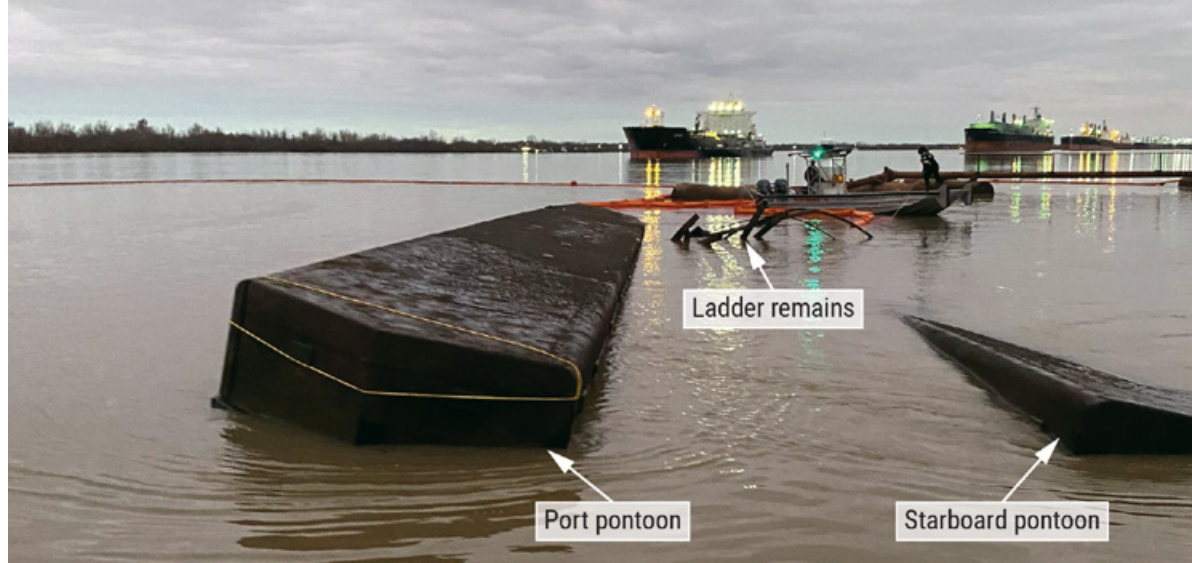
The overturned hull of the *WB Wood* with its pontoons downside up, the morning after the capsizing.

Postrecovery, a 2-inch through-hull pipe into the starboard storage space was found to be open, as its overboard check valve was missing and likely had been since before the casualty. The center of the through-hull pipe was about 5 inches above the dredge's normal waterline, so waves, a list to starboard, and/or an increase in stern trim could have submerged

the opening, allowing water to enter the storage space. Thus, it is likely that the initial starboard list was caused by flooding through the unsecurable through-hull pipe.

Investigators found wastage holes along the bottom 10 inches of the transverse forward bulkhead of the starboard aft void. If the adjacent starboard storage space flooded first, the water level in the starboard aft void would eventually increase from communication with the storage space. Additionally, investigators found that the 2-inch through-hull pipe with the missing valve ran transversely along the overhead from the storage space and through the bulkhead into the service water room—where it was uncapped. Therefore, once the storage space filled with water, it would have begun flooding the service water room. The only

THE PROBABLE CAUSE of the capsizing of the dredging vessel *WB Wood* was a lack of company requirements for crew to regularly check compartments below deck, which resulted in undetected flooding from a through-hull pipe that was missing its overboard check valve and subsequent progressive flooding from compromised watertight bulkheads.

Vessel crews should regularly check tanks and voids that are adjacent to the vessel's hull to identify hull integrity issues (such as potential corrosion and steel wastage, and watertight integrity deficiencies) that can lead to flooding. The presence of water can indicate an issue with watertight integrity or wastage and should be addressed. Vessel operators should ensure crews have procedures for anticipating, preventing, and addressing the potential for water ingress and flooding, including establishing scheduled checks. Bilge alarms set to detect water at a low level in voids and other spaces are another means to ensure early detection.

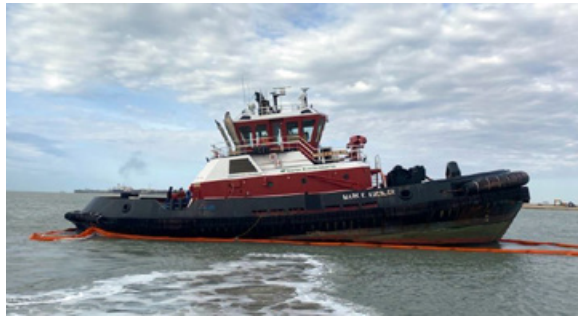
Mark E Kuebler aground following the collision.

In the collision, the *Nisalah's* propeller struck the *Mark E Kuebler*, resulting in multiple gashes in the *Mark E Kuebler's* hull at the stern, along with hull warping and damage to the vessel's fendering system. The tugboat's aft peak tank and Z-drive machinery room were breached, flooding both spaces to the waterline and inundating equipment. All four blades on the *Nisalah's* propeller sustained damage when it struck the *Mark E Kuebler's* hull.

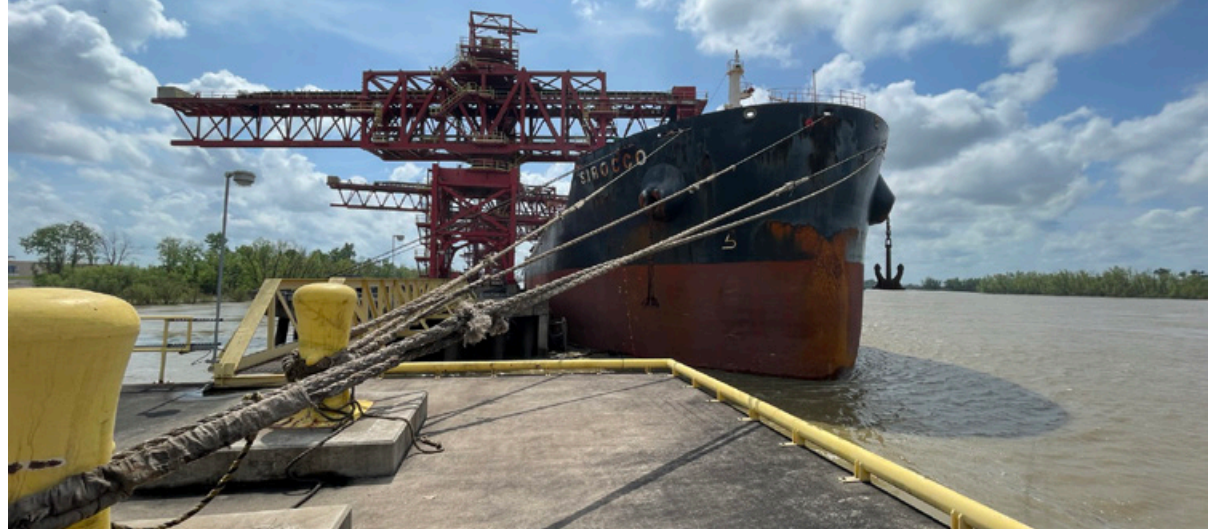
The forward mooring arrangement of the *Sirocco* at the Convent Marine Terminal dock at 1227 on March 26, 2023. SOURCE: OLDENDORFF PORT CAPTAIN.

At 0208, the *Sirocco's* bow began to move farther to port, away from the dock, with its stern remaining alongside, and greater tension was placed on the stern lines. At the forward mooring deck, the second officer observed smoke and sparks coming from the winches. A postcasualty examination of the winch brake liners on the *Sirocco's* bow found that they exhibited extreme heat and friction, indicating that the tension on the forward mooring lines exceeded the forward mooring winches' brake-rendering load (capacity). Because the winches' brake-rendering load was exceeded, about 0213, one line parted, and, as the stern started to move away from the dock, the remaining lines began to pay out, causing the vessel to break away from the dock.

THE PROBABLE CAUSE of the breakaway of the bulk carrier *Sirocco* from the Convent Marine Terminal dock and the subsequent collision with moored barge *MEM 5087* was the bow coming off the dock during cargo loading in the forward holds, exposing more of the vessel's underwater hull to the strong river current, resulting in the brake-holding capacities of the ship's mooring winches being exceeded and the lines paying out until the vessel broke free from the dock.

To reduce the risk of a vessel breakaway, it is important for vessel crews to understand the forces that act on a vessel when it is moored into a strong current at a dock. Crews should ensure that slack is taken out of lines as the vessel loads, especially as the forward draft increases and the bow begins to sit lower in the water, exposing more of the hull to the current. Continuously monitoring and taking up any slack from bow lines as forward holds are loaded can help to ensure that the bow does not come away from the dock. Developing a response plan for a breakaway can ensure that crews are prepared to respond when one occurs. Vessel masters should also consider incorporating additional safety measures such as keeping propulsion, thrusters, and steering systems on short standby and having anchors ready for immediate use (even if not required by the loading facility). Vessel masters should be familiar with how to request tug support on short notice.

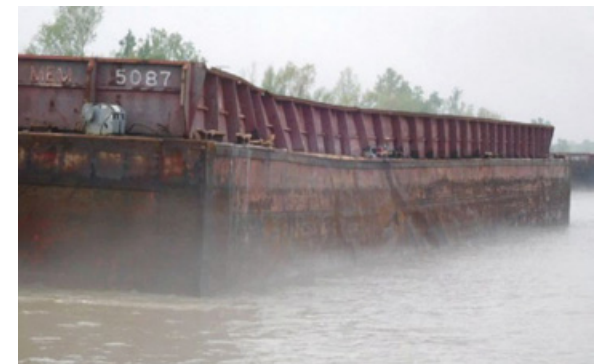
The damaged barge *MEM 5087*.

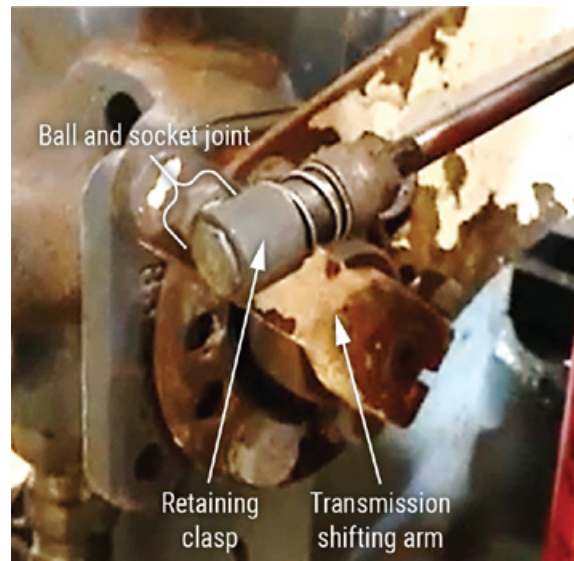
had conducted maintenance on the vessel's main propulsion systems. During the maintenance, he had disconnected both engines' transmission linkages at the ball and socket joints, which connected the mechanical linkages to the shifting levers on the transmissions. Each ball on the joint was held in place in the socket with a spring-loaded clasp. The captain reconnected the joints when the maintenance was completed; however, he stated that the ball for the port transmission linkage joint may not have been fully seated in the socket when it was reconnected, even though it would have appeared to be seated correctly. A postcasualty examination found no material discrepancies with the transmission linkage, including the ball and socket joint. Therefore, disconnection of the port transmission linkage at the ball and socket joint was most likely due to the ball not being fully seated in the socket when the joint was reconnected after maintenance.

***Kathleen K* transmission mechanical linkage at ball and socket joint.** SOURCE: COAST GUARD.

THE PROBABLE CAUSE of the collision of the fishing vessel *Kathleen K* with recreational vessels moored at a marina was the loss of directional control to one of the *Kathleen K*'s propulsion engines due to the disconnection of its transmission linkage, likely because the linkage's ball and socket joint was not fully reconnected after maintenance.

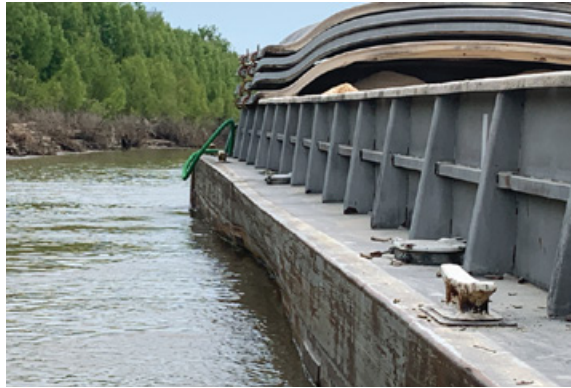
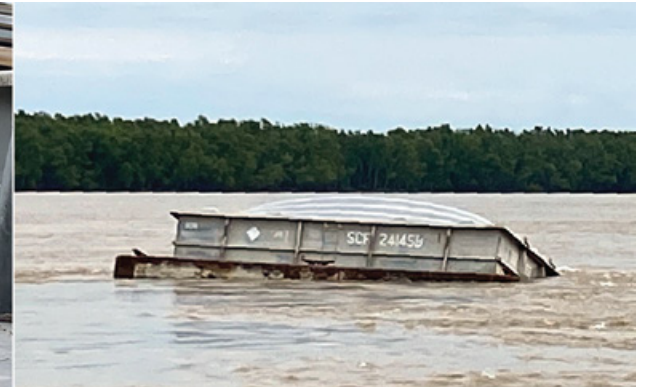
Left to right: Hull indentation on barge SCF14119B and partly sunk barge SCF24145B. SOURCE (RIGHT): COAST GUARD.

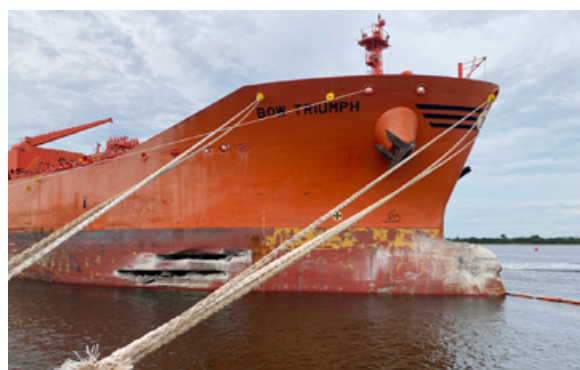
Witness photograph taken shortly after the contact showing damage to Pier B. BACKGROUND SOURCE: JACOB WALL.

On September 5, 2022, about 1602 local time, the 600-foot-long tanker *Bow Triumph* was transiting outbound on the Cooper River near Naval Weapons Station, Joint Base Charleston, South Carolina, when the vessel struck Naval Weapons Station Pier B. The vessel's bow sustained significant damage, and a 300-foot section of the pier collapsed. No pollution or injuries were reported. Damage to the vessel and pier was estimated at \$29.5 million.

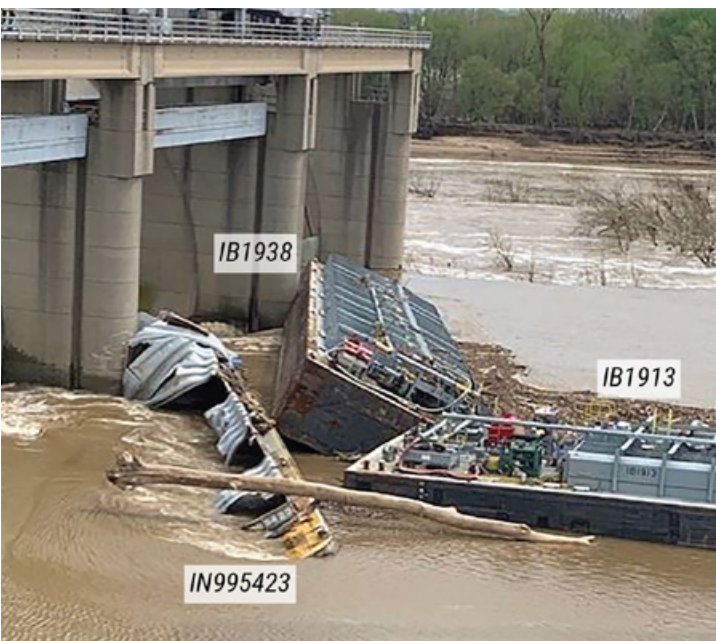
About 0224, the tow struck the vane dike mooring cell. The tow broke apart after the contact; six barges went through the lower dam gates, and three were pinned against the gates.

Barges IN995423 and IB1938 against the lower dam gates. IB1913 is receiving methanol from IB1938 through a cargo transfer hose.

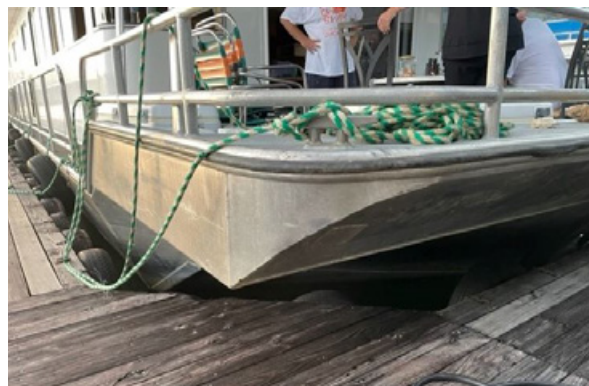
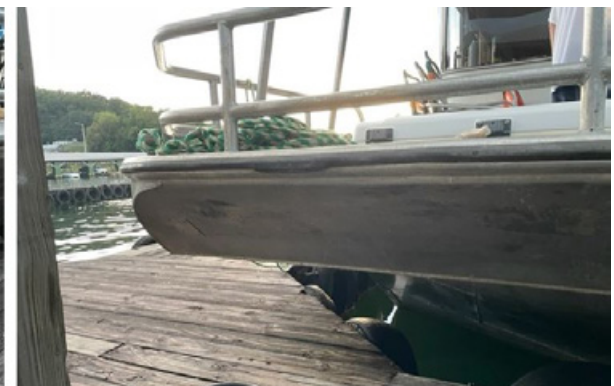
The gas dispenser was set back 5 feet from the dock face to meet the standard for protecting fuel pipes against physical damage arising from impact for marina fuel docks as required by the Tennessee Fire Code. The setback was intended to prevent contact with the gas dispenser by boats with standard bow designs coming alongside the dock. However, in this casualty, the dock's height and houseboat deck's overhang dimensions (above the water and from the bow stem) allowed the houseboat's duckbill bow to freely move over the fueling

THE PROBABLE CAUSE of the contact and subsequent fire at the Sunset Marina was a houseboat's "duckbill" bow striking a gasoline fuel dispenser (pump) when docking in windy conditions, which caused an undetermined electrical source on the dock to ignite vapors from the broken gasoline fuel line. Contributing to the contact was the proximity of the gas pump to the dock edge.

Below: The *Flagship 604*'s duckbill bow extended over the dock.

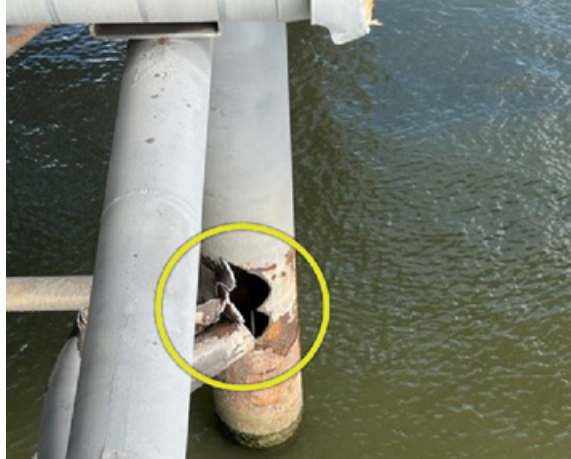
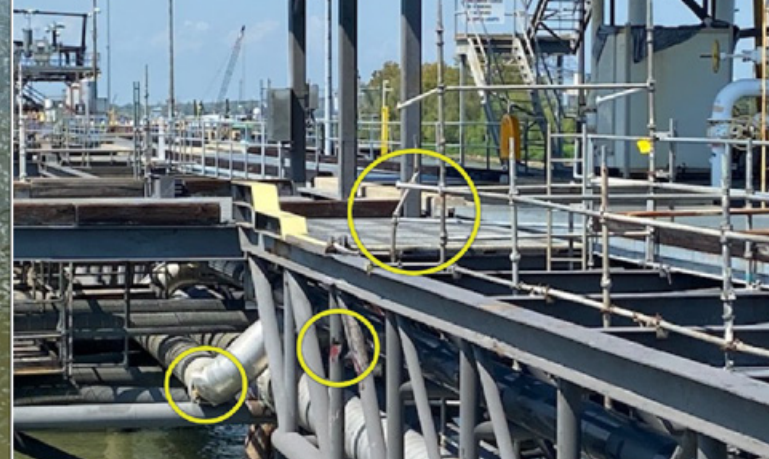
Damage to pier (circled). Left to right: A vertical piling. Insulated pipe, pier support bracing, and railing.

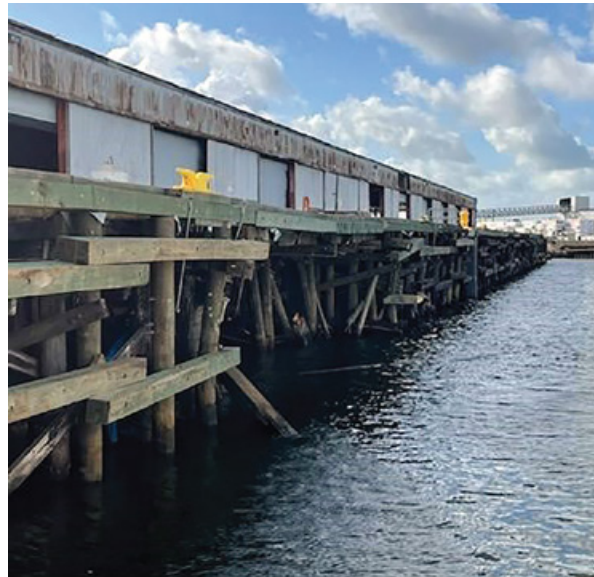
Left to right: Damage to the Port of Lake Charles pier. Timber from the pier found on the starboard lead barge of the *Danny Terral*. SOURCE: COAST GUARD.

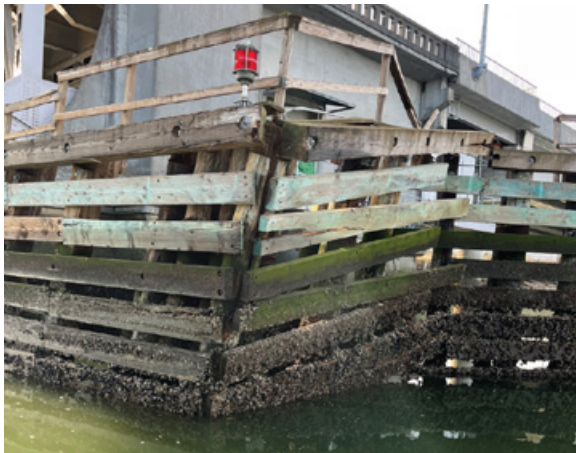
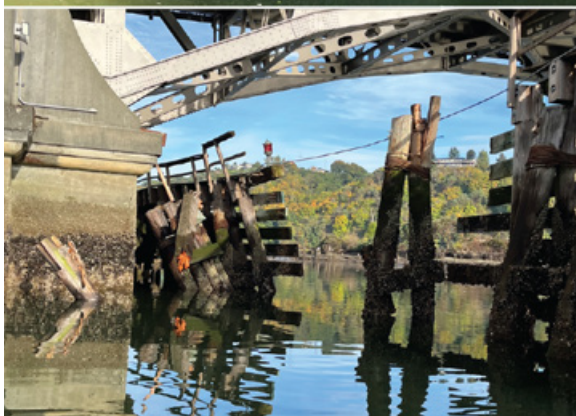
Damage to Hylebos Bridge fender system.

From top: Displaced center section and damaged dolphin. Broken and missing timber facing boards on eastern and center sections. SOURCE: COAST GUARD.

The bridge was undamaged during the casualty, but the fender was catastrophically damaged. Precasualty inspections of the bridge's fenders in 2017 and 2022 noted significant deterioration of the fender piles from marine borer damage and fungal decay. A postcasualty inspection found similar damage. It is

notable that the entire fender sustained catastrophic damage when the *Olympic Scout* struck it at one end (at an angle—not directly), yet the tugboat sustained almost no damage. The Hylebos Bridge fender system prevented damage to the bridge structure by the *Olympic Scout*; however, the system's degraded condition contributed to its extensive damage.

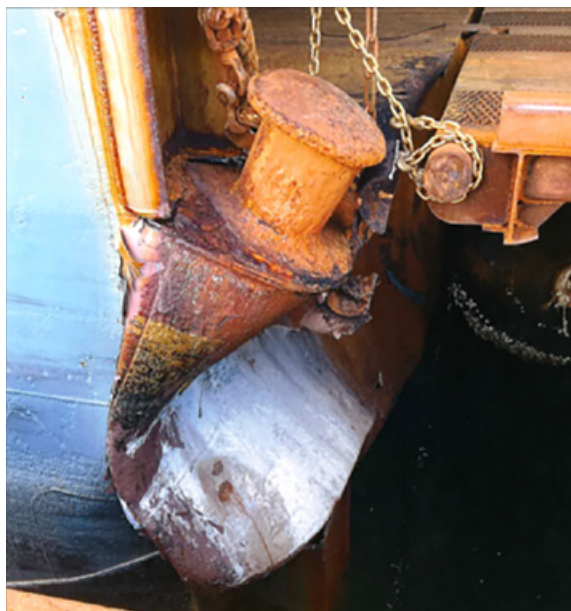
Due to the height of the barge, the captain of the *Brooklyn McAllister* was not able to see the Army Terminal Pier from where his tug was positioned at the barge's starboard quarter. According to the docking pilot, he first instructed the *Brooklyn McAllister's* captain to keep the barge's stern clear of the *Axios*. However, he then gave instructions intended to move the barge's stern away from the Army Terminal Pier so that the barge would clear the corner of the dock while entering the slip, given a light breeze on the starboard beam. The *Brooklyn McAllister* captain later stated that he had heard the docking pilot's instructions as "ahead and to starboard." The docking pilot stated that he requested and received confirmation that the captain was carrying out his instructions. However, the captain of the *Brooklyn McAllister* maneuvered his vessel in a way that pushed the port quarter of the barge toward the pier, contrary to the docking pilot's intention. The miscommunication resulted in the barge contacting the pier.

***San Juan-JAX Bridge's* damaged port quarter.**

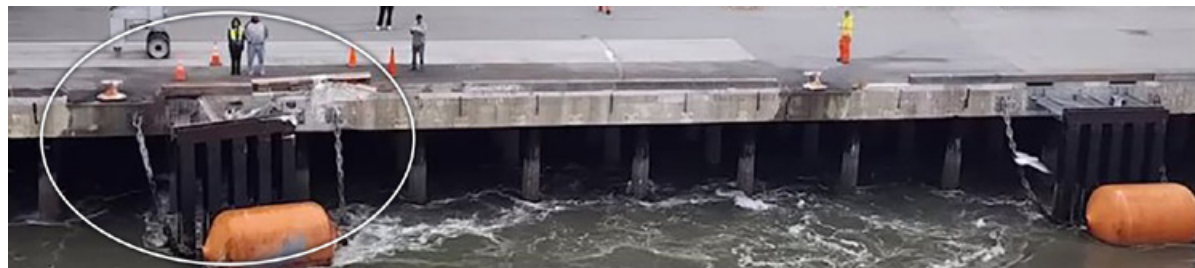
Pier 27 damage (circled). BACKGROUND SOURCE: KRON4.

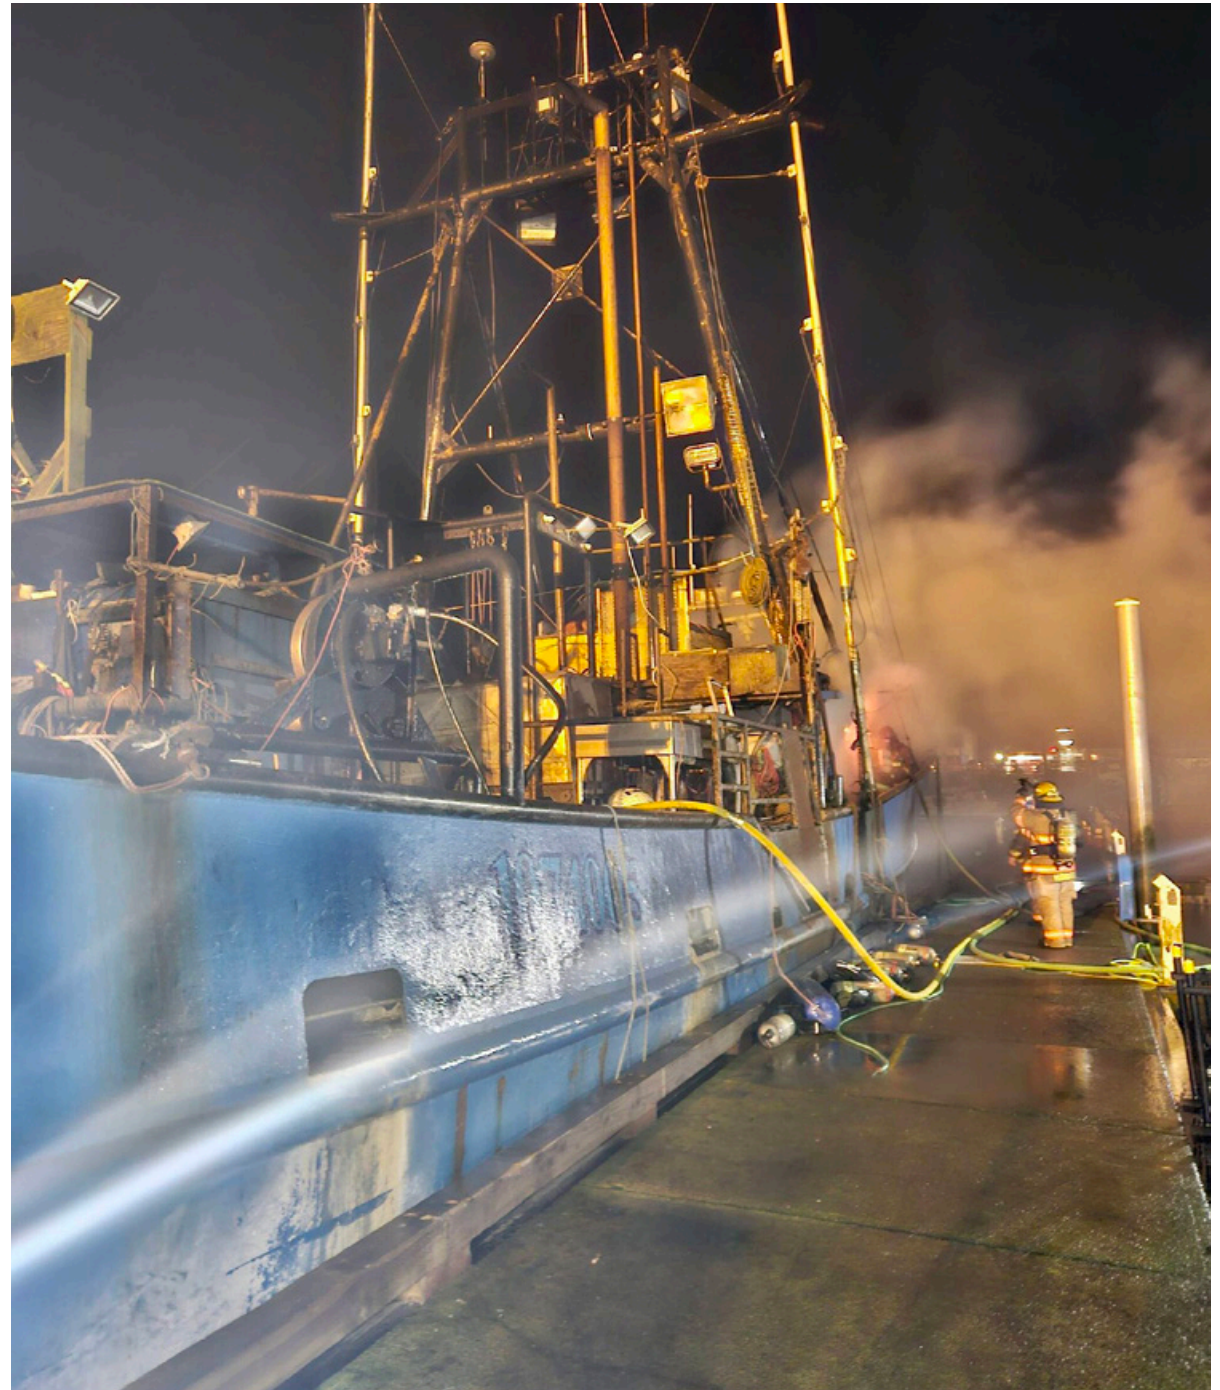
A certified fire and explosions investigator ruled out that the fire started from discarded smoking materials, a lightning strike, or from an issue with the shoreside power supply. He concluded that the fire originated from within the vessel's galley near a chest freezer that had been plugged into an extension cord and energized before the fire. The examination report stated that the cause was most likely a failure of the extension cord that was powering the freezer.

Right: *Marlins II* at the dock during firefighting efforts.

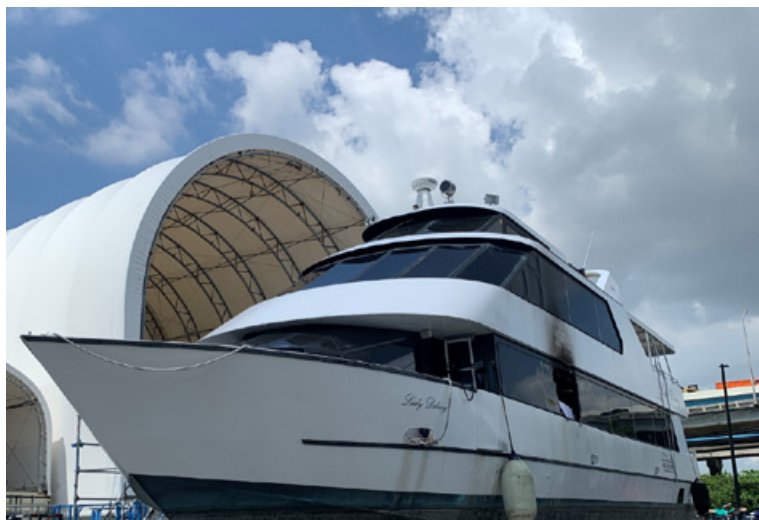
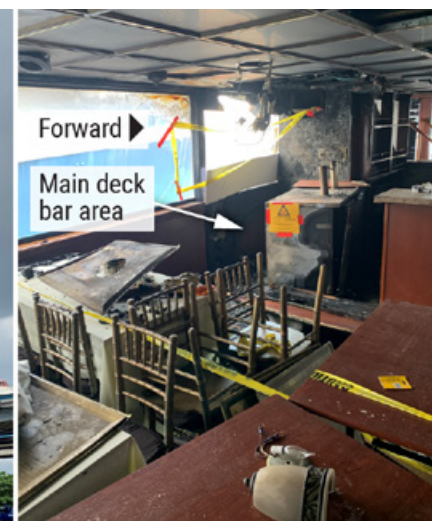
Left to right: Lady Delray after the fire, with fire-damaged portside window and portside main deck bar area.

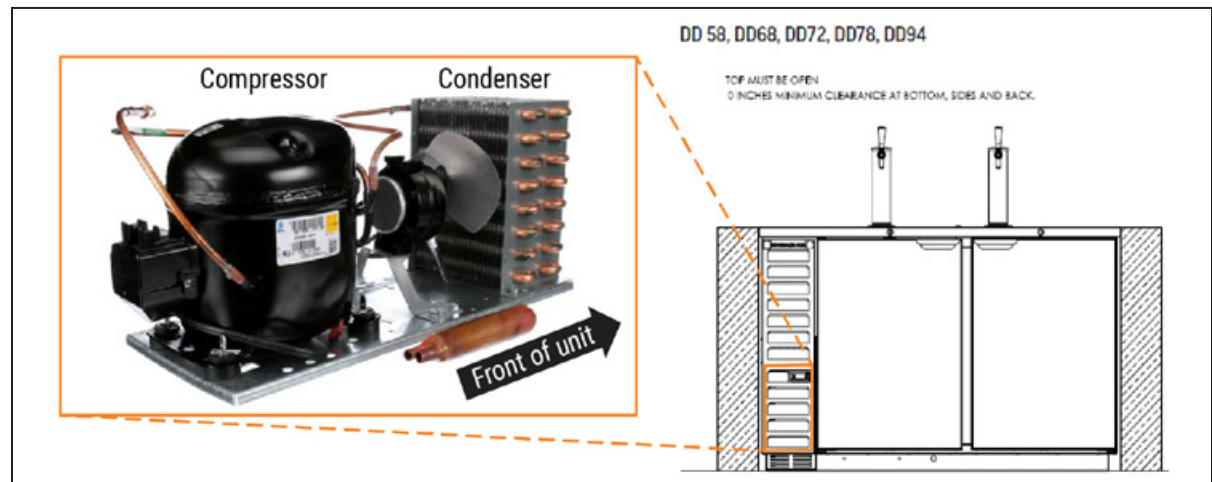
Exemplar hermetically sealed compressor and condenser coil unit similar to the two-door, keg-type refrigeration unit installed aboard the *Lady Delray*. The condenser end of the unit (outlined and shown in inset) would have been directly behind the grill on the front of the refrigeration unit. BACKGROUND SOURCE: BEVERAGE-AIR.

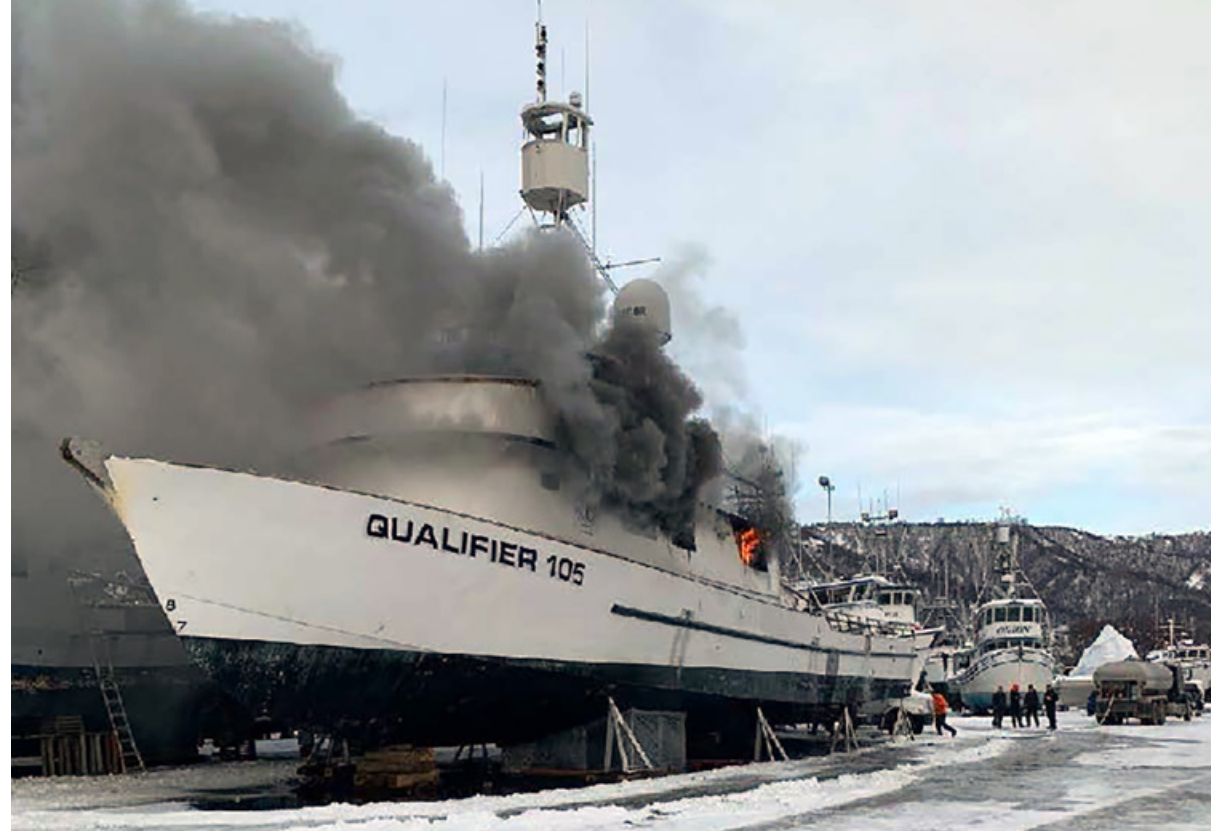
Qualifier 105 on fire in the boatyard. SOURCE: HOMER VOLUNTEER FIRE DEPARTMENT.

On January 19, 2023, about 1155 local time, a fire started in a stateroom below the main deck of the small passenger vessel *Qualifier 105*, which was being stored ashore for the winter, on blocks, in the Northern Enterprises Boat Yard in Homer, Alaska. The local fire department responded and extinguished the fire. No pollution or injuries were reported. The owners declared the vessel a constructive total loss. Damages were estimated at \$1.2 million.

The fire started in stateroom J, below the main deck of the *Qualifier 105*, and was discovered by a crewmember who was serving as the fire watch. At the time the fire started, welders were on board performing aluminum hot work, cleaning up the area around a fuel tank that had been repaired and tested the day before, and reinstalling the deck in a head that was directly above the fuel tank.

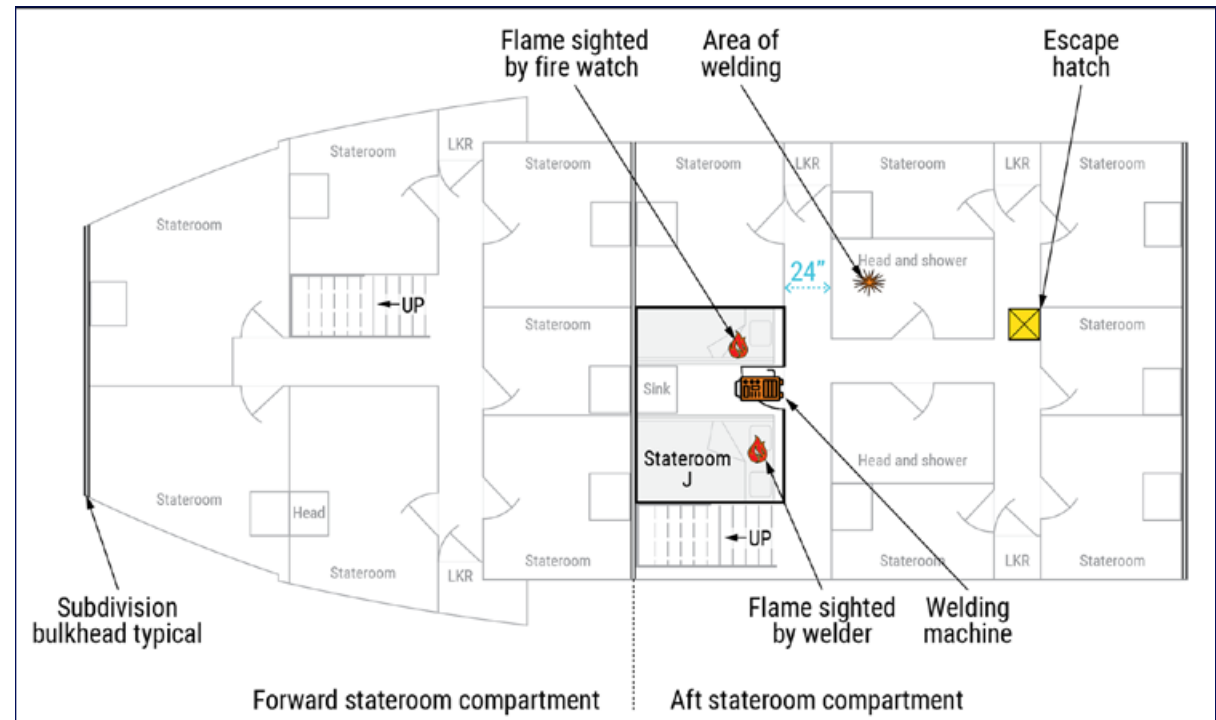
The fire watch and welder 1 each saw a small flame on two different bunks in stateroom J—the first sign of a fire observed. Those small flames were likely caused by hot droplets of plastic sheeting—used to protect the carpet-covered, plywood drop ceiling above—that had melted and caught fire from heat or fire between the aluminum overhead and the drop ceiling. Therefore, it is likely that the initial ignition source and the eventual fire in stateroom J originated from the overhead.

An electrical wire in the overhead of stateroom J could have served as an unintended conductor and become overheated and eventually led to a fire. However, investigators could not definitively determine that stray welding current caused wires to overheat. Additionally, there were several wires and electrical boxes in stateroom J that may have been energized and become a potential electrical ignition source due to a fault. Therefore, the exact ignition source could not be determined.

THE PROBABLE CAUSE of the fire aboard the passenger vessel *Qualifier 105* was an undetermined electrical source that ignited a stateroom ceiling. Contributing to the extent of the fire damage was the substantial use of combustible materials composing the stateroom ceilings and bulkheads throughout the vessel's accommodation spaces.

Qualifier 105 forward and aft stateroom compartments.

Stray welding current is a fault condition in which current goes through unintended conductors and back to the return terminal of a welding machine; it can cause fires by overheating wires. To avoid potential fires caused from stray welding current, maintenance personnel, owners, and operators should follow industry practice to place the work clamp (the return current clamp) of the welding machine as close as possible to the point of welding.

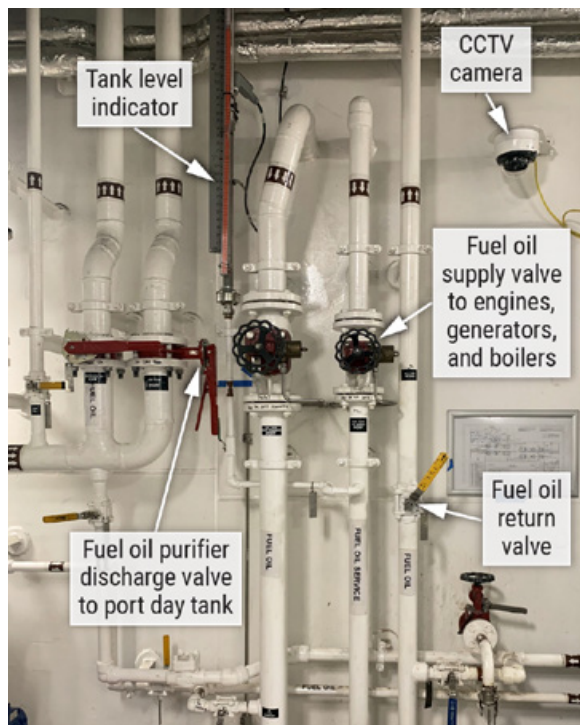
of the two fuel oil day tanks. They adjusted several valves at both fuel oil stations and adjusted the fuel oil service supply globe valve to the engines, generators, and boilers on the port day tank several times. They also adjusted the fuel oil purifier discharge valves and the fuel oil return isolation ball valves to both day tanks. In their ongoing response to correct the divergence in the fuel oil day tank levels, the oilers closed both the port and starboard day tank fuel oil return isolation ball valves, causing the fuel oil system to overpressurize.

Fuel oil piping at the port (Staten Island end) fuel oil station aboard SSG *Michael H. Ollis*, which was a vessel of the same class as the *Sandy Ground* and had a similar piping arrangement (SSG *Michael H. Ollis* piping shown due to postfire condition of *Sandy Ground* fuel oil station). The fuel oil return valve is a ball-type valve. Note the valve is partially closed (ball valve open-to-close range is 90° and indicated by handle position).

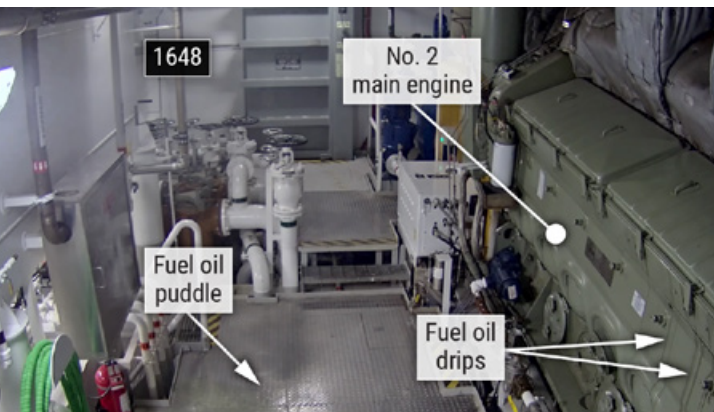
The chief engineer began acknowledging and silencing alarms on the MCS computer. He stepped out into the engine room and saw fuel oil leaking from the no. 2 main engine secondary duplex spin-on fuel filter assembly and that nos. 3 and 4 main engines had “fuel on them.” The oilers, who were in the engine room at

this time, told the chief engineer they observed fuel oil spraying from the nos. 3 and 4 main engines.

Above: Fuel oil dripping onto the no. 2 main engine and on the adjacent deck in the lower engine room (looking toward the New York end) at 1648.

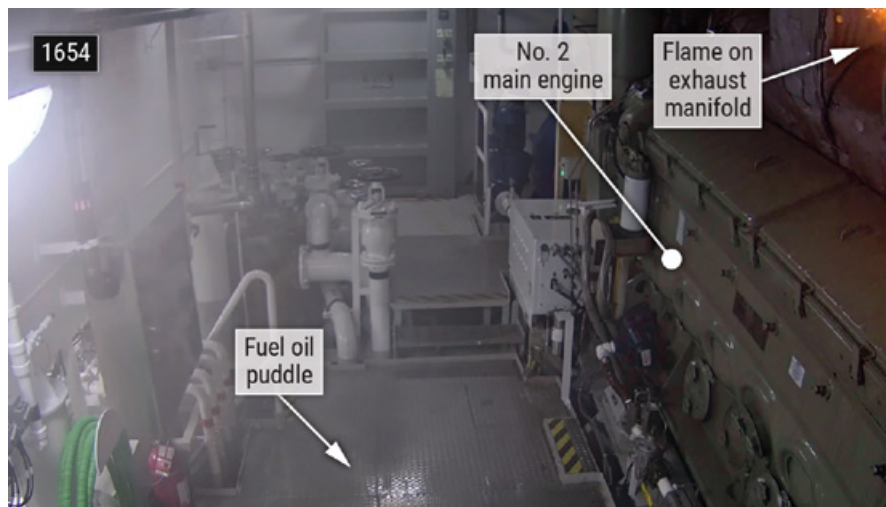
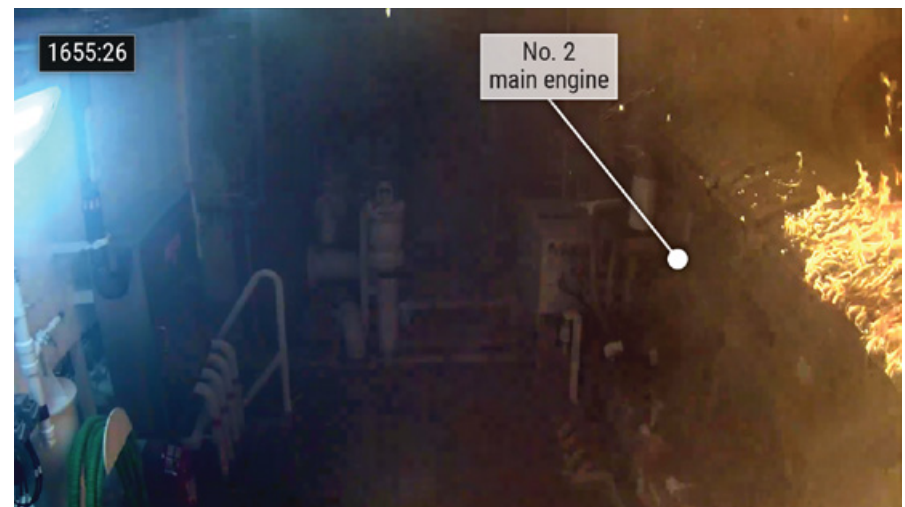
Below, from left: Initial fire breaking out on exhaust manifold on no. 2 main engine at 1654. Fire at 1655:26.

We found that the on-duty engineering crewmembers ineffectively managed fuel oil levels in the vessel's two fuel oil day tanks, causing the difference in the two tanks' levels to sharply increase. To correct this difference in levels, the engineering crewmembers closed the fuel oil return isolation ball valves to both day tanks, causing the fuel oil system to overpressurize and the fuel oil filters on the main engines to rupture. Fuel oil spraying from a ruptured fuel oil filter onto the operating no. 2 main engine ignited, causing a fire to break out in the engine room.

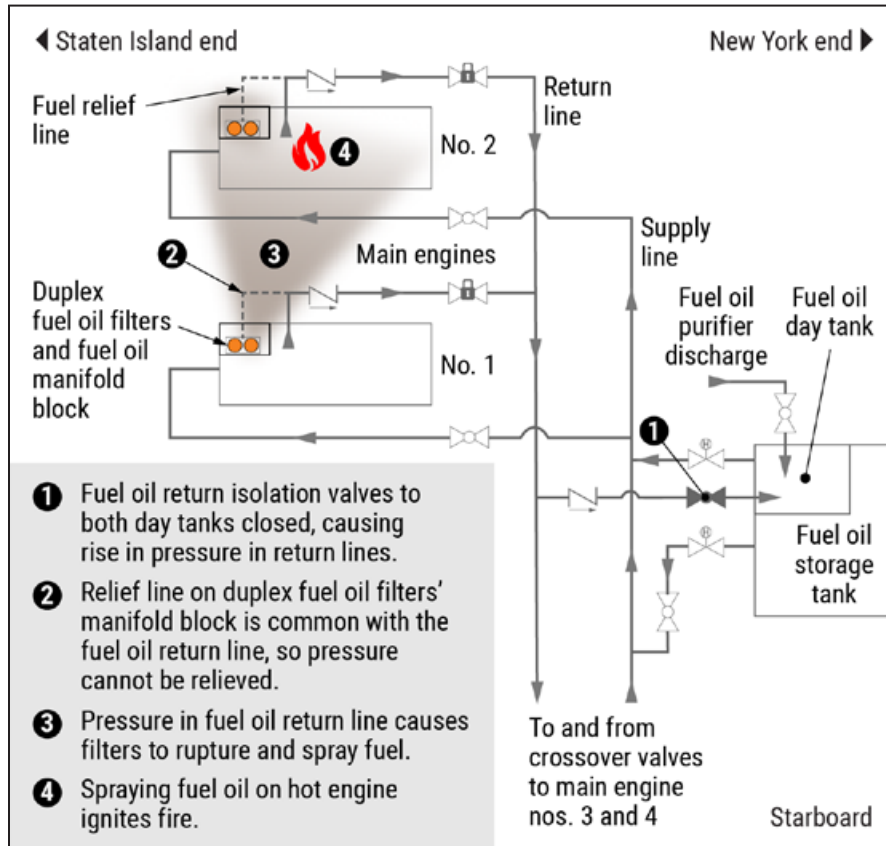
THE PROBABLE CAUSE of the engine room fire aboard the passenger ferry *Sandy Ground* was the design of the vessel’s diesel engine fuel oil return system, which included isolation valves that could be regularly adjusted by the crew and, when closed, stopped return fuel oil flow from all operating engines, resulting in the overpressurization of the fuel oil system and the ignition of fuel oil spraying from ruptured fuel oil filters onto the exhaust manifold of a running engine. Contributing to the overpressurization was the operator’s inadequate training program on fuel oil system operation, which did not provide follow-on instruction after the installation of fuel oil return isolation valves at the day tanks.

Simplified New York end main engine fuel oil supply/return system drawing for *Sandy Ground* and sequence of events leading to overpressurization and fire.

Staten Island Ferry determined that, for operational reasons, the Ollis-class ferries should be fitted with fuel oil return isolation valves before the day tanks to regulate day tank levels by throttling these valves. However, these vessels did not have a means to relieve the pressure in the fuel oil return line after the oilers closed both fuel oil return isolation valves. Had the *Sandy Ground* been equipped with a pressure relief valve installed in the fuel oil return line, the elevated fuel oil pressure caused by the closed fuel oil return isolation ball valves would have been relieved, and fuel oil system overpressurization would have been prevented.

As a result of its investigation into this accident, the NTSB issued five new safety recommendations to the Coast Guard and ABS. When the fuel oil system drawing (diagram) was initially submitted to the Coast Guard and ABS for approval, the drawing complied with all applicable regulations and classification rules. However, explicit requirements and guidance for maintaining unimpeded return flow in diesel engine fuel oil return systems would mitigate the risk of a system overpressurization. We **recommended** that the Coast Guard update marine engineering regulatory requirements applicable to US-flagged vessels to require diesel engine fuel oil return systems be designed to have either unimpeded return flow from the engine or the installation of a pressure relief valve. We **recommended** that ABS similarly revise its rules used to class vessels.

We also **recommended** that, until regulatory requirements can be updated, the Coast Guard develop and disseminate design guidance for new construction diesel engine fuel oil return systems so they have unimpeded flow from the engine or other arrangements to prevent overpressurization. Additionally, we **recommended** that the Coast Guard share our related safety alert with marine inspectors so they can ensure existing vessels' diesel fuel oil systems have unimpeded return flow. Finally, we found that other classification societies would benefit from learning about the circumstances of the engine room fire aboard the *Sandy Ground* and therefore **recommended** that ABS propose to the International Association of Classification Societies that they ensure their rules require diesel engine fuel oil systems to be designed to have unimpeded return flow or other arrangements to prevent system overpressurization.

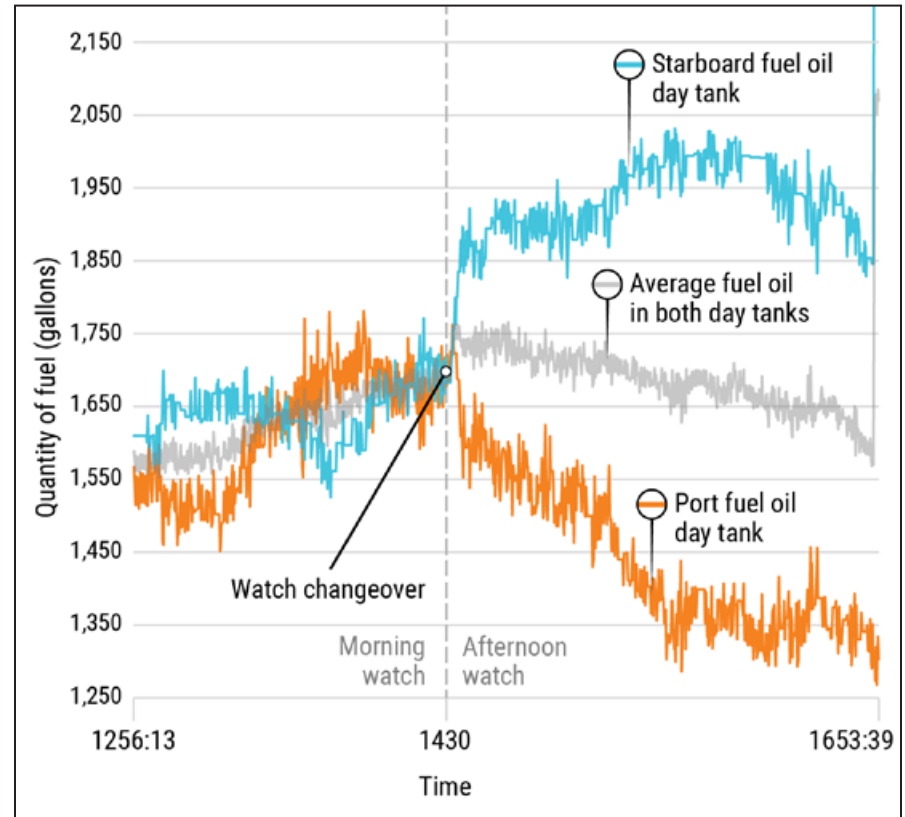
When the afternoon engineering watch took over from the morning watch at 1430, the MCS indicated a difference of 5 gallons between the two day tanks. Over the next four transits and during the casualty transit, as the ferry continued to operate, the engineering crewmembers observed substantial differences in the fuel oil levels of the vessel's two fuel oil day tanks (about 1600, the MCS logged a difference of about 550 gallons between the port and starboard fuel oil day tanks). Additionally, the total amount of fuel oil in the day tanks (combined amount) decreased steadily.

Graphic representation of fuel oil quantities in port fuel oil day tank and starboard fuel oil day tank. Average fuel oil in both tanks, calculated by NTSB, is depicted in gray. DATA SOURCE: SANDY GROUND MCS.

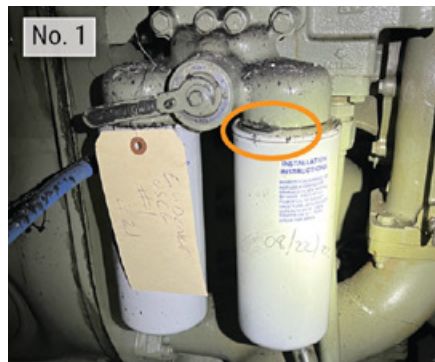
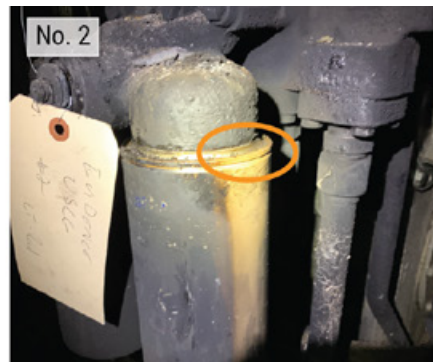
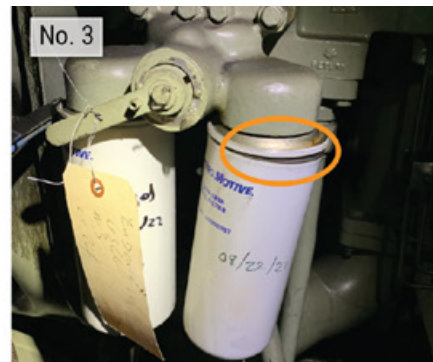
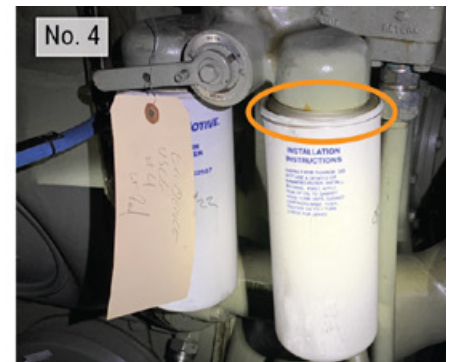
Damage (circled) found on secondary spin-on duplex fuel oil filters from each of the four main engines after the casualty. The no. 1 main engine has a protruding gasket in the direction (outboard) of the no. 2 main engine, and the nos. 2, 3, and 4 main engine filter housings are distorted.

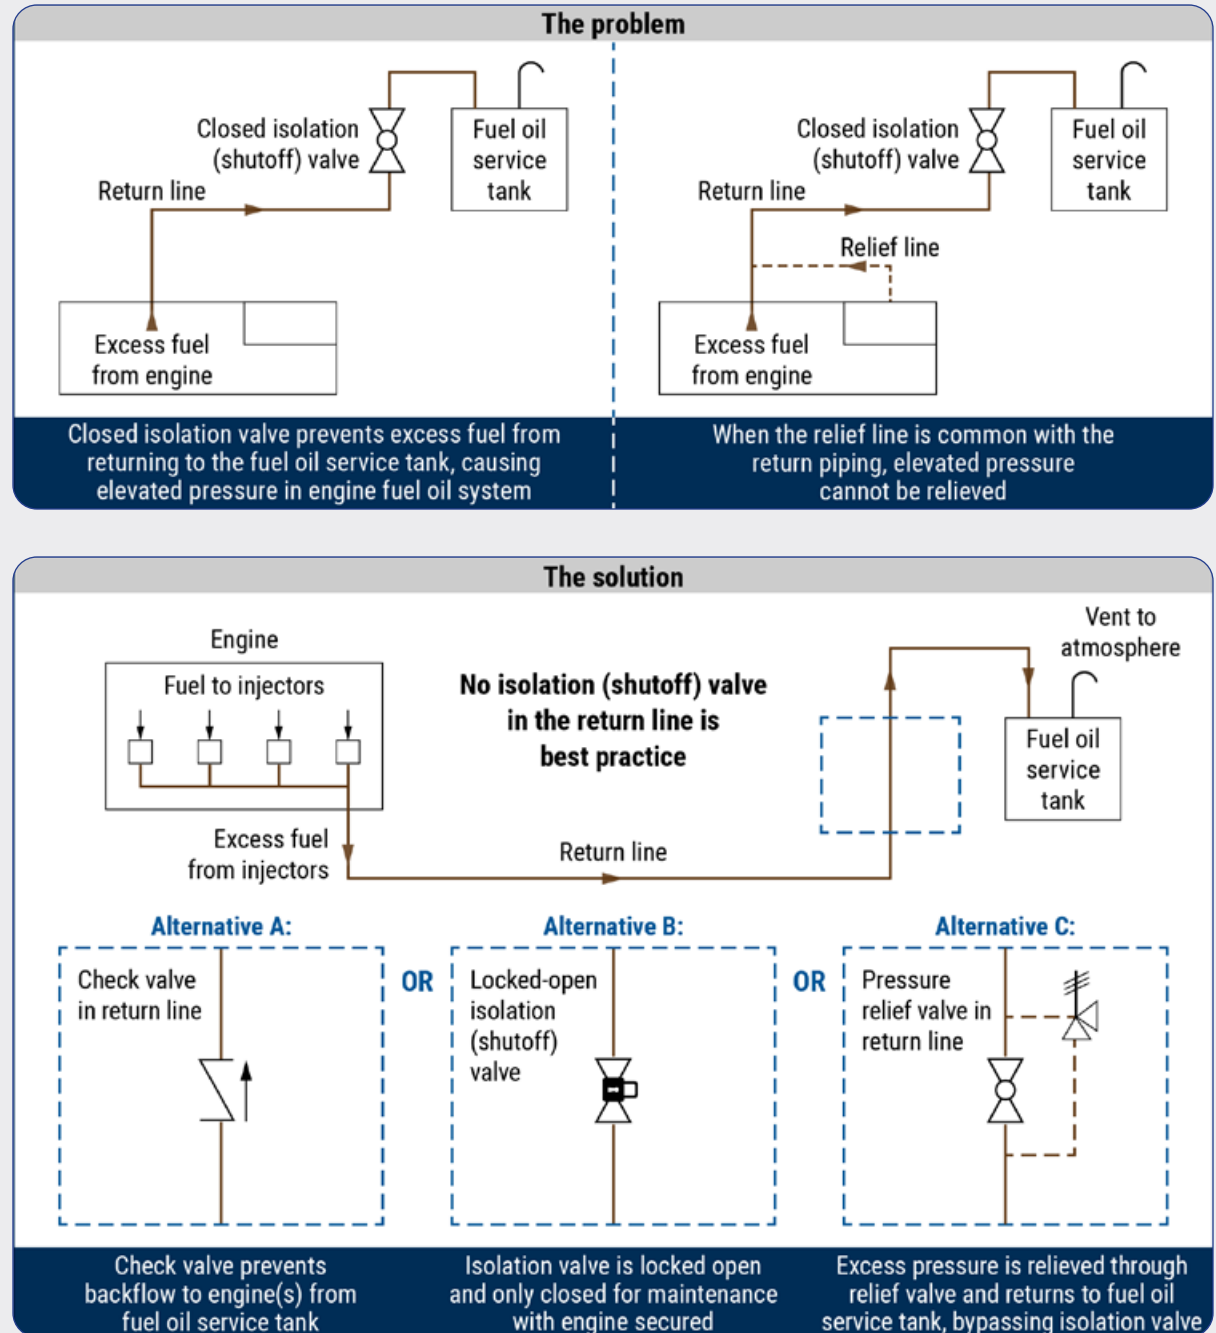
This Safety Alert is a result of our investigations of casualties in which overpressurization of a main engine fuel return system—caused by closed valves—led to diesel fuel spraying onto hot components and igniting a fire. We found that if an isolation (shutoff) valve is installed in the return line before a tank, closing the valve will result in a pressure buildup in the return line. Additionally, if relief valves are piped into a fuel oil return like that has a closed isolation (shutoff) valve, the relief valves will be ineffective, and pressure will continue to rise. **Vessel owners and operators can mitigate the risk of engine room fires resulting from overpressurization of diesel engine fuel systems by ensuring all return lines leading to the service tank(s) are unimpeded, with no valves in the lines, and providing crewmembers training on diesel engine fuel system design and operations.**

Right, from top: Simplified diagrams of a diesel engine fuel system showing the problem—a return line with closed isolation (shutoff) valve and relief line common with return piping system; and the solution—a return line with no isolation (shutoff) valve, or, alternatively, with a check valve, locked-open isolation valve, or pressure relief valve in return line.
