NATIONAL TRANSPORTATION SAFETY BOARD

2024

SAFER SEAS Digest

Lessons Learned from
Marine Investigations

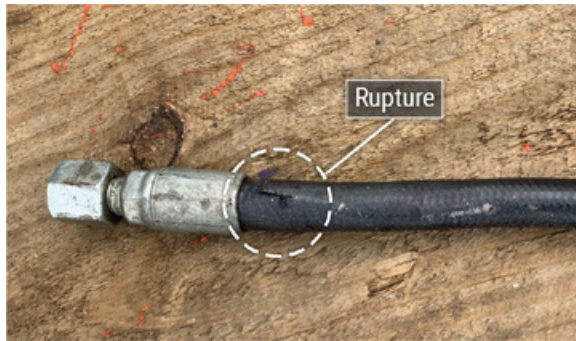
The captain told the Coast Guard that the cause of the fire was a ruptured hydraulic line on the portside steering pump, which subsequently caused flammable hydraulic oil to spray onto the hot port main propulsion engine exhaust manifold and turbocharger and ignite. The line was 0.5 inches in diameter and about 16.5 inches long, and the rupture was found near the hose end crimped fitting. The captain and deckhands removed the ruptured hydraulic line from the portside steering pump directional manifold valve and replaced the hose with an onboard spare.

The ruptured port steering pump hydraulic hose, after the fire.

After reviewing photographs of the area where the fire occurred and where the replacement hydraulic hose was installed, investigators identified issues with how the hose had been installed. Contrary to manufacturer guidance, the hose appeared to exceed

the bend radius; it was not guided with clamps, fittings, or adapters; and it did not have any protective cover. The manufacturer guidance warned that an improperly installed hose could fail. Given that the original hydraulic hose that ruptured was the same length and diameter as the replacement hose, it is likely that the same issues existed for the ruptured hose. Therefore, the lack of adherence to the hose manufacturer's guidance on installation likely resulted in the hose exceeding its bend radius, rupturing, and spraying fuel, which led to the fire.

THE PROBABLE CAUSE of the fire aboard the towing vessel *Desperado* was a hydraulic hose that likely exceeded its bend radius, eventually causing the hose to rupture, resulting in hydraulic oil spraying onto a hot engine exhaust manifold and turbocharger and igniting.

Mariners and technicians who design, install, and maintain systems should follow the manufacturer's guidance on the minimum bend radius for a hydraulic hose. The minimum bend radius is the radius below which an object cannot (or should not) be bent. Bending or flexing a hose to a radius smaller than the minimum recommended, or subjecting a hose to tension or torque, can place excessive stress on the hose and severely reduce the ability of the hose to withstand pressure. Tight space constraints may cause a hose to bend severely around corners. A machine or cylinder extending and retracting can also bend a hose. Hoses attached to moving parts may bend more than a hose in or near a machine's stationary position. Actions to avoid hose damage or failure include clamping a hose in place to provide support, rerouting a hose assembly by installing fittings and adapters, and using a hose with more reinforcement (two braid instead of one braid).

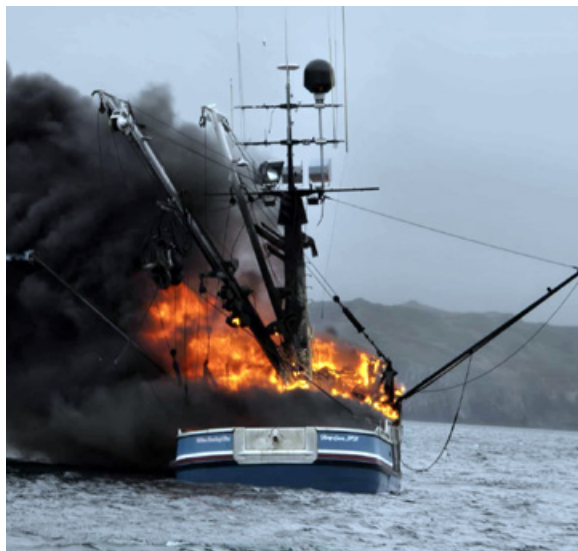
Miss Courtney Kim on fire on June 18, 2024.

Given the burning electrical smell, the cause of the fire may have been electrical in nature. If there was an electrical fault within nearby circuits or equipment, it could have created excessive resistance heating, which may have led to the ignition of nearby combustibles. However, because the vessel sank and was not recovered, the cause of the fire could not be determined.

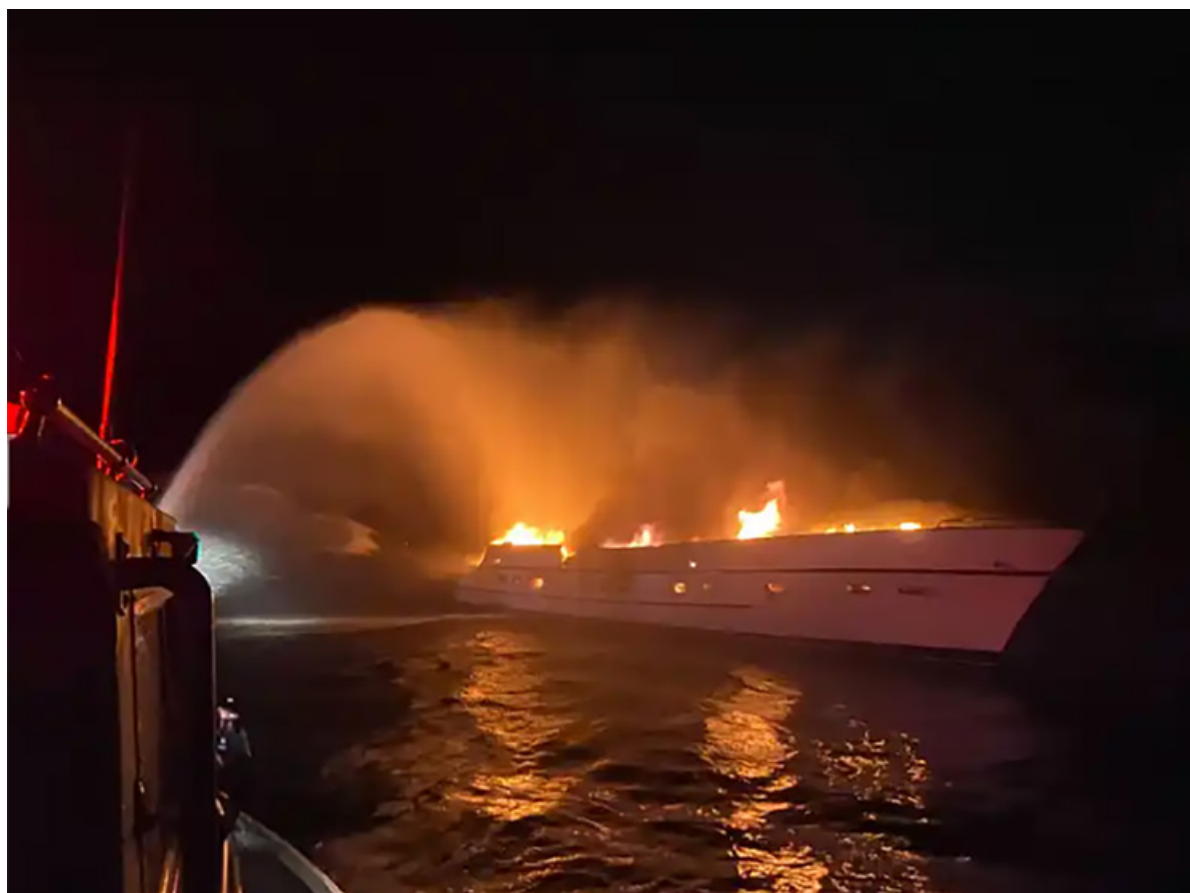
Savage during firefighting efforts. SOURCE: VIRGINIA BEACH FIRE DEPARTMENT VIA COAST GUARD.

Potential ignition sources include the operating diesel propulsion engines and electrical generator, and other equipment. The extensive damage to the vessel precluded examination of components, and, therefore, the exact ignition source could not be determined.

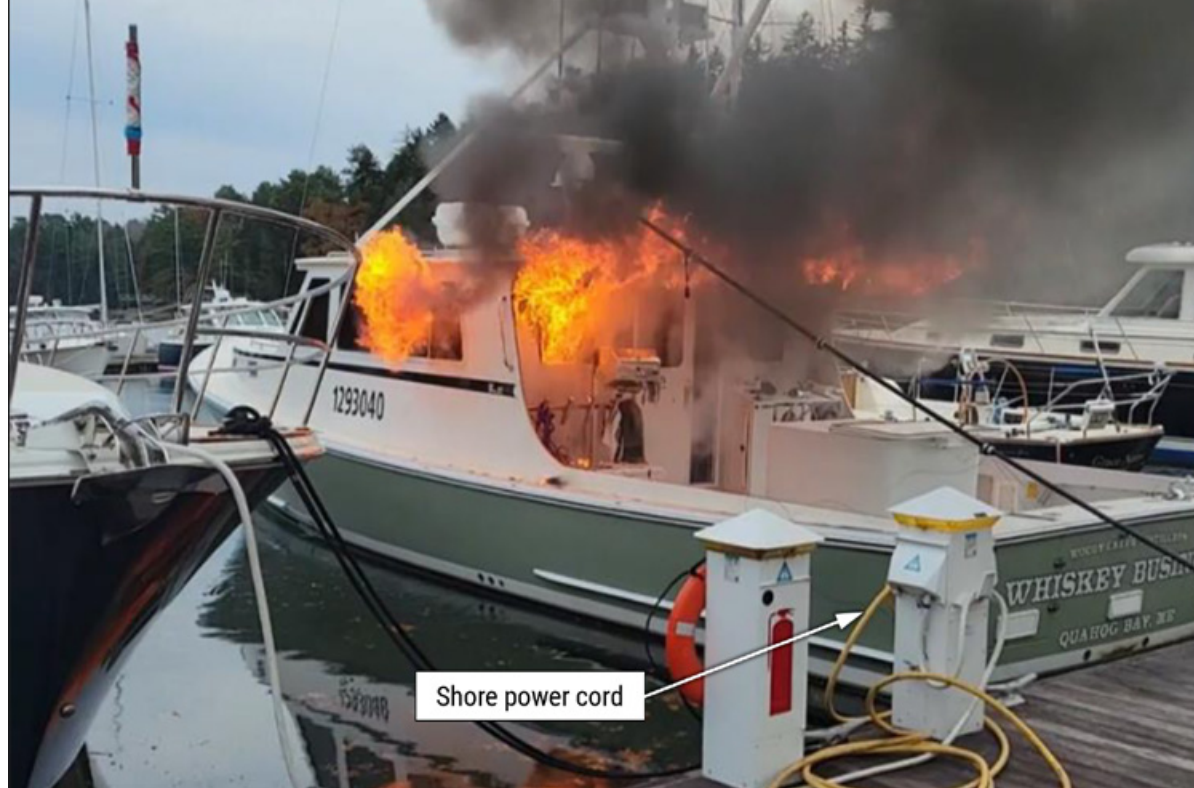
Fire aboard the *Whiskey Business*, about 0918 on November 5, 2024. The shore power cord had been connected from the shore power pedestal to the boat. BACKGROUND SOURCE: MARK LENZI.

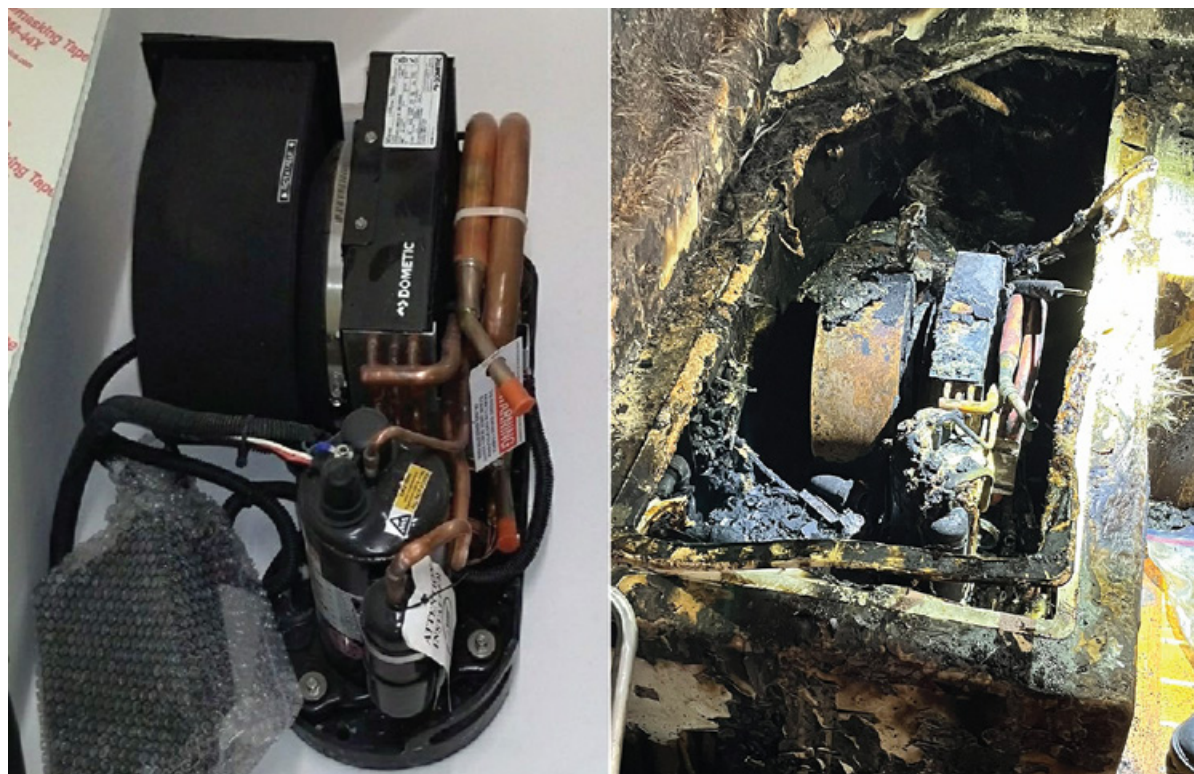
Left to right: Larger soft start control device from damaged air conditioning unit alongside identical forward unit (shown as an exemplar). Smaller soft start control device from damaged air conditioning unit alongside forward unit after fire.

Left to right: Air conditioning unit aboard *Whiskey Business* in 2019 after vessel construction, and same unit after fire. SOURCE (LEFT): *WHISKEY BUSINESS* CAPTAIN.

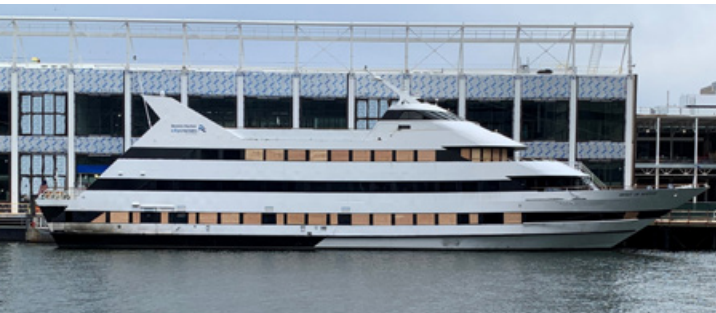
Passenger vessel *Spirit of Boston* after the fire.

On March 24, 2023, about 2252 local time, a fire broke out in the deck 1 wait station on the passenger vessel *Spirit of Boston* while it was moored at the Commonwealth Pier in Boston Harbor, Boston, Massachusetts. All 16 persons aboard evacuated the vessel to the pier. The local fire department responded and extinguished the fire. There were no injuries, and no pollution was reported. Damage to the vessel was estimated at \$3.1 million.

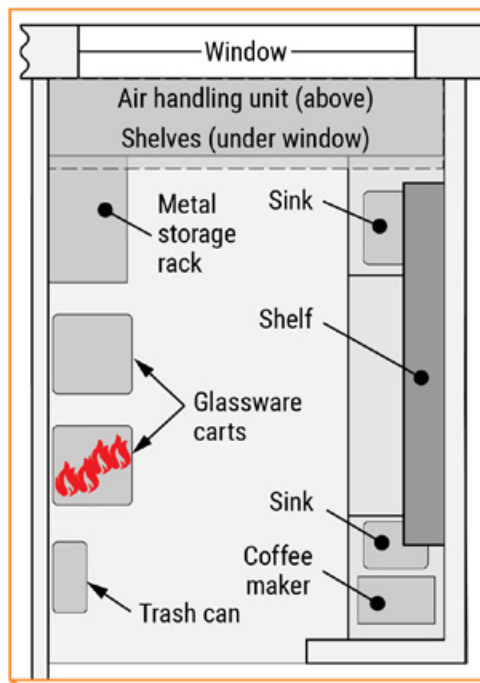
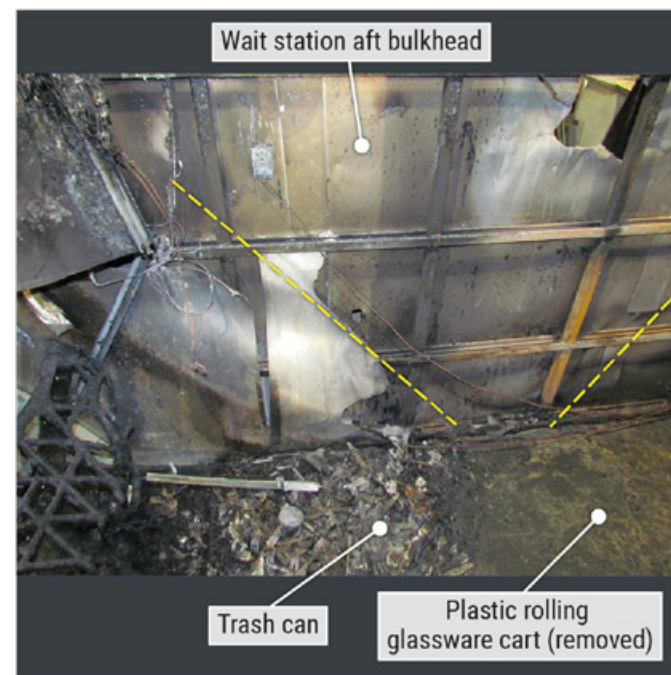
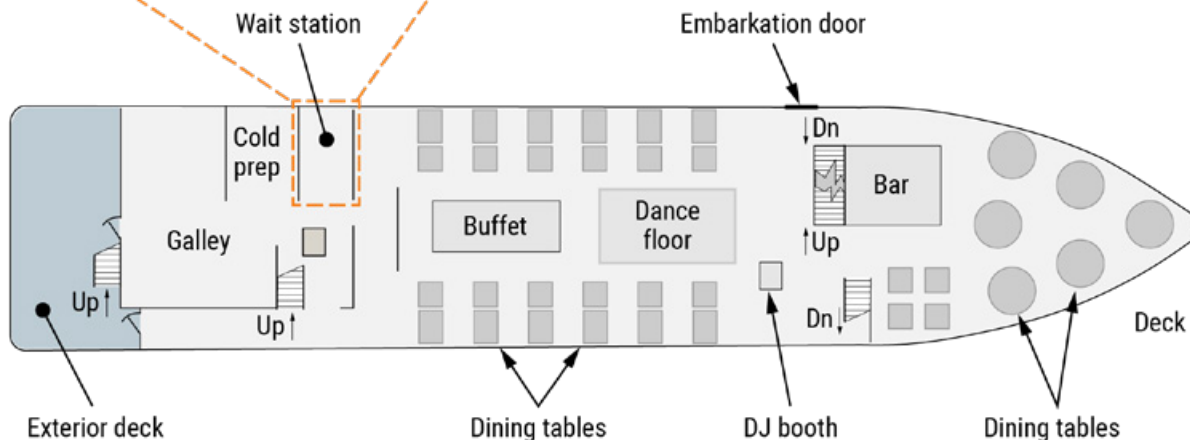
Five minutes later, server assistant 2 entered the deck 1 wait station and saw gray smoke near the wait station's overhead light. She saw "a spark moving around" under one of the two plastic glassware rolling carts in the wait station and notified the senior restaurant manager that "something [was] burning."

The restaurant manager entered the wait station and saw smoke and "a line of fire ... like a snake basically going across the floor." He believed it was coming from under one of the plastic glassware rolling carts. He called (via cell phone) the captain, who did not answer at that time. About the same time, the senior restaurant manager saw sparks under the plastic glassware cart break out into flames.

Plan view of Spirit of Boston deck 1 and detail of the wait station area including approximate location of fire, indicated by a fire symbol, as reported by the restaurant manager (scale approximate). Top right: "V" pattern (shown as yellow dashed lines) as observed by ATF on aft bulkhead of deck 1 wait station near waste trash can and plastic rolling glassware carts. BACKGROUND SOURCE: ATF.

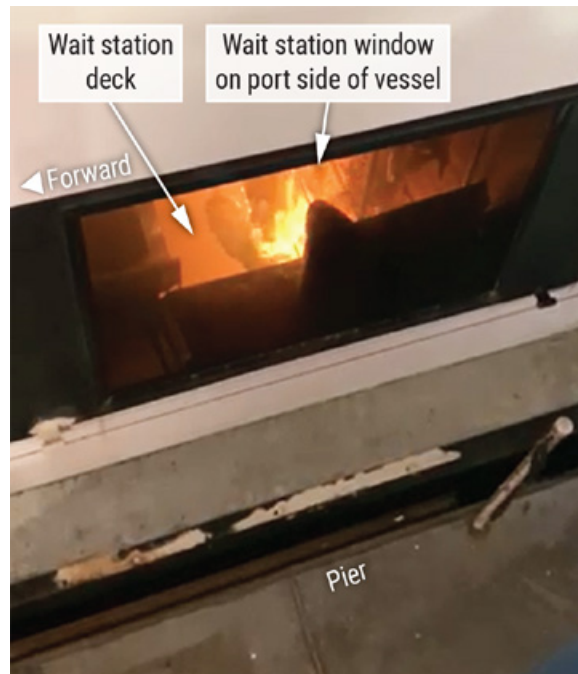
Screenshot from video taken on the pier at 2307, after hospitality staff evacuated the vessel, showing fire in the *Spirit of Boston* wait station as seen through the wait station window.

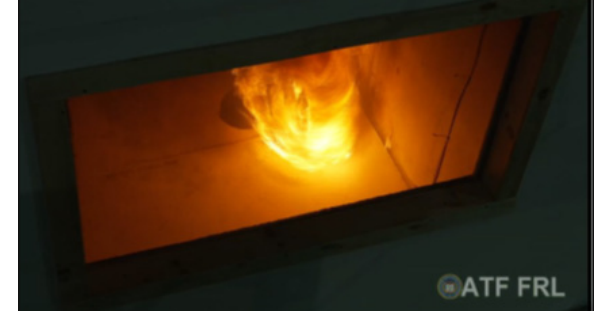
Screenshot of video looking through window of ATF test structure in replicated deck 1 wait station showing flame vectoring and liquified plastic pool (to left of flames) in the area where the plastic glassware rolling cart was located. SOURCE: ATF.

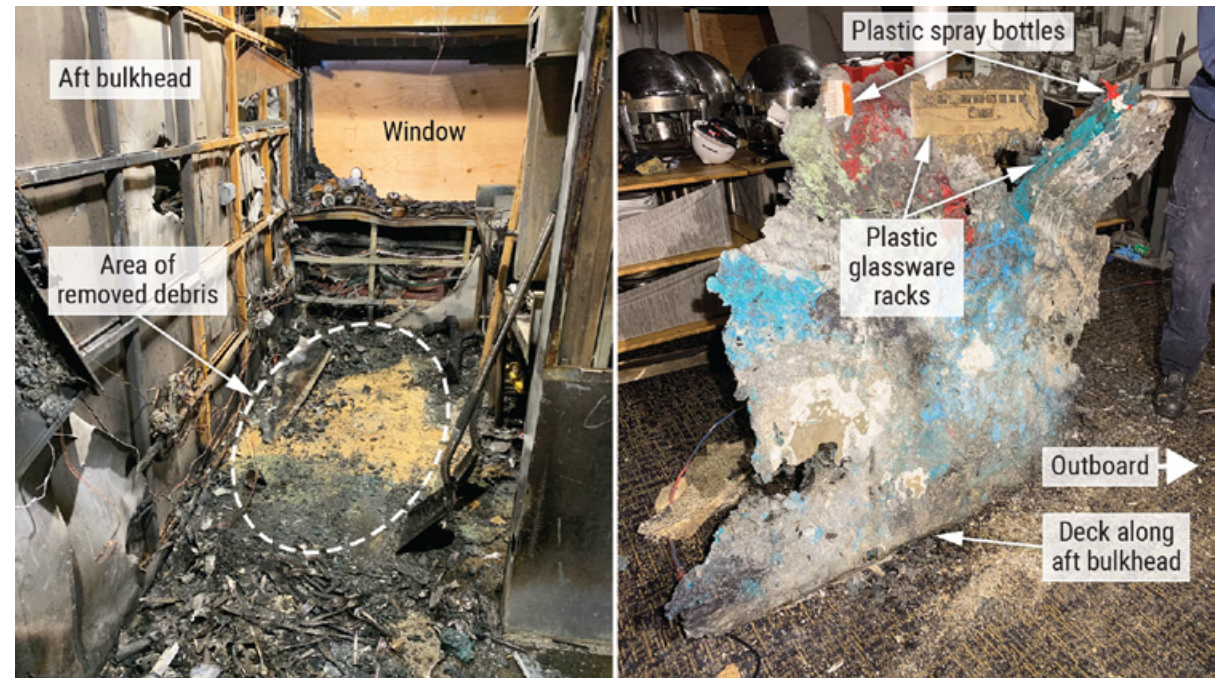
Left to right: Location of the melted mass of debris—comprising the remains of the plastic glassware rolling carts—removed from the deck 1 wait station on *Spirit of Boston* after the fire. Bottom of the melted mass of debris from the wait station after flooring material was removed.

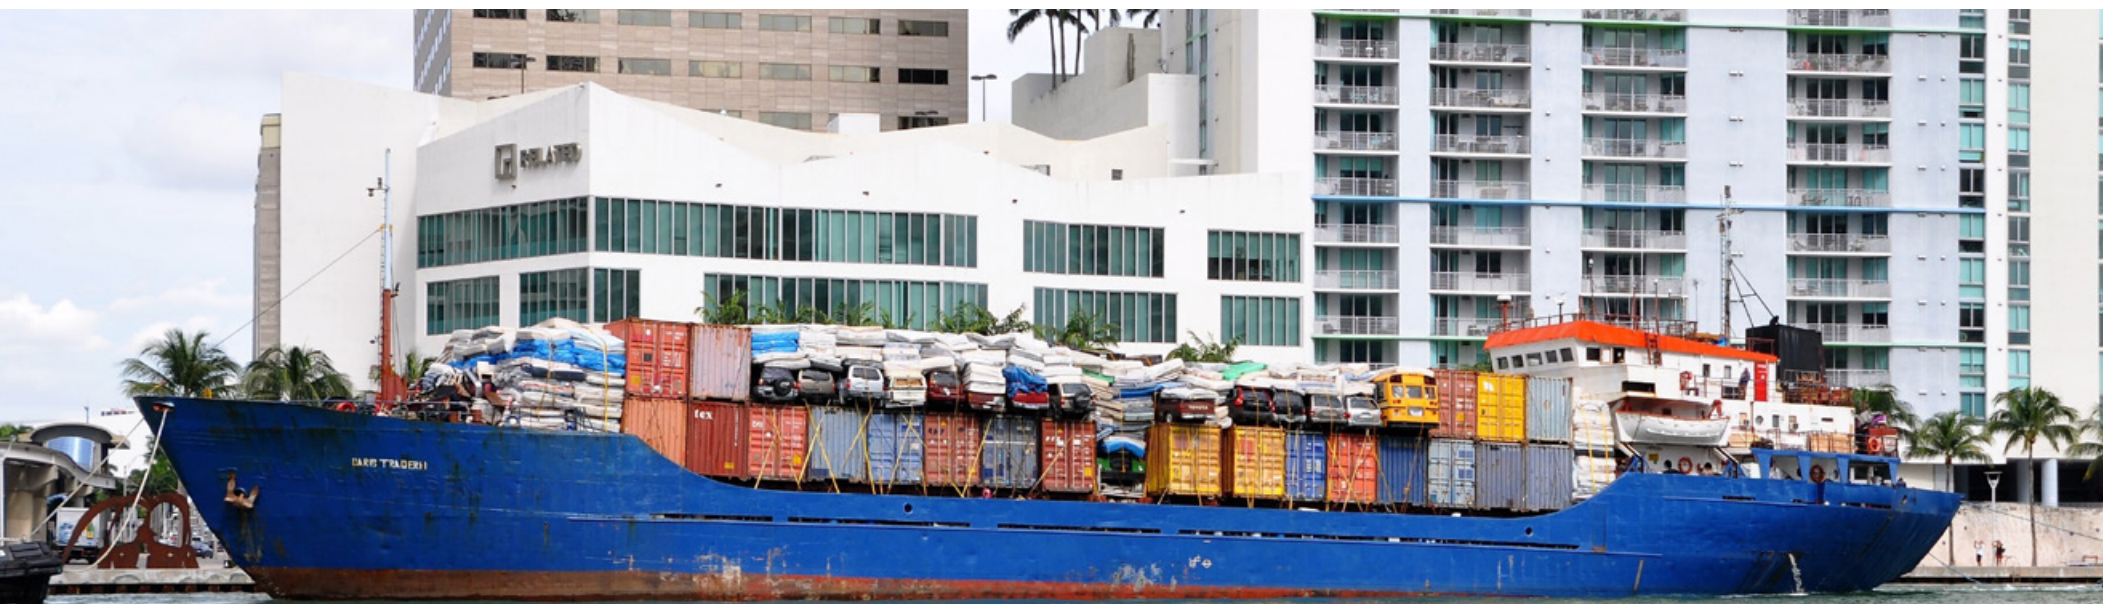
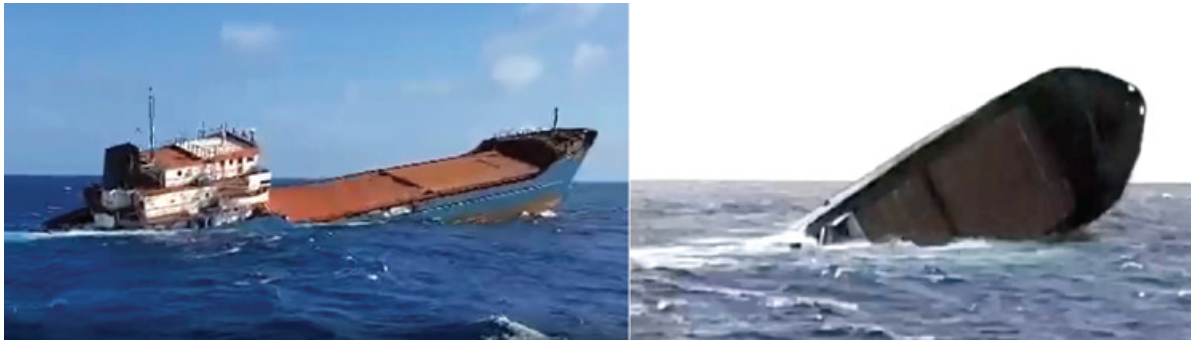
Left to right: *Carib Trader II* while flooding and sinking. SOURCE: CAPT. BEAU CREW.

After sunrise, the captain thought the ship was trimmed by the stern more than it had been when they recovered the tow several hours earlier. At 0720, the mate boarded the *Carib Trader II* and found the engine room flooded, with water above the main engine. The mate was not able to identify the source of the flooding. Because the engine room was found to be flooding rapidly, it is likely that the source of the flooding was below the waterline. Although the mate attempted to dewater with a portable pump prestaged for the dead ship tow, the pump was not able to keep up with the flooding.

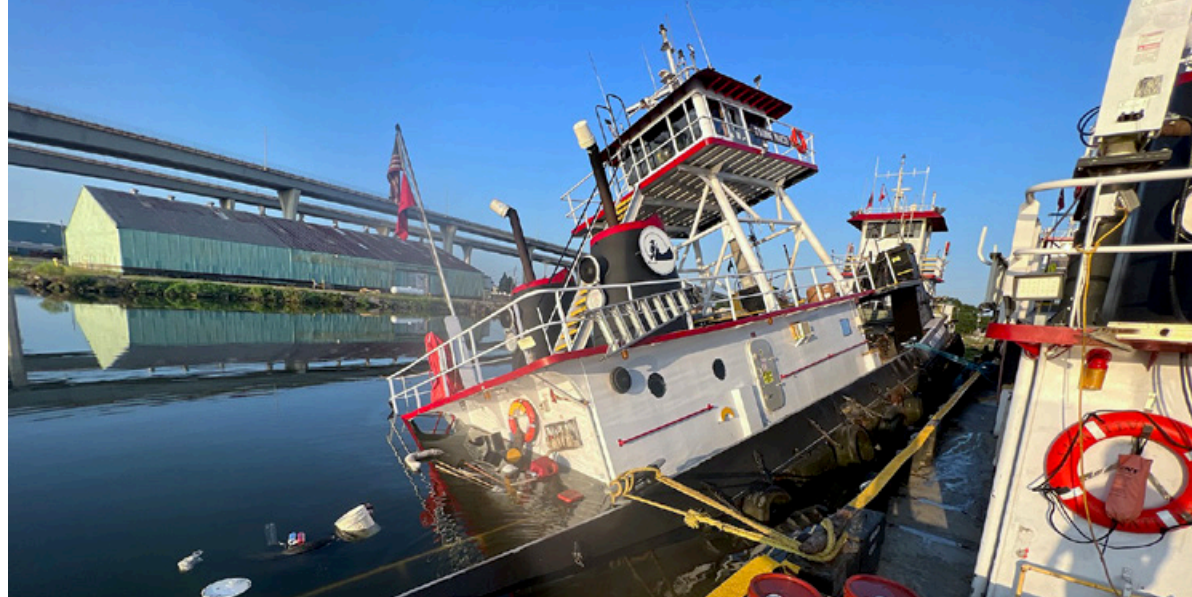
***Joanne Marie* listing at the shipyard on the morning of June 25.** SOURCE: COAST GUARD.

On June 25, 2023, about 0600 local time, the inspected towing vessel *Joanne Marie* was found partially submerged while moored at a shipyard on the Harvey Canal near New Orleans, Louisiana. There were no crewmembers or shipyard workers on board the vessel. An estimated 10 gallons of diesel fuel were released into the water. Damage to the vessel was \$176,751.

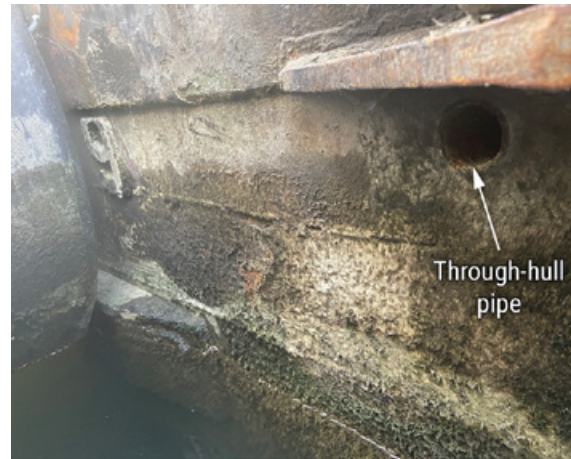
Through-hull pipe

THE PROBABLE CAUSE of the flooding and partial sinking of the *Joanne Marie* was the ingress of water into the engine room through a through-hull pipe located near the waterline due to an obstructed spring-loaded check valve on a cofferdam bilge pump discharge. Contributing to the sinking were inadequate procedures for securing unattended vessels.

Joanne Marie through-hull pipe for the cofferdam pumps' overboard discharge on the port quarter shown postcasualty.

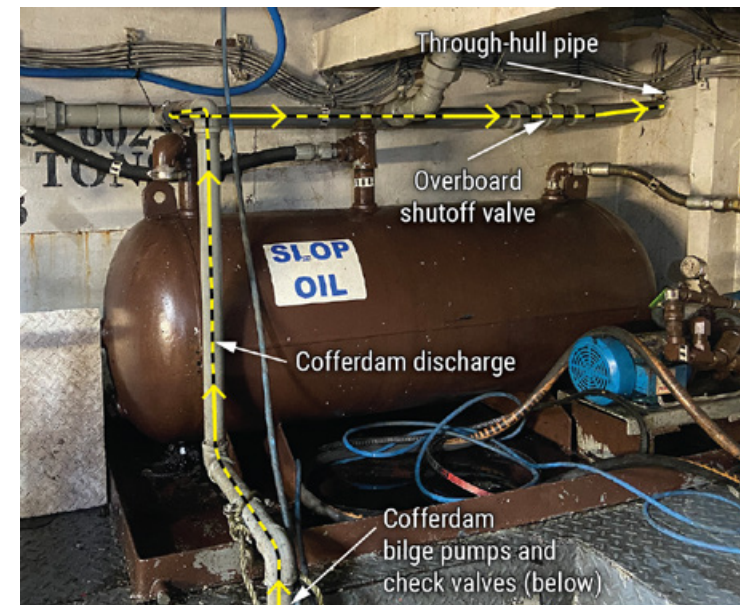
Joanne Marie cofferdam discharge system (facing aft). BACKGROUND SOURCE: COAST GUARD.

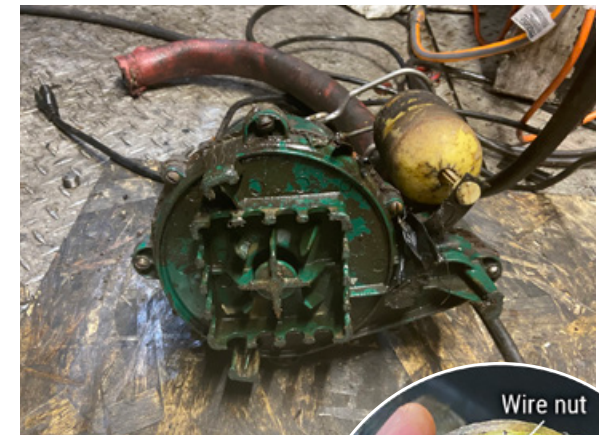
Cofferdam bilge pump with inlet shown with strainer removed. Inset shows associated spring-loaded check valve shown with lodged wire nut.

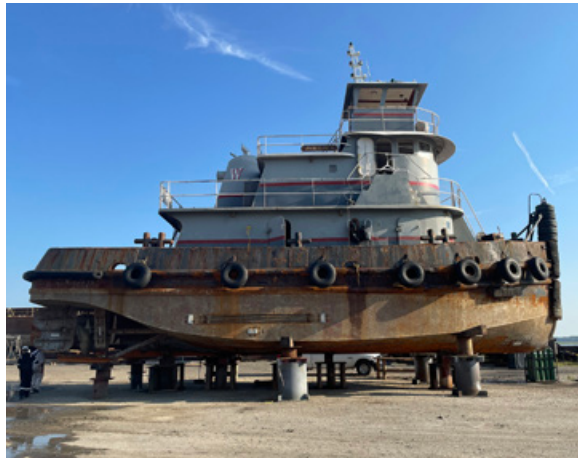
Jacqueline A following salvage after the sinking.

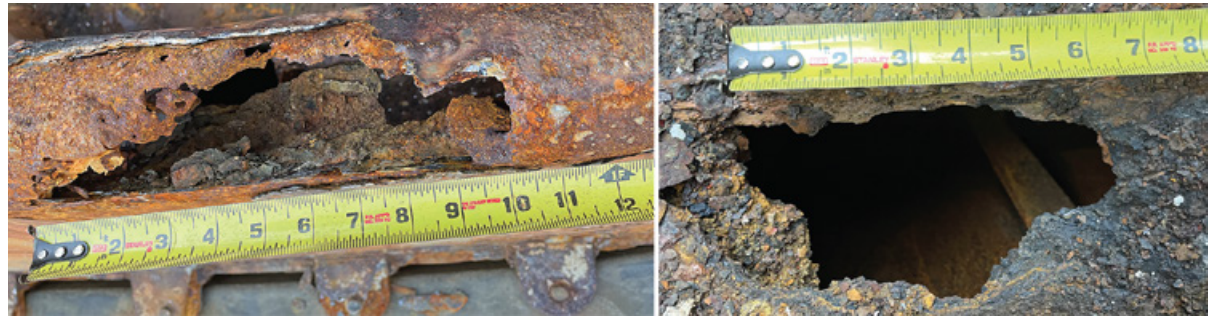
The vessel's stern sank first, with the bow remaining above the water for a period of time, indicating the flooding originated in the aft portion of the vessel. After the vessel was salvaged, investigators found several large wastage holes in the main deck plating above the lazarette within the voids formed by the enclosed bulwark on the main deck. The bulwarks on the *Jacqueline A* had been modified by adding plating to the inboard side of the bulwark frames, creating small void spaces within the bulwarks. The

voids were inaccessible spaces in which corrosion cells developed and eventually progressed into large wastage holes. Wastage holes were also found on the top and outboard side plating of the bulwarks.

THE PROBABLE CAUSE of the flooding and sinking of the towing vessel *Jacqueline A* was a lack of watertight integrity due to the poor material condition of the vessel's bulwarks and main deck plating, which allowed water to ingress through wastage holes into the lazarette, and unsealed penetrations in transverse bulkheads, which led to progressive flooding forward into the engine room. Contributing to the sinking was the lack of a high-water bilge sensor in the lazarette, which prevented early detection of flooding into the space.

Left to right: Wastage holes on top rail of portside aft bulwarks and in main deck above lazarette within enclosed bulwarks.

Inaccessible voids or difficult to reach pockets or crevices that are poorly ventilated and provide no access for maintenance pose a risk to vessels due to the potential for severe rusting/corrosion. Because these spaces are inaccessible, corrosion can grow undetected. Operators and manufacturers should keep these risks in mind when designing, constructing, or modifying a vessel. Ensuring all spaces are accessible enables maintenance personnel to check for and remediate any potential hazards, such as corrosion.

For the safety of a vessel and all on board, the integrity of the hull and watertight bulkheads must be maintained, and any deficiencies must be appropriately addressed. Known issues with watertight integrity, including unsealed watertight bulkhead and deck penetrations and deck and hull plate wastage, need to be addressed by permanent means. The Coast Guard advises, "Ensure electrical cables and conduits, piping runs, remote valve actuators, and other components that penetrate watertight bulkheads, decks, and compartments are inspected frequently and properly maintained. Each may have a unique sealing method involving glands with packing assemblies, penetration seals, or other methods. Frequent inspection and proper maintenance of these various fittings and assemblies will assist in minimizing the possibility of progressive flooding."

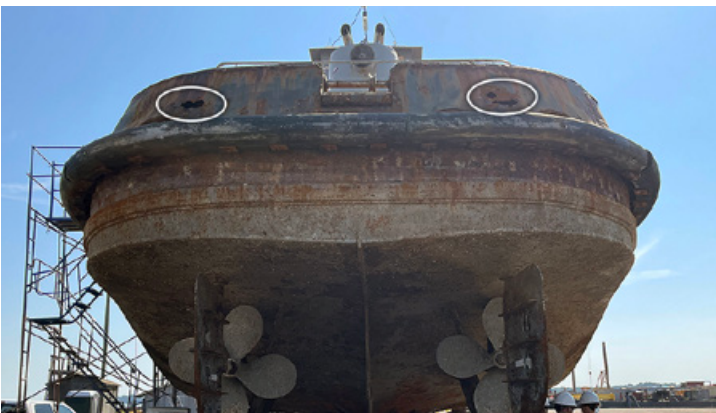
Wastage holes (circled) on outboard plating of stern bulwarks.

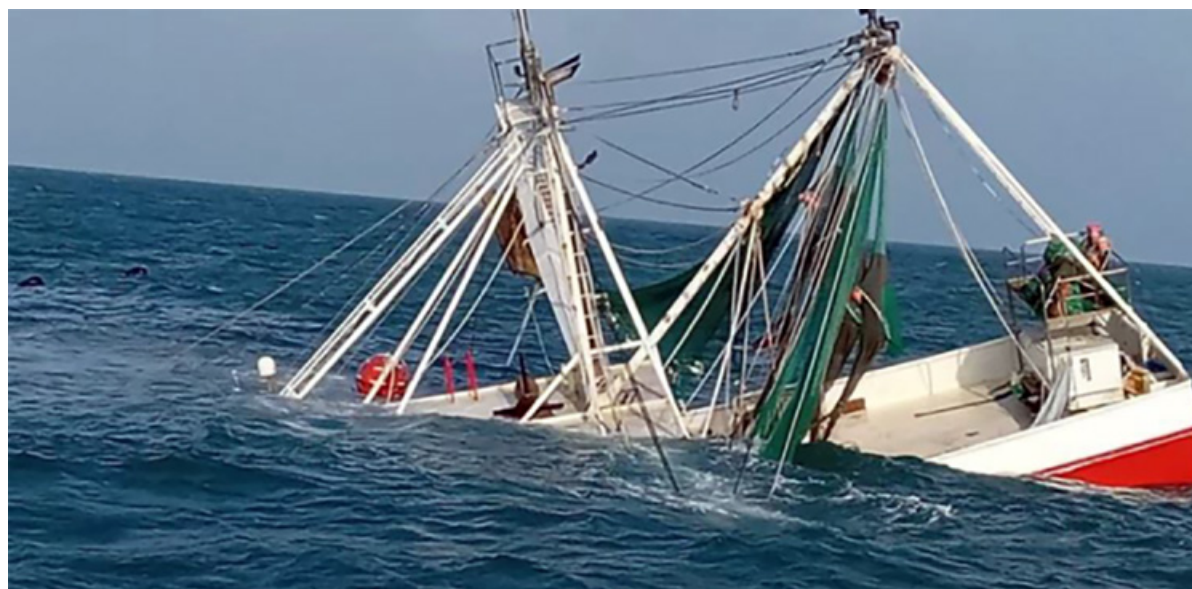
Christian G sinking in the Gulf of America on October 4, 2023. SOURCE: CREW OF THE *CHRISTIAN G*.

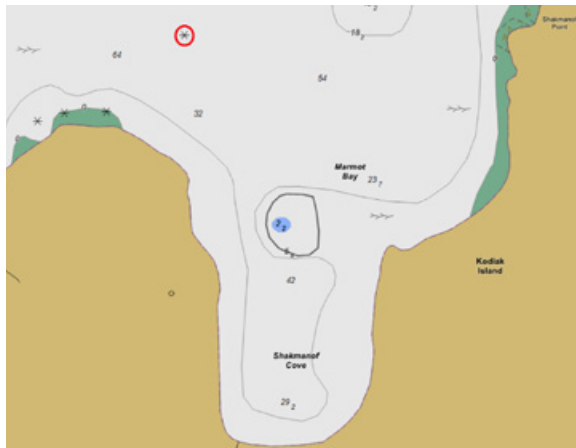
Although the rock was charted on the ENC, the captain did not notice the asterisk marking the rock's location. Because ENCs are customizable based on vessel characteristics and user settings, investigators were unable to determine precisely how the information was presented to the captain when he was planning

the ATB's route. However, when investigators viewed the area on an equivalent ECS, the asterisk marking the rock was displayed alongside soundings of similar size and color, so it is possible that the captain mistook the asterisk for a depth sounding or other chart information when plotting and reviewing the route. The vessel had a copy of the *United States Coast Pilot* for the area, which called out the rock's location, on board. However, the captain did not reference it and relied on the ENC when planning and reviewing the route. Using other available resources, such as the *Coast Pilot*, would have helped the captain in identifying the rock when planning and reviewing the route.

ENC US4AK5PM, for the area near Shakmanof Cove, as viewed by investigators using an equivalent ECS. The asterisk symbol for the rock in the area of the grounding is indicated by a red circle. BACKGROUND SOURCE: NOAA ENC AS VIEWED ON ROSE POINT ECS.

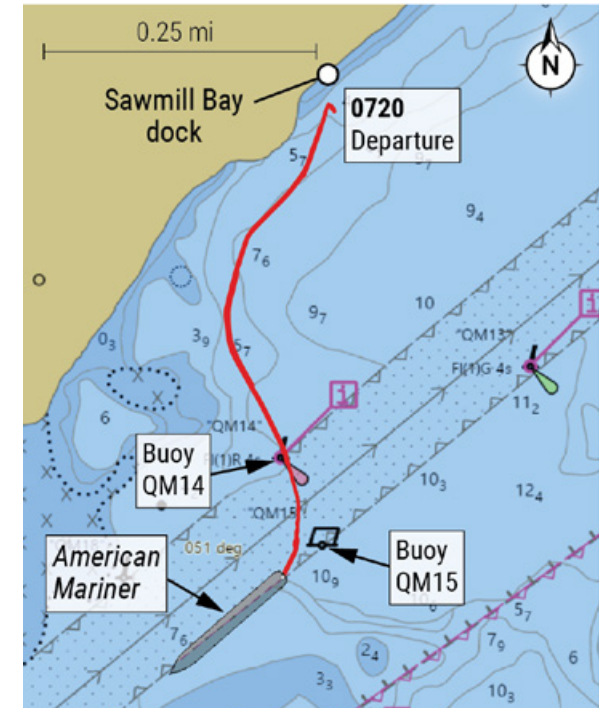
While the master was maneuvering the vessel into the Vidal Shoals Channel, crewmembers reported a sound and "shudder;" they then discovered that one of the vessel's ballast tanks appeared to be communicating with the lake, and therefore was likely damaged. Although the master stated the ship was in the channel, the shoals were located immediately outside the buoyed channel, and the AIS data from that time showed the vessel on the far (southeast) side of the channel.

***American Mariner's* AIS path after it left the facility, in relation to the buoys, channel, and shoal water (final vessel position shown is at 0730:55). Soundings are in meters; shoal water is indicated with darker blue. BACKGROUND SOURCE: NOAA ENC US4MI2QU AS VIEWED ON MADE SMART AIS.**

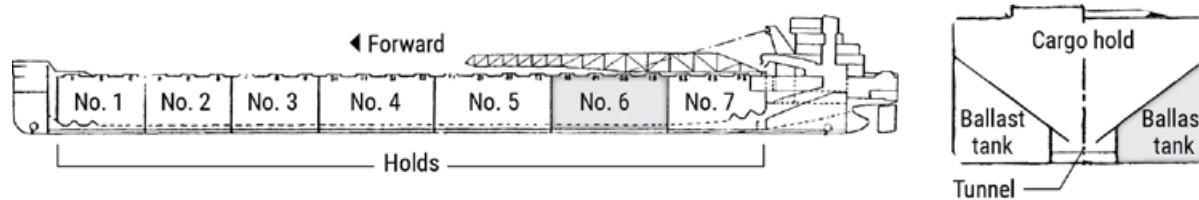
Left to right: Inboard profile drawing of *American Mariner*. Section drawing showing the vessel's no. 6P ballast tank (highlighted), where the engineers detected flooding, in relation to the cargo hold, void, and fore and aft tunnel. BACKGROUND SOURCE: GRAND RIVER NAVIGATION.

The vessel proceeded to a shipyard in Superior, Wisconsin, where it was drydocked, and damage to three ballast tanks at the bilge chine along the port side was found—including breaches of the hull to hold no. 6. Given the crew reports, damage to the port chine and bottom plating, and the vessel's position at the southeast edge of the channel, the *American Mariner* grounded on Vidal Shoals at the edge of the channel.

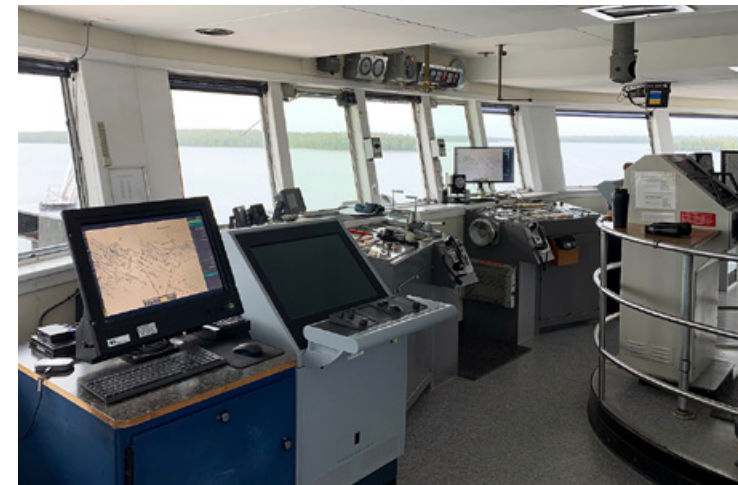
THE PROBABLE CAUSE of the grounding of the bulk carrier *American Mariner* was the master maneuvering the vessel away from the dock and into the channel while alone on the bridge, which required him to multitask (navigation, steering, and lookout duties) and resulted in the vessel overshooting the turn into the channel and running aground on the shoals on the opposite side of the channel.

***American Mariner*'s bridge and centerline conning station.** SOURCE: COAST GUARD.

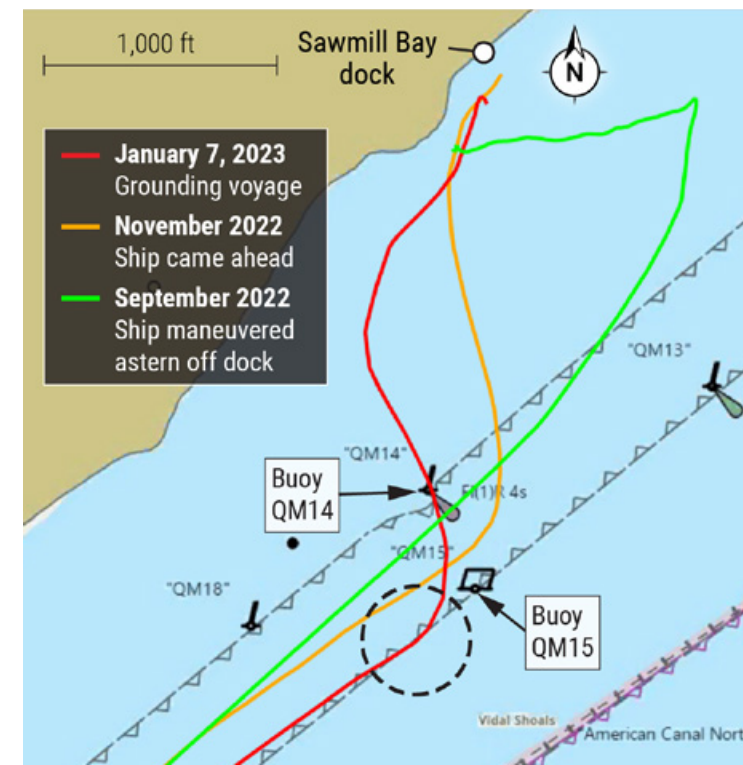
AIS tracklines of the *American Mariner* navigating into the channel from the facility. The area where the vessel's course took it near the edge of the channel is circled with dashes. BACKGROUND SOURCE: NOAA ENC US4MI2QU AS VIEWED ON MADE SMART AIS.

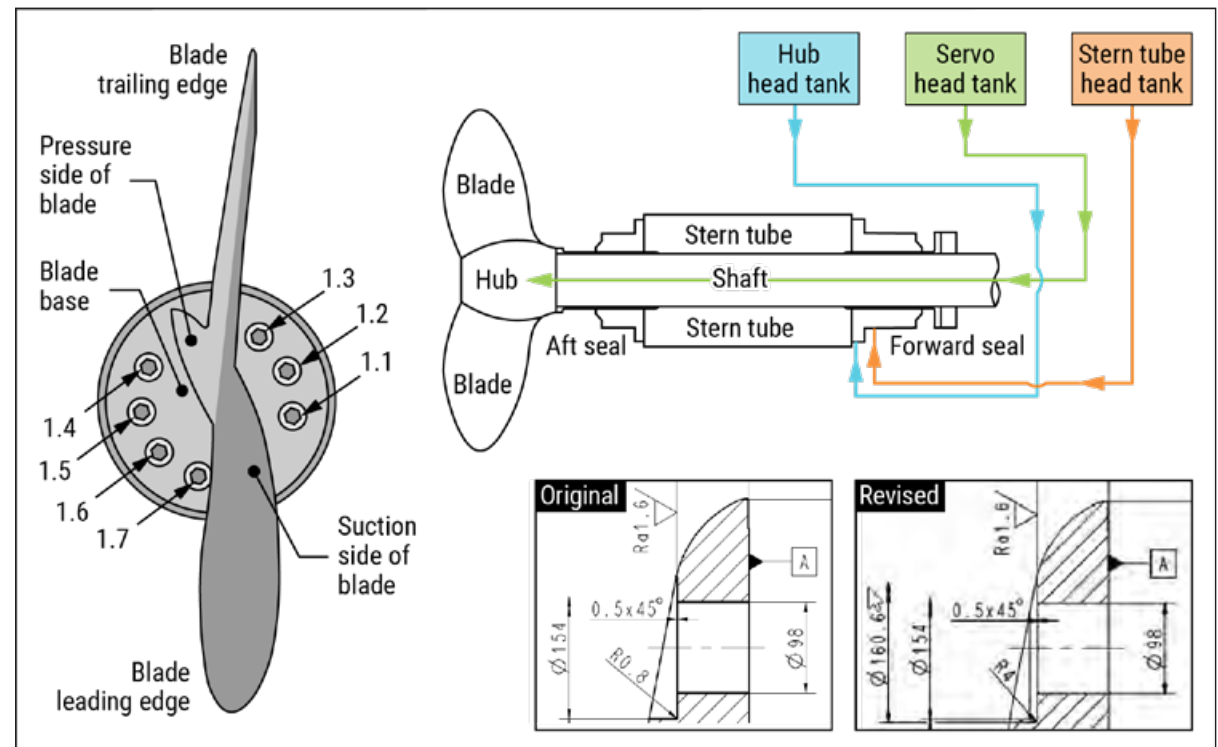
Postcasualty testing completed by a third-party company found that the cracks and fractures on the no. 4 blade base initiated at the bolt hole counterbore radius and were consistent with progressive cracking due to high cycle fatigue. The company also found that the bolt hole counterbore radius did not meet manufacturer machining requirements (the radius was about 0.2 millimeters smaller than the required 0.8 millimeters). Additionally, the no. 4 blade did not meet other manufacturer design specifications, such as material specifications for Charpy impact toughness—which measures the material's tendency to resist breaking when subjected to a sudden shock—tensile strength, yield strength, or percent elongation. Lastly, the chemical composition of the blade did not meet compositional requirements (the silicon content exceeded the specified minimum). Propeller blades require adherence to specified engineering design, material selection, and manufacturing requirements to maintain optimum performance and extend fatigue life. Because the no. 4 blade did not meet manufacturer design specifications, it was more susceptible to high cycle fatigue, which resulted in the development of cracks and fractures in the blade base. As a result of the *Maunalei's* loss of propulsion, the CPP blade manufacturer revised the internal radius requirement—enlarging it—for all seven bolt hole counterbores to improve fatigue fracture resistance.

THE PROBABLE CAUSE of the loss of propulsion on the containership *Maunalei* was a crack developing in a controllable pitch propeller blade base and progressing into a fracture due to high cycle fatigue as a result of the blade not meeting manufacturer design specifications.

Maunalei propeller blade no. 1 bolt positions and simplified schematic of hydraulic oil system head tanks for CPP system. Insets show CPP blade original and revised machining drawings reflecting the increased internal radius required for the bolt holes. INSET SOURCE: MAN ENERGY SOLUTIONS.
