NATIONAL
TRANSPORTATION
SAFETY
BOARD

HIGHWAY ACCIDENT REPORT

COLLAPSE OF THE
NORTHBOUND U.S. ROUTE 51 BRIDGE SPANS
OVER THE HATCHIE RIVER
NEAR COVINGTON, TENNESSEE
APRIL 1, 1989

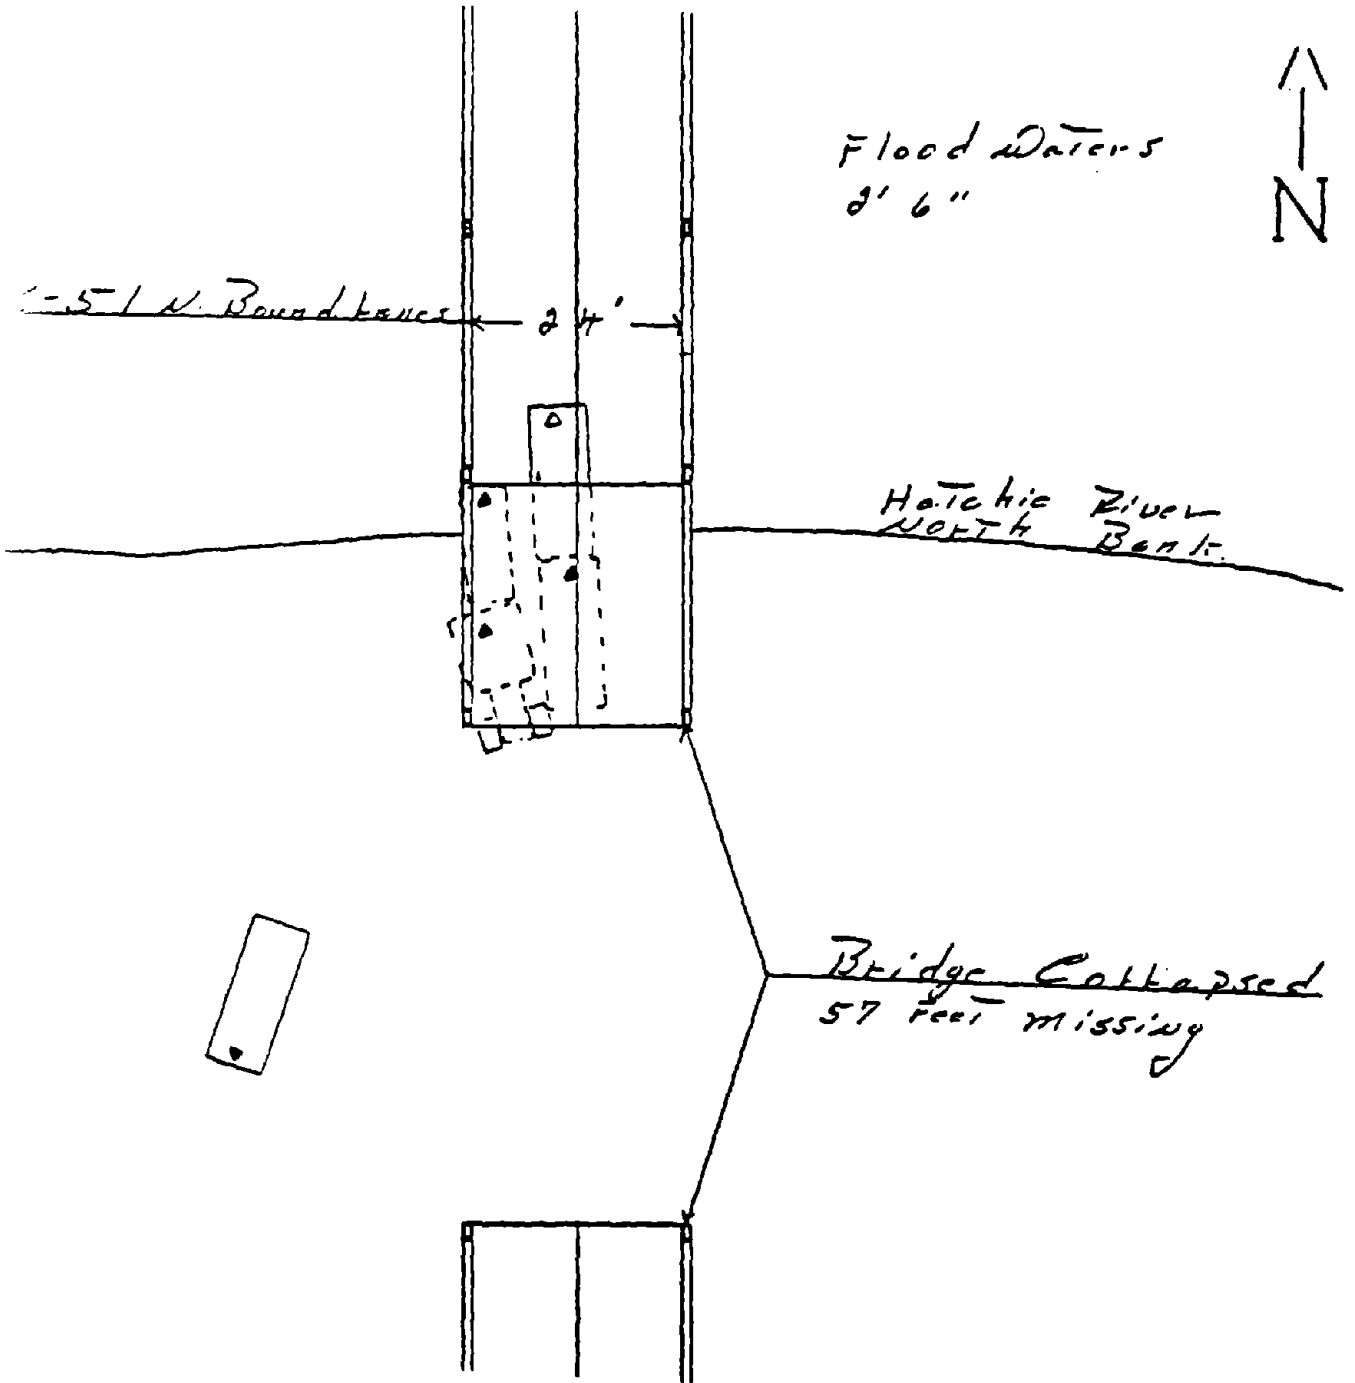
Courtesy of the
Tennessee Highway Patrol

E. 1990 International Series 8300 3-axle tractor, red, in combination with a 1978 Great Dane 2-axle 45-foot box trailer loaded with major kitchen appliances.

A post mortem examination of the 49 year old male driver of this vehicle revealed that the probable cause of death was " multiple severe injuries, including massive head injuries." According to the THP, this victim was found unrestrained in the drivers seat of his vehicle.
