Highway Investigation Report HIR-25-02

# Collision of Motorcoach with Combination Vehicles Parked Along Exit Ramp to I-70 Rest Area

Highland, Illinois  
July 12, 2023

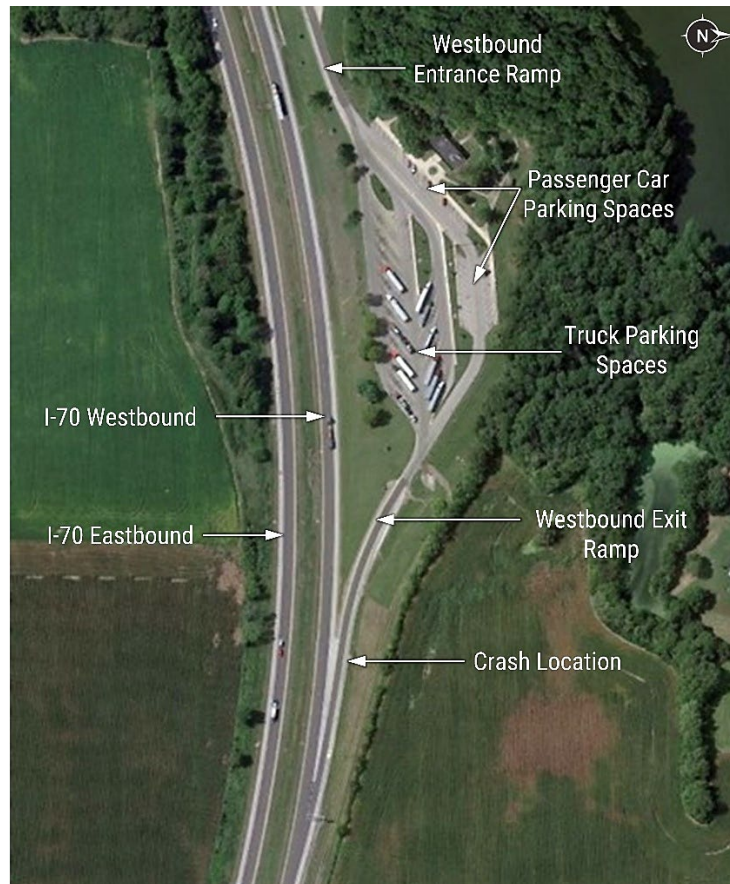
**Figure 1.** Aerial photo of the westbound Silver Lake Rest Area, including the exit and entrance ramps, truck parking spaces, passenger car parking spaces, and crash location relative to I-70. (Source: Google Earth; annotations by NTSB)

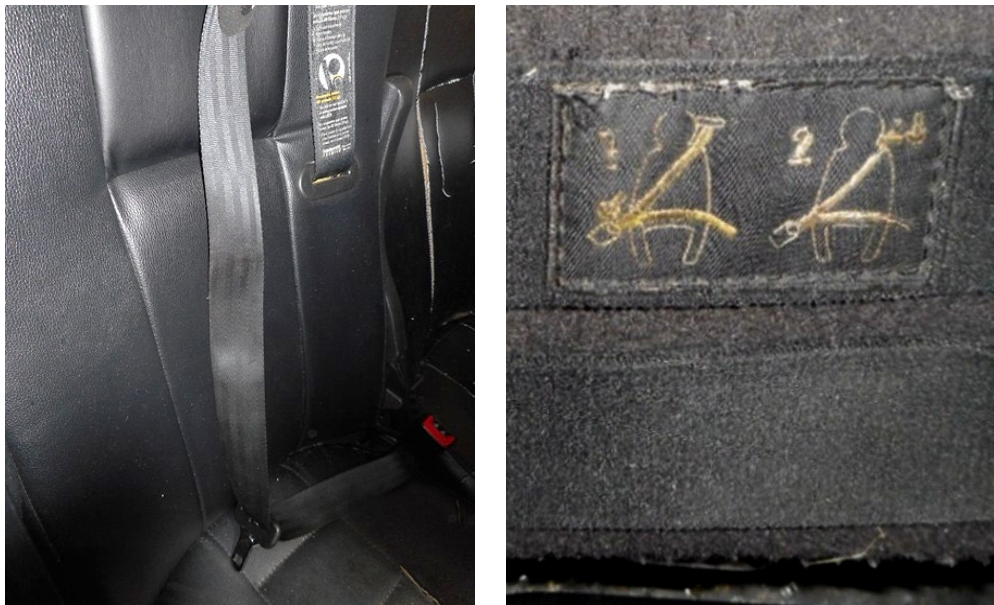
The motorcoach had 13 rows of two-person seats on the left side and 12 rows of two-person seats on the right side forward of the lavatory. All 50 passenger seats were equipped with lap/shoulder belts. The NTSB examined the seat belts postcrash and determined that they all functioned properly and were accessible to passengers. The shoulder portion of the seat belts was equipped with a height adjuster on the outboard portion of each seatback. Labels reminding passengers to wear the seat belt were stitched into the base of most seatbacks, with at least one label visible in each two-person seating area. The labels illustrated the two-step process for fastening the seat belts: first, putting the belt on, and second, using the shoulder height adjuster so that the shoulder belt was adjusted to the top of the occupant's shoulder (figure 4).

**Figure 4.** Left, lap/shoulder belt for motorcoach passenger use; right, label stitched onto the back of passenger seats, illustrating the two-step process, visible to passengers seated behind this seat, for fastening the seat belt.

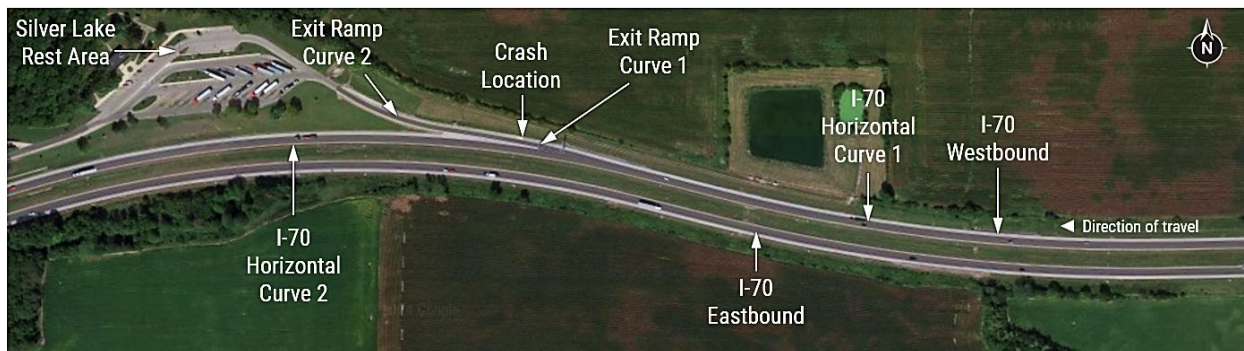
The NTSB documented four horizontal curves, located ahead of and after the crash location: two curves on I-70 and two curves on the westbound rest area exit ramp.<sup>9</sup> The curve sequence is shown in figure 5.

**Figure 5.** Horizontal curves on I-70 and the exit ramp to westbound Silver Lake Rest Area before and after the crash location. (Source: Google Earth; annotations by NTSB)

The I-70 road geometry may explain how the fatigued motorcoach driver could follow the exit ramp instead of staying on I-70. Just before the exit ramp, I-70 makes a horizontal curve to drivers' right. The travel lanes of I-70 continue past the exit ramp to the rest area, curving back to the driver's left; however, continuing straight will take a vehicle onto the exit ramp to the rest area. The motorcoach driver successfully navigated the first curve, but failed to follow the second, instead proceeding straight and onto the offramp (both horizontal curves were noted in figure 5). Figure 18 shows an overhead photo of the crash location, facing east, toward the direction of the motorcoach's travel. The crash site is located immediately after exit ramp curve 1, as shown in figure 18, which the motorcoach driver also failed to navigate, leaving the exit ramp travel lane onto the paved shoulder where the combination vehicles were parked. The illuminated parking lights may have resembled highway traffic, particularly if the driver had lapses in attention due to his fatigued state. The NTSB concludes that the crash dynamics, failure to navigate the roadway geometry, and passenger statements are consistent with a fatigued motorcoach driver.

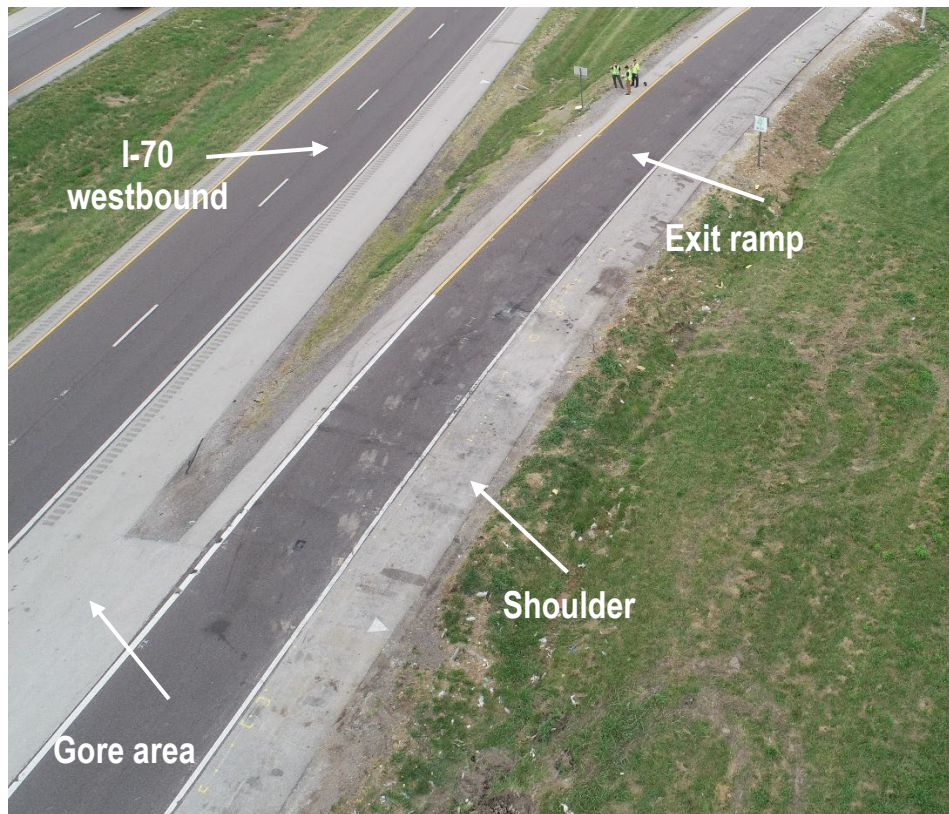
At the exit ramp, a gore area separates the westbound travel lanes from the approximately 14-foot-wide exit ramp.<sup>10</sup> The right shoulder of the exit ramp is about 9 feet wide. Near the crash location, the highway marking separating the exit ramp to the westbound Silver Lake Rest Area from the right paved shoulder consists of a 6-inch-wide solid white line. The highway marking separating the exit ramp from the gore area consists of an 8-inch-wide solid white line that is reflective. Figure 6 shows an overhead view of the exit ramp and travel lanes.

**Figure 6.** Overhead photo of the Silver Lake Rest Area exit ramp, noting the main roadway, gore area, and shoulder.

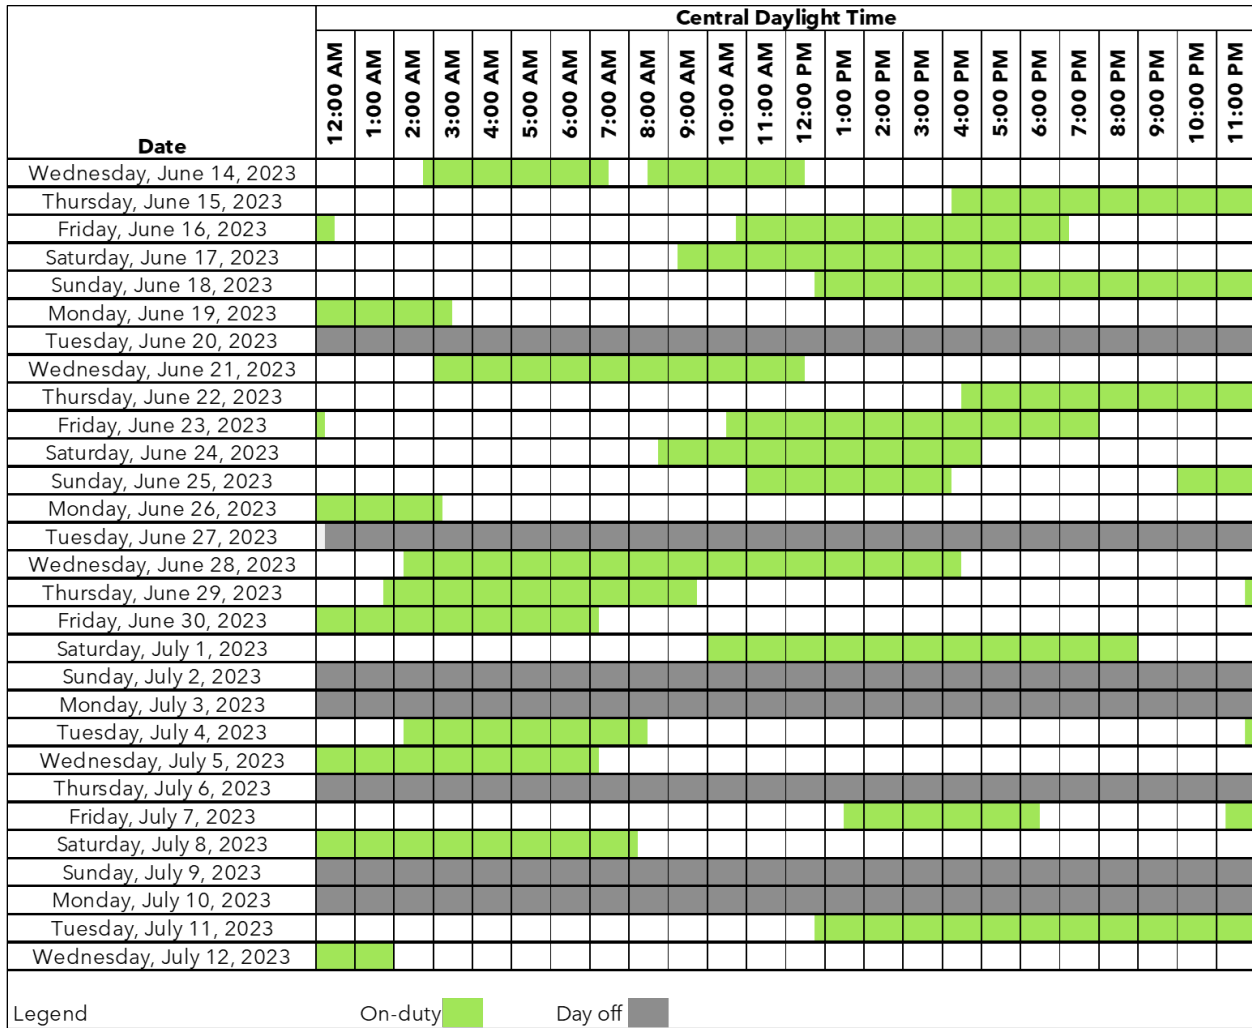
Figure 15 summarizes the motorcoach driver's on- and off-duty status for the month before the crash. The driver logs showed that he had a shift work schedule in which he would shift between the three assigned routes and would go on duty at any time during a 24-hour period.<sup>26</sup> His off-duty time and days off would also vary from week to week.

**Figure 15.** Approximate on-duty times for the motorcoach driver, in 15-minute increments, during the month before the crash. Increments shorter than 15 minutes are not shown.

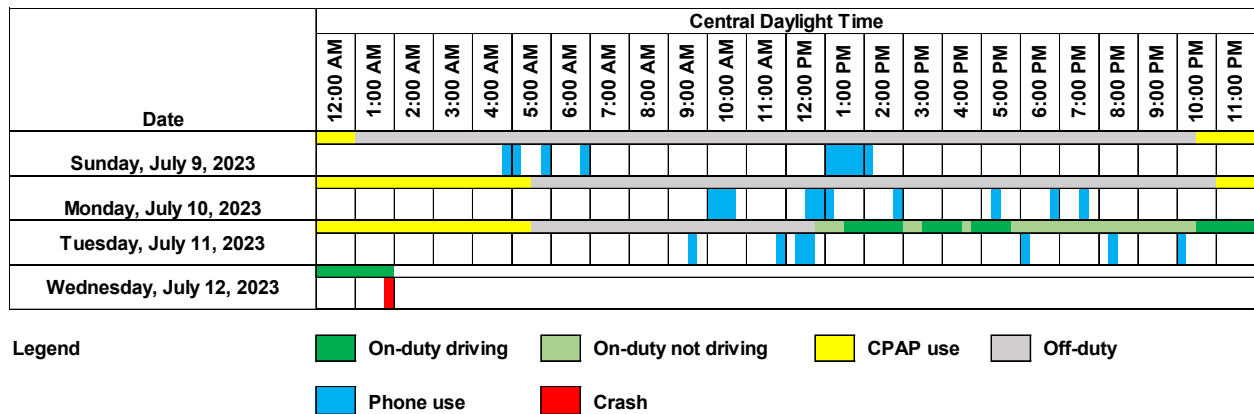
According to the motorcoach driver’s ELD data, he was off duty on July 9-10, 2023. Based on review of the times he used his prescribed continuous positive airway pressure (CPAP) device and his cell phone activity, he returned to a schedule during his off-duty time of being active during the day and sleeping at night (see figure 16).<sup>27</sup> Figure 16 also includes annotations of his CPAP use as recorded by the CPAP

**Figure 16.** Times when the motorcoach driver used his personal or work phone (including texts, calls, web use, and photos) during the 3 days before the crash. Phone use is based on records and forensic data downloaded from the motorcoach driver’s cell phones. Phone use is shown as a contiguous block if fewer than 15 minutes separated the time between outgoing texts or phone calls. Phone records obtained from Greyhound begin at 4:54 a.m. on July 9, 2023 (phone use after the crash is not shown).

The motorcoach driver had a 4.5-hour layover in Indianapolis on July 11, between 5:54 p.m. and 10:23 p.m. During this time, he could have rested in the Greyhound-provided rest facilities; however, no evidence indicates that he used the breakroom or checked into the provided hotel. All that is known about his activities during that time was that he used his personal phone to make an outgoing call at 6:07 pm; at 8:21 p.m., he downloaded photos from an application, and at 10:09 p.m., he made another outgoing call. Active use of his phone during the layover suggests that he did not rest, and furthermore, as was shown in figure 16, his CPAP records did not show use during his layover period.
