Railroad Investigation Report RIR-26-07

# Canadian Pacific Kansas City Railroad Derailment with Subsequent Hazardous Materials Release and Fire

Bordulac, North Dakota  
July 5, 2024

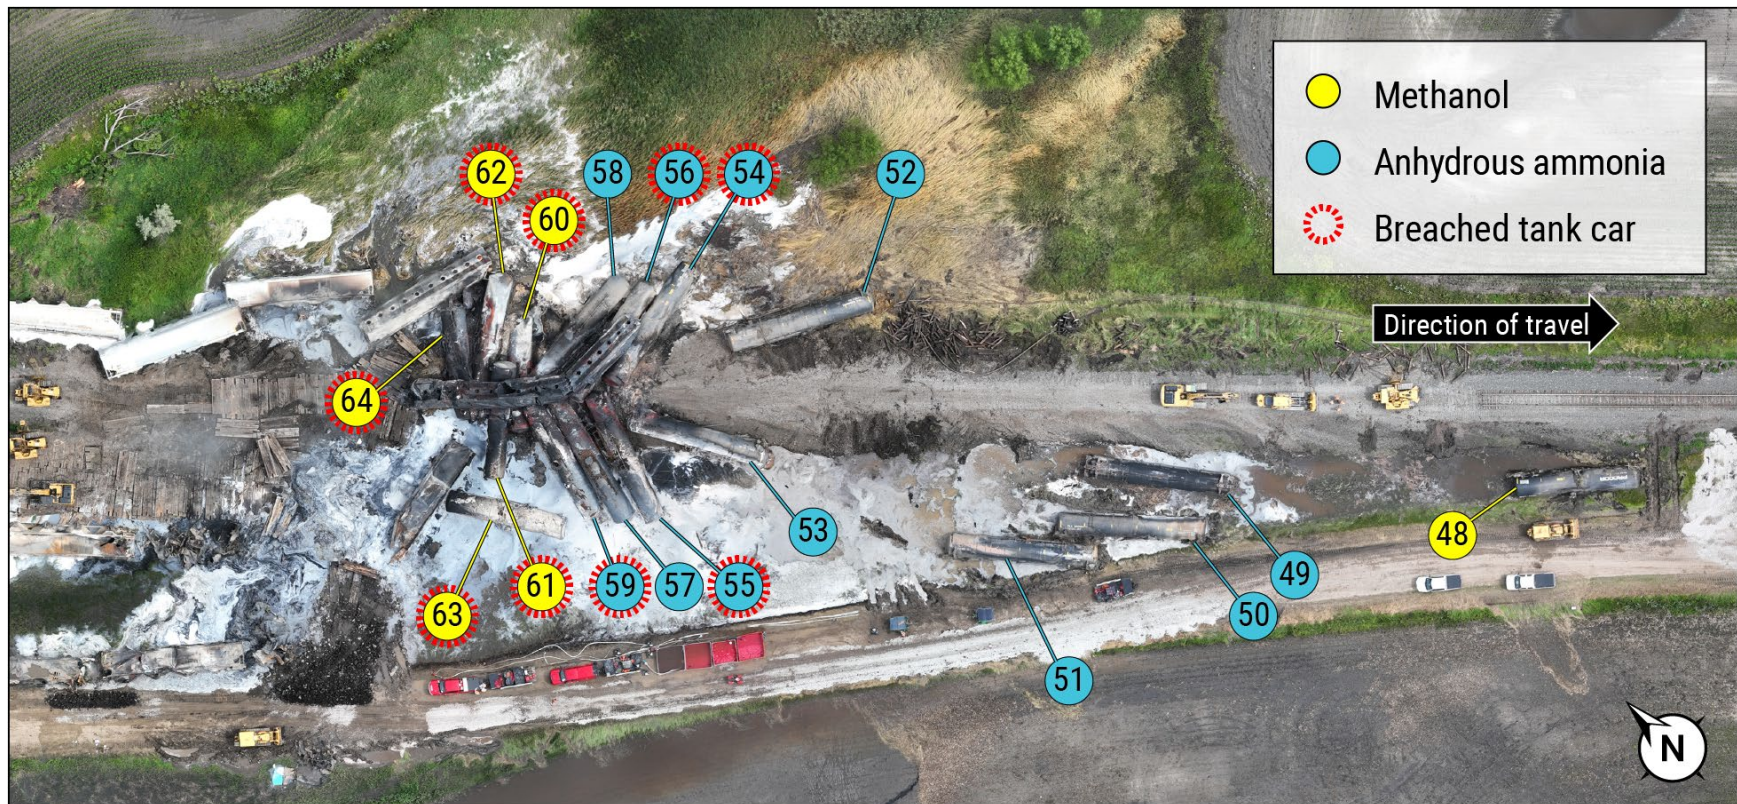
The derailed equipment, all loaded railcars, included 12 covered hopper cars of polypropylene (plastic) pellets, 6 tank cars of methanol, and 11 tank cars of anhydrous ammonia. (See figure 3.) Methanol tank car (48) PROX045220 was the first to derail and came to rest south of the track. Anhydrous ammonia tank cars line 49-59 came to rest in an alternating left-right chevron style.<sup>10</sup> Five methanol tank cars (line 60-64) ran into the derailed anhydrous ammonia tank cars from behind and derailed in an accordion fashion. The final 12 railcars to derail (line 65-76) were the hopper cars carrying plastic pellets; two of these railcars overrode the methanol and anhydrous ammonia tank cars and came to rest on top of them. CPKC estimated that about 122,000 gallons of methanol and 140,000 gallons of anhydrous ammonia were released from the derailed tank cars.<sup>11</sup> (See table 1.)

**Figure 3.** Postderailment positions of derailed railcars in train 242-03. Some of the cars had been moved during emergency response activities. (Source photo: Pinnacle Engineering.)

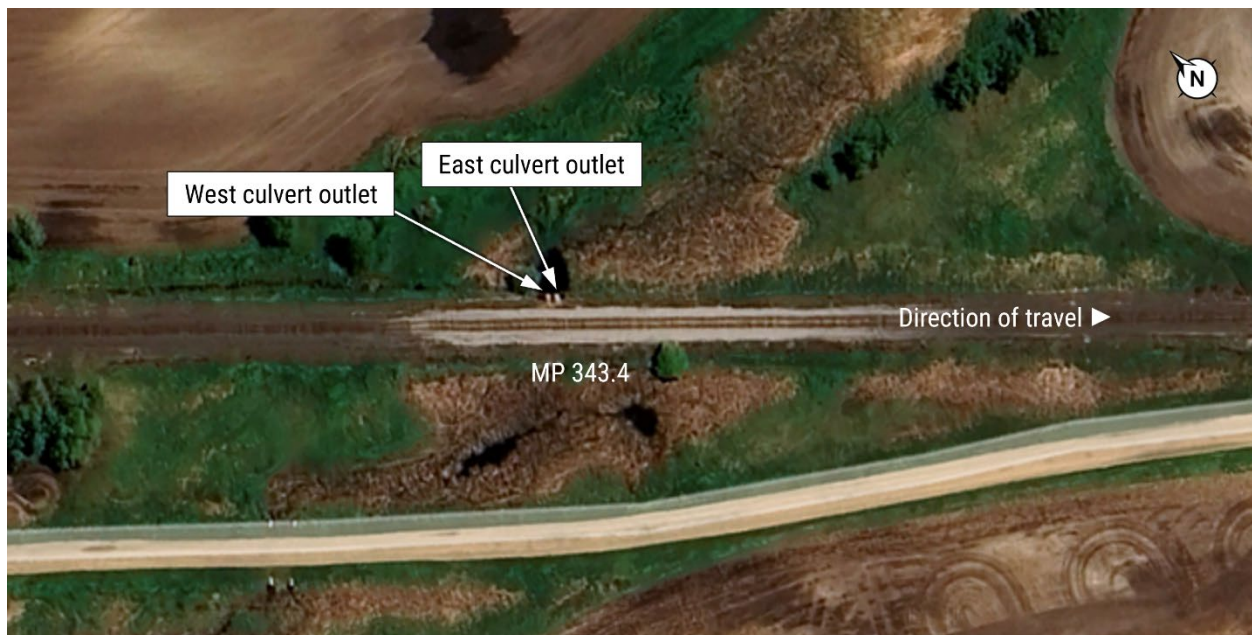
Two drainage culverts ran perpendicular beneath the track at the derailment site at MP 343.4. Installed in October 1913, the two culverts were each 48 feet long and consisted of five sections of 48-inch-diameter concrete pipe, connected at bell-and-spigot joints.<sup>28</sup> This report refers to them as the west culvert and east culvert, as indicated in figure 6.

**Figure 6.** Aerial image of derailment location. (Source: Google Earth).

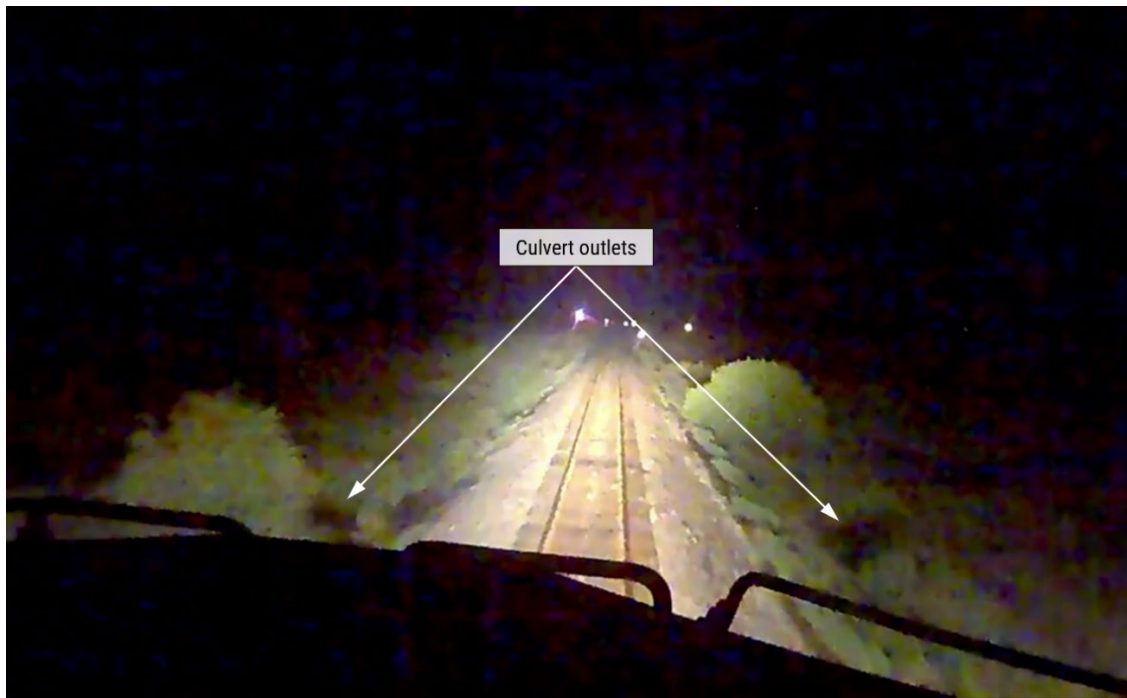
Both locomotives on train 242-03 were equipped with image recording systems. NTSB investigators reviewed the video from these locomotives and video from the outward-facing cameras on the ATI vehicle and six other trains that traversed the area on July 4 or 5. The videos showed no indications of visible track or culvert defects or of developing unsafe conditions, either in the hours preceding the derailment or as the accident train approached the derailment location, shown in figure 7.

**Figure 7.** A still image from lead locomotive CP8882 as it approached the derailment area, with the outlets of the east and west culverts visible. (Source: CPKC).

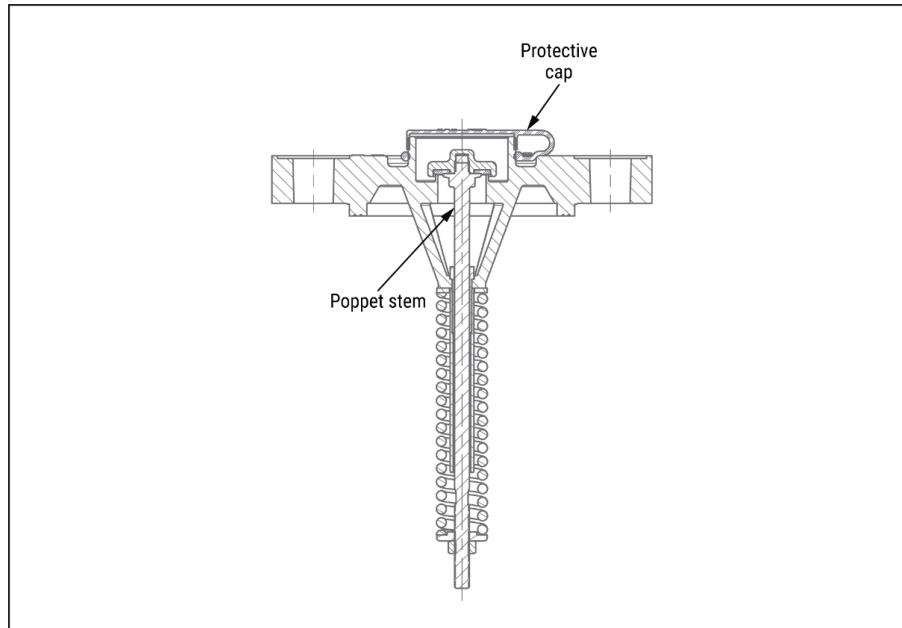
The PRDs used on each of the anhydrous ammonia tank cars involved in this derailment were REGO A8434FA series.<sup>37</sup> (See figure 12.) These shear-resistant low-profile PRDs are about 1 inch high and have a start-to-discharge pressure of 280.5 psig and a flow capacity rated at 3,549 standard cubic feet per minute (SCFM, nitrogen).<sup>38</sup>

**Figure 12.** Diagram of the REGO A8434FA-series PRD.

The PRDs from the four breached anhydrous ammonia tank cars and one additional derailed anhydrous ammonia tank car were removed and sent to the National Board of Boiler and Pressure Vessel Inspectors (NBBI) Pressure Relief Laboratory in Worthington, Ohio, for examination.<sup>39</sup> The NTSB's post-derailment PRD examination reported the flow area of the PRDs to be about 0.809 square inches.<sup>40</sup>

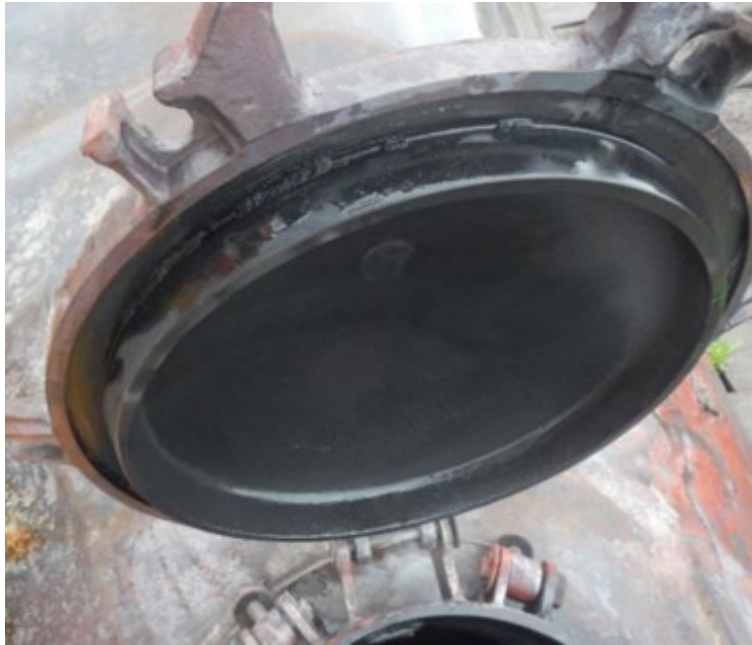
Tank car (60) CTCX300362 came to rest upright in the middle of the general pileup. Its manway cover gasket was absent. Some carbon fragments remained in the gasket groove. (See figure 18.) The shipper, Methanex Corporation, specifies that manway gasket material used in these tank cars must be made from ethylene propylene diene monomer (EPDM), a synthetic rubber.<sup>51</sup>

**Figure 18.** Manway cover on tank car (60) CTCX300362.

The tank car also had large dents on both the B-end head shield and the top of the tank shell, where a hopper car had come to rest. About half of the tank's surface had been exposed to fire, with scorched paint and red oxidation discoloration of the tank jacket steel across the surface, including near the manway.

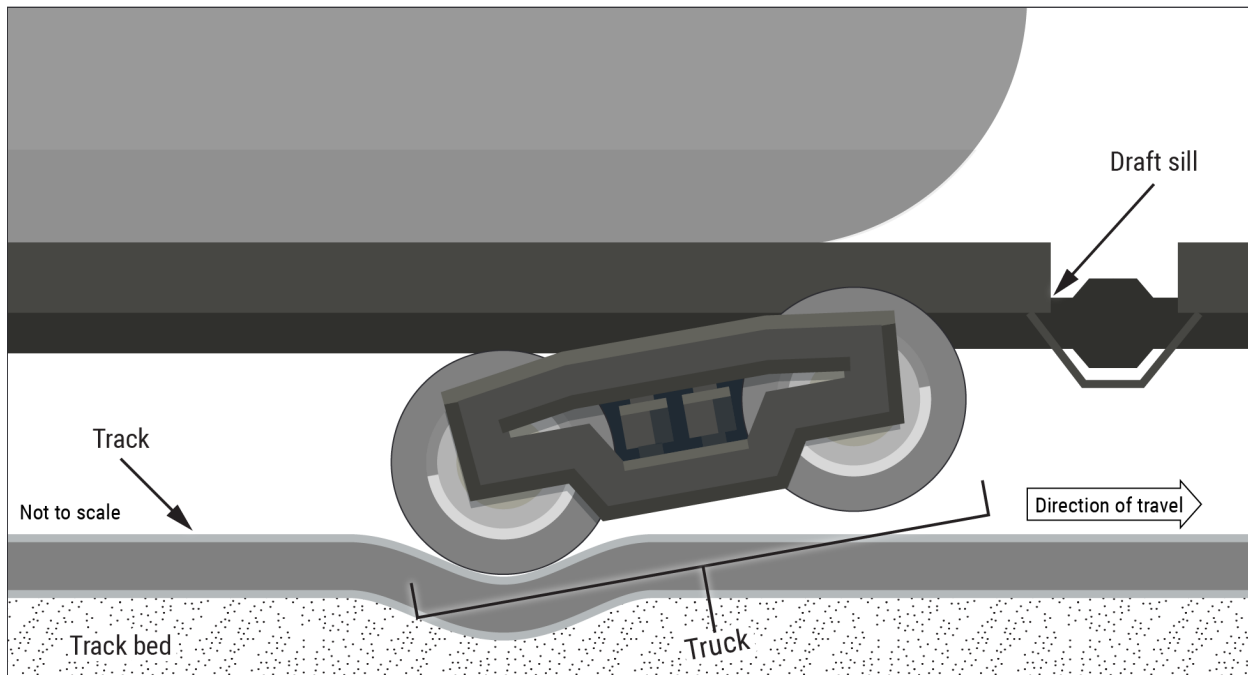
Tracks are designed to transmit the loads from the train’s wheels to the rails, then into tie plates, crossties, ballast, and finally the subgrade. The pattern of witness marks on the axles of the 36th through the 39th railcars indicated a sudden loss of vertical track support, which initiated an extreme vertical profile condition (a dip) on the surface of the rails. The axles struck the railcar’s draft sills as the trucks passed over the newly formed dip and pitched up and down. (See figure 28.)

**Figure 28.** Illustration of the movement of railcar trucks, showing axle contact with draft sill.

When a train traverses rails that lack vertical support from ballast, the loads on the rail can exceed a rail's strength and result in a rail break; then, as the train traverses a broken rail, railcar wheels impact the broken rail ends, leaving witness marks. The pattern of witness marks on the wheels of the railcars indicated that the south rail likely broke as railcars 39 and 40 passed over it—after the void collapsed and as the railcars were negotiating the extreme dip in the rails. Therefore, the NTSB concludes that the sudden collapse of the void in the subgrade supporting the track at MP 343.4 initiated a dip in the rails, and as the 39th and 40th railcars traversed the dip, the applied forces from train 242-03 likely caused the south rail to break.

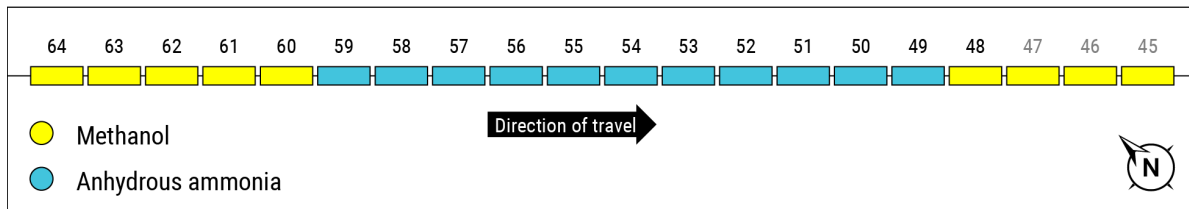
In this accident, the hazardous conditions typically present in a derailment were compounded by the placement of general-service tank cars carrying about 164,000 gallons of flammable liquid methanol both immediately in front of and immediately behind several anhydrous ammonia tank cars. (See figure 30.) The in-train placement of the methanol and anhydrous ammonia tank cars provided a scenario in which the anhydrous ammonia tank cars were run into from behind by the less-crashworthy DOT-117R flammable liquids tank cars. This scenario ultimately led to the DOT-112 tank cars being engulfed in a pool fire, resulting in the thermal tears discussed in section 2.4. Without the methanol-fueled pool fire, about 90,000 gallons of anhydrous ammonia would not have been released from the three tank cars that experienced thermal tears.

**Figure 30.** Arrangement of hazmat tank cars line 45 through 64 on train 242-03.

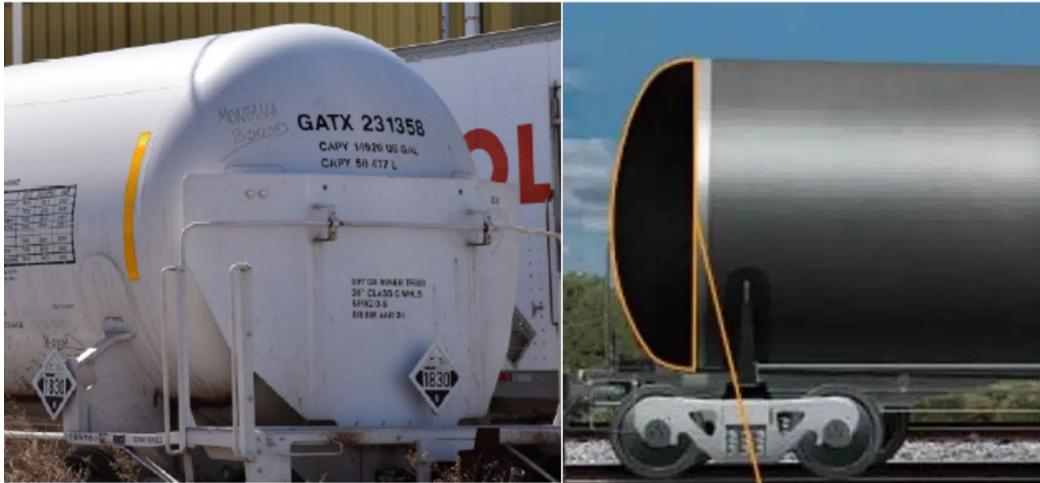
In its investigation report on the Lac-Mégantic accident, the Transportation Safety Board of Canada noted that all but four of the 63 derailed DOT-111 specification tank cars exhibited some form of impact damage in the top portion of at least one head, and that a full head shield on the tank cars that derailed “would have been beneficial” (TSB 2014). (See figure 31 for examples of half- and full-height head shields.)

**Figure 31.** An example of a half-height head shield (*left*) and a full-height head shield (*right*), which is typically built into the tank shell. (Source: AAR.)
